RESERVE FUND STUDY LAKE LINGANORE ASSOCIATION

LAKE LINGANORE ASSOCIATION

Criterion-Harbor Engineers

November 2, 2017

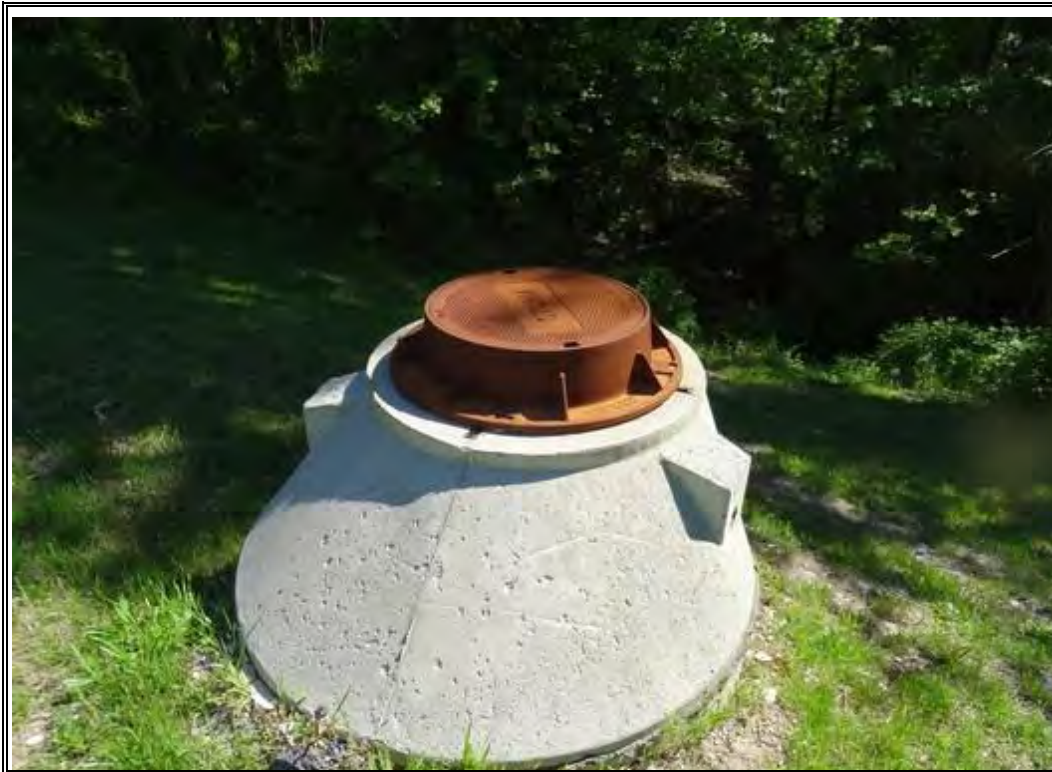
Photo Number
21

About four years ago, the Association experienced a sinkhole along the Eaglehead Drive related to the collapse of a large stormwater pipe at a significant depth and appropriate repairs were performed. We believe it would be prudent to perform inspections on a regular basis of similar facilities within the community in order to avoid possible similar problems in the future.

New storm water manhole was installed on south side of Eaglehead drive as part of recent sinkhole repairs

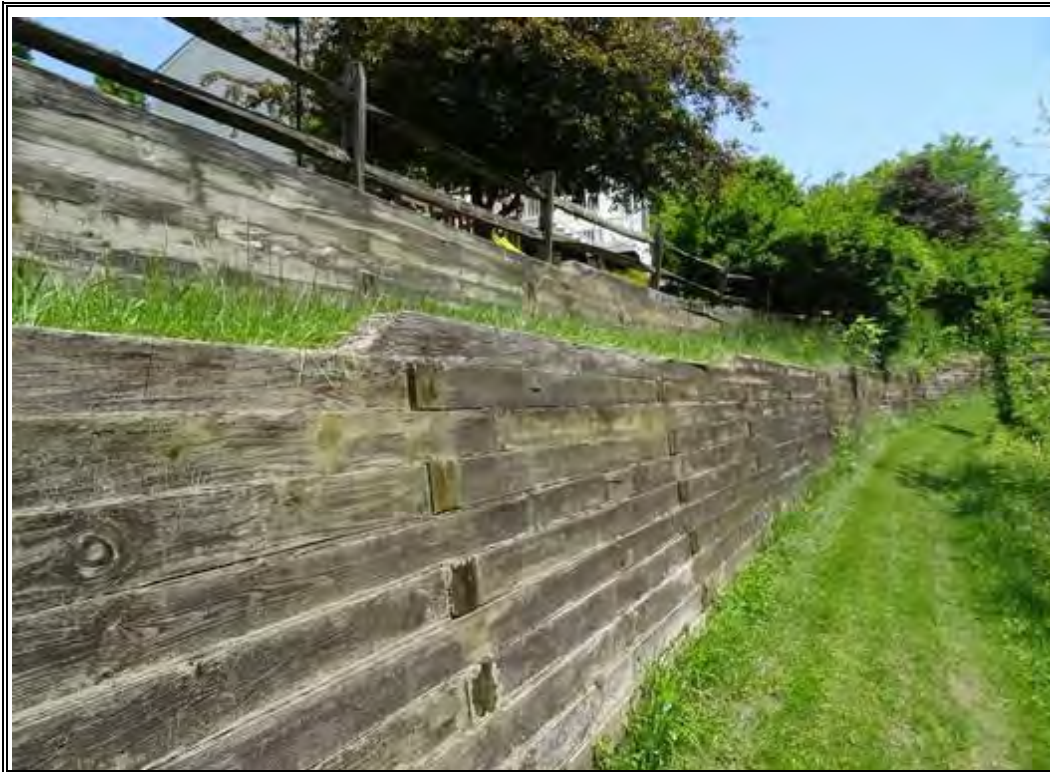
The wood timber retaining walls vary in condition, however most are older and nearing the end of their useful lives. Based on an engineering evaluation of the walls that was recently performed for the Association, we have included replacement cost estimates in the reserve tables.

Timber log retaining wall in Summerfield village located on south side of Huckleberry Way:

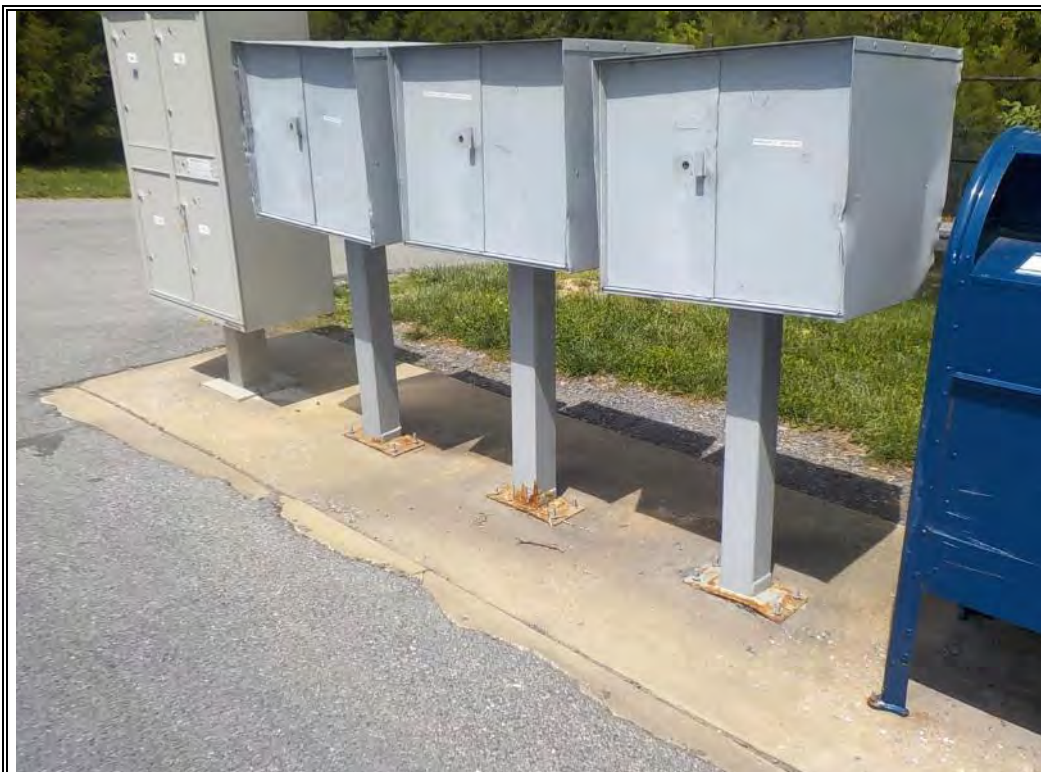
The cluster mailboxes are in good to fair condition with some rusting. Due to budget restrictions, the United States Postal Service may not provide for replacement of these mailboxes and we recommend that the Association reserve funds for this component. We have included a cost estimate in the reserve tables for periodic partial replacement of the cluster mailboxes.

The mailbox units vary in condition and are replaced on an as needed basis.

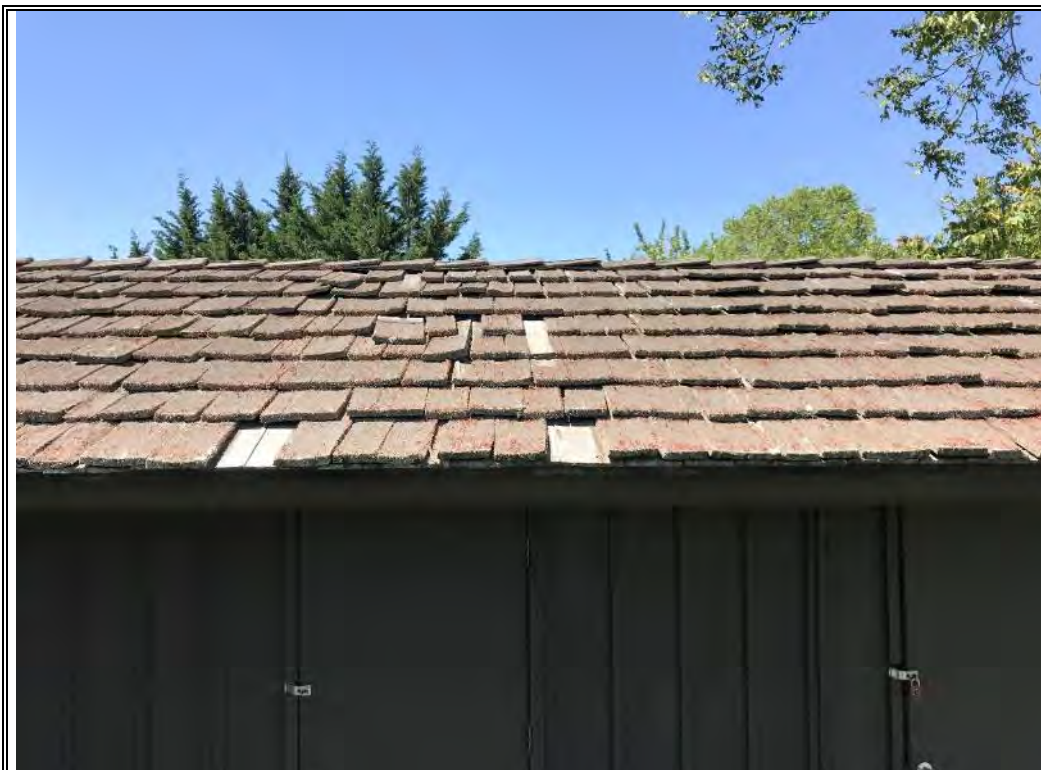
The wood shake roof surfaces appear to be near the end of their EUL. We have included a cost estimate for replacement of these roof surfaces in the reserve tables. The Association has decided to replace the wood shake surfaces with asphalt/fiberglass shingles.

The Cabanas building also has a wood shake surface which is in poor condition.

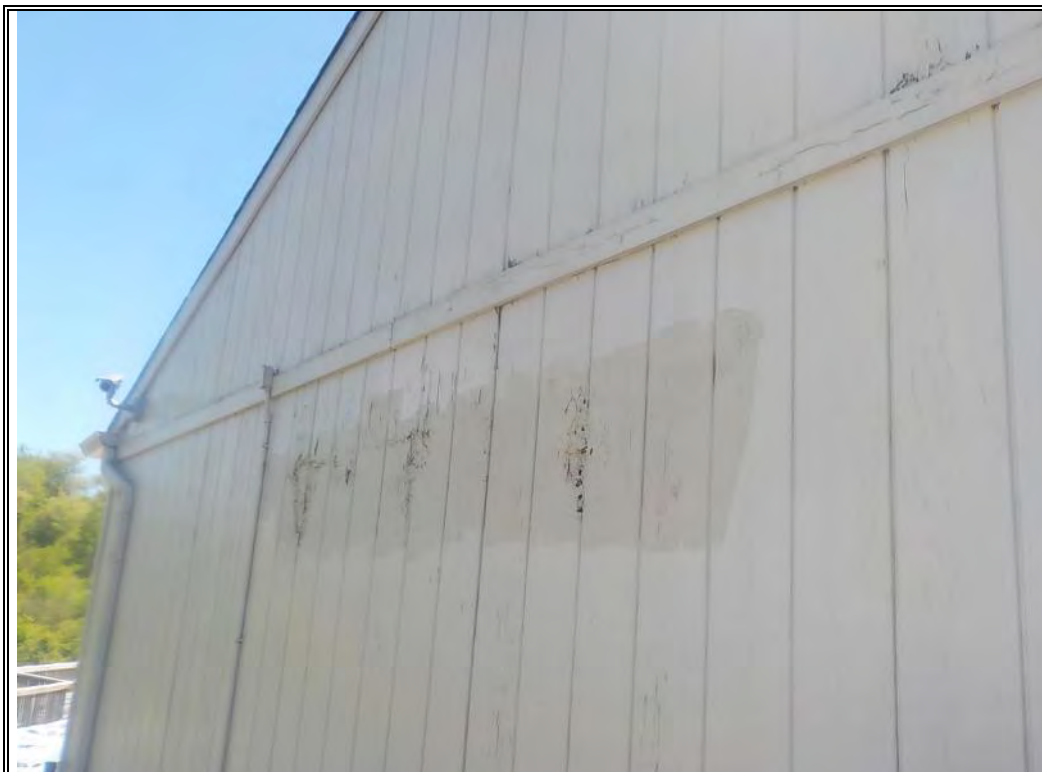
The exterior finishes are in good to fair condition. We observed some wood rot at the West Winds pool building and some deteriorated wood at the Cabanas. We have included a cost in the reserve tables for replacement of the West Winds exterior siding, as well as costs for periodic painting and replacement of wood trim as required on the other buildings.

We observed wood rot at several locations on the West Winds building exterior

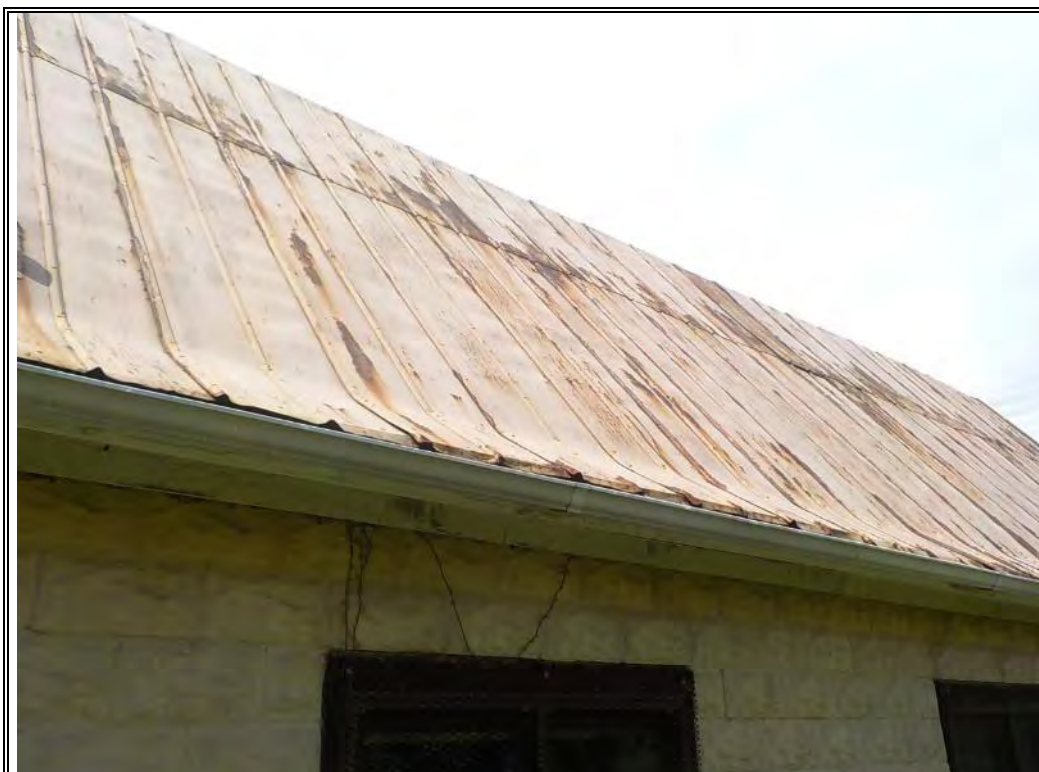
The metal roof surface on the barn is also nearing the end of its EUL. We observed considerable rusting and recommend that this surface be replaced soon.

The barn has a metal roof surface which is in fair to poor condition

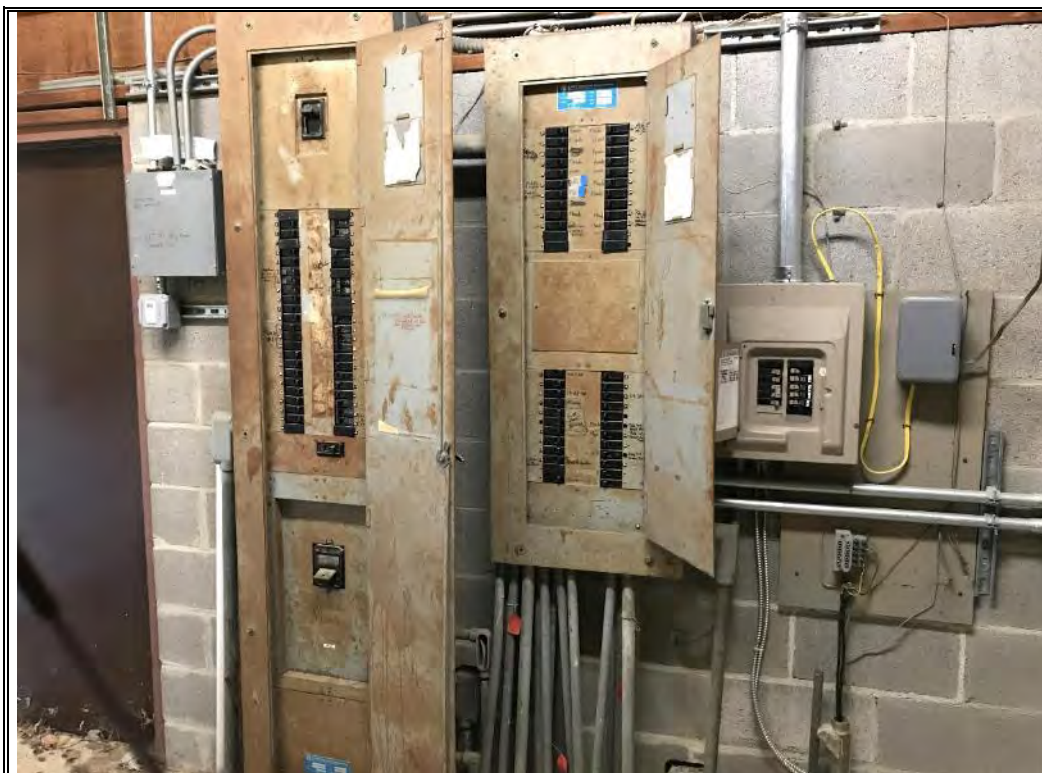
Electrical circuit breaker panels in the Coldstream building are rusting and should be replaced soon.

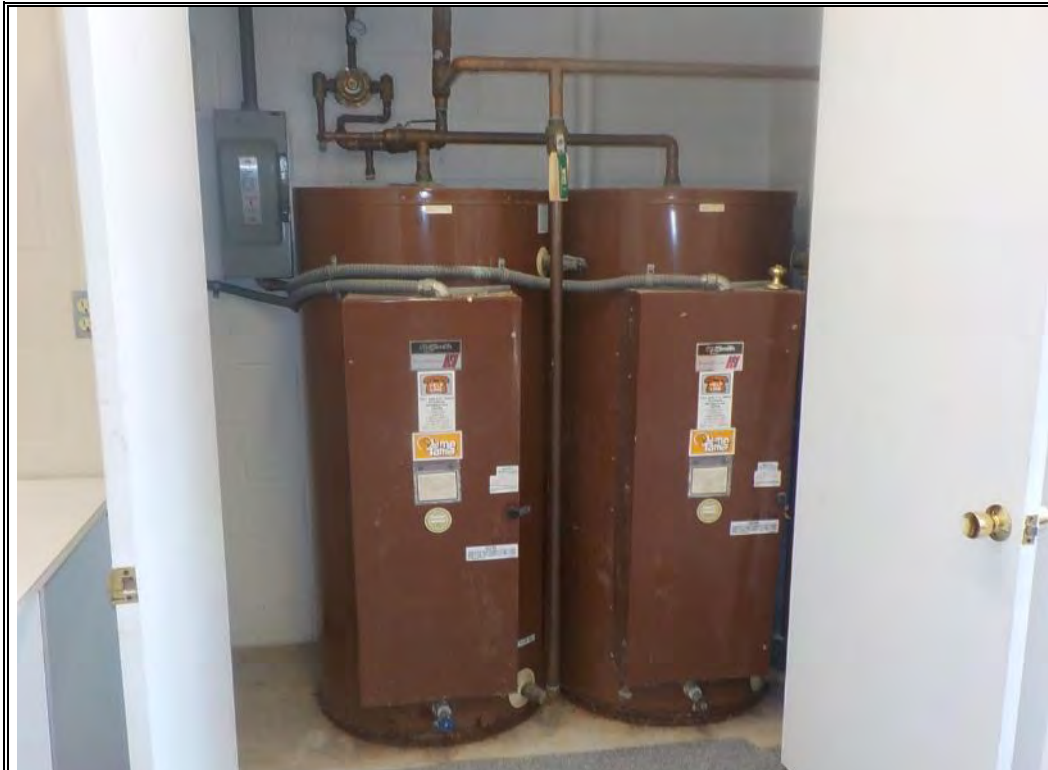
The electric water heaters at Summerfield pool are 26 years old. (two @ 120 gallons)

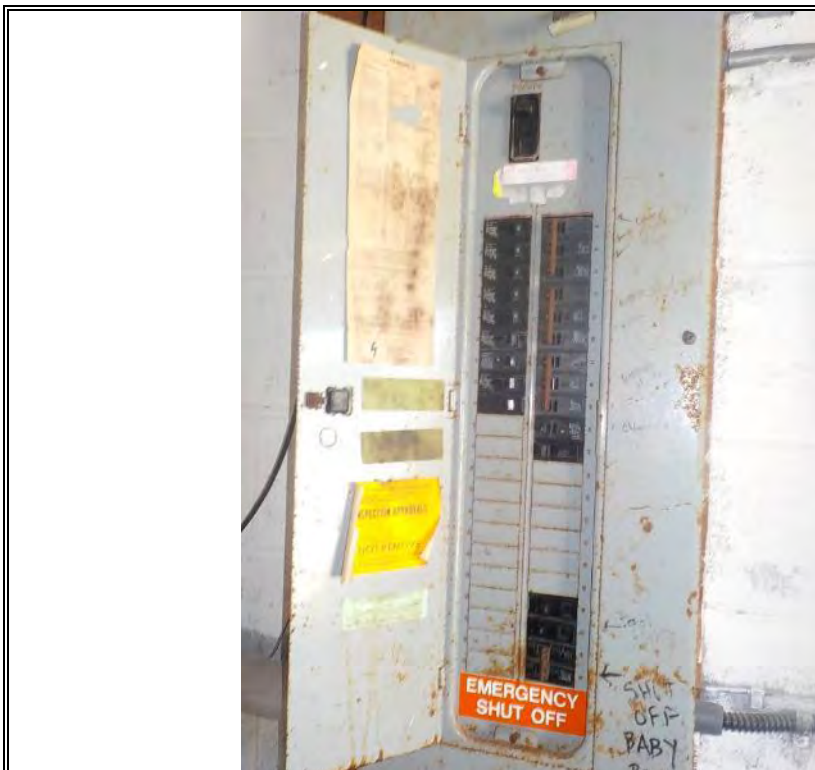
The electric panel at the Summerfield pool building is rusting and should be replaced soon

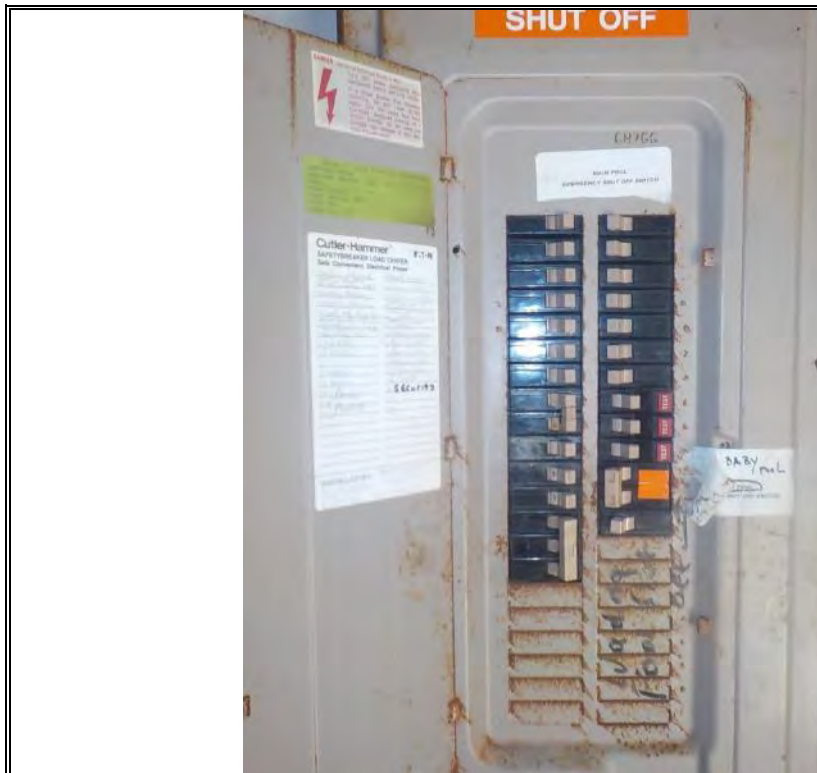
The electric panel at the West Winds pool building is rusting and should be replaced soon

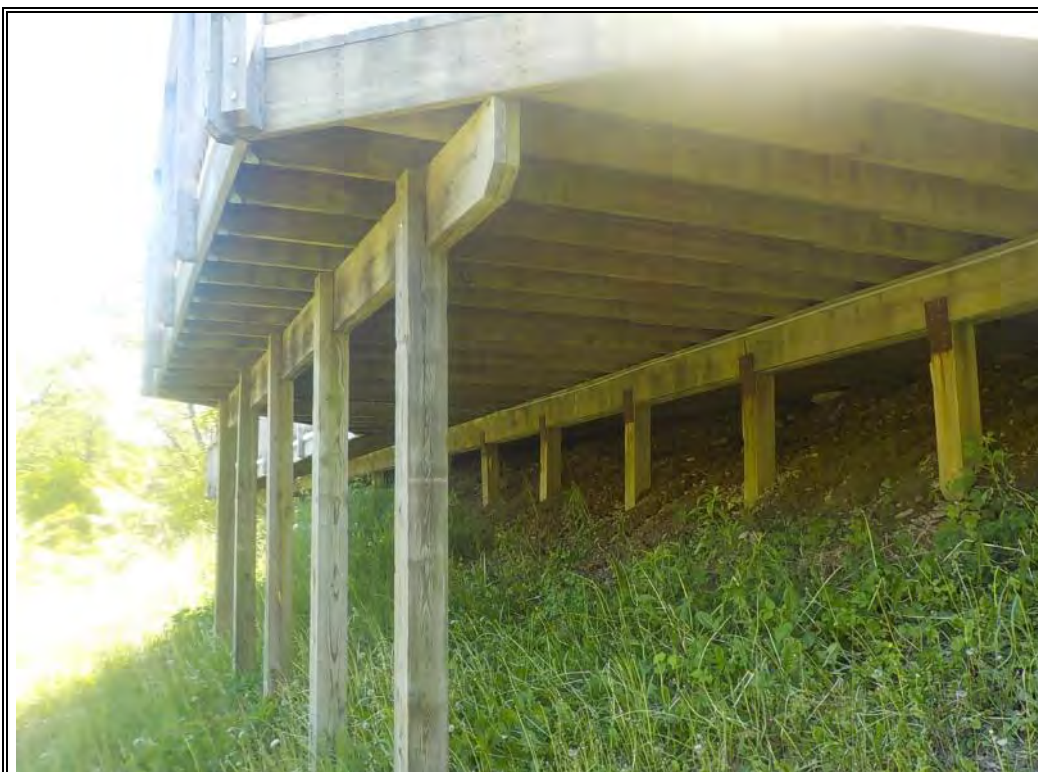
West Winds wood deck structure is generally in good condition, although some fasteners are rusting.

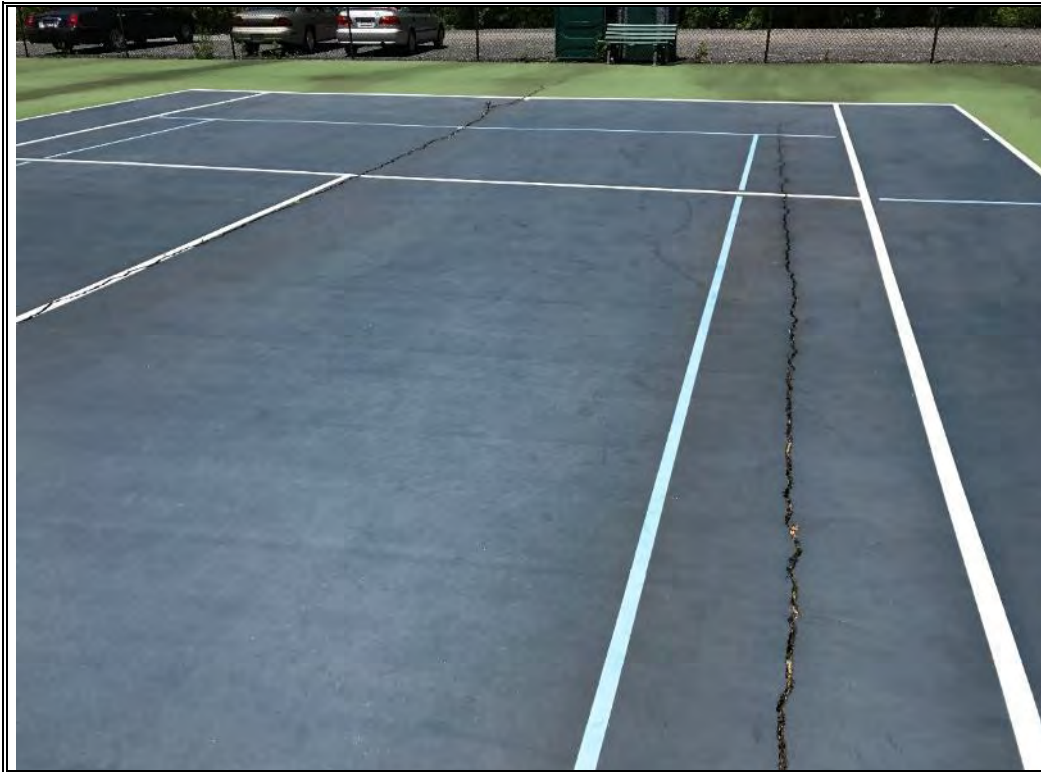
Photo Number
99

Description:
Coldstream tennis courts currently have several large longitudinal cracks

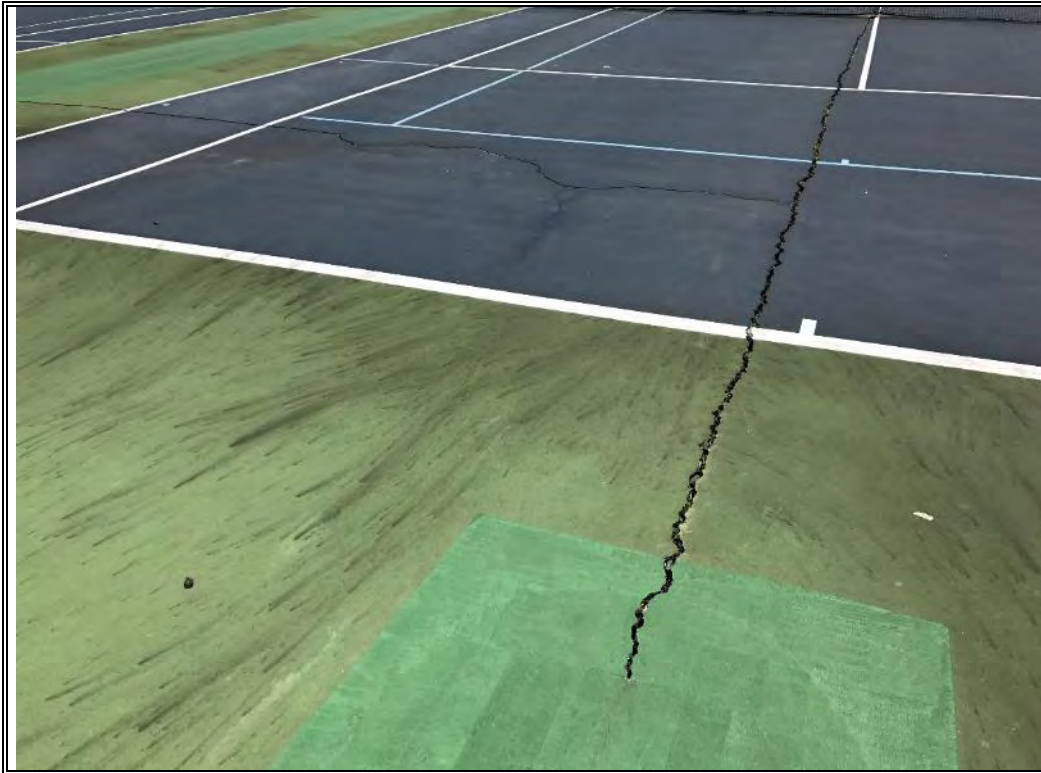
Photo Number
100

Description:
Apparent attempt to patch one of the existing cracks

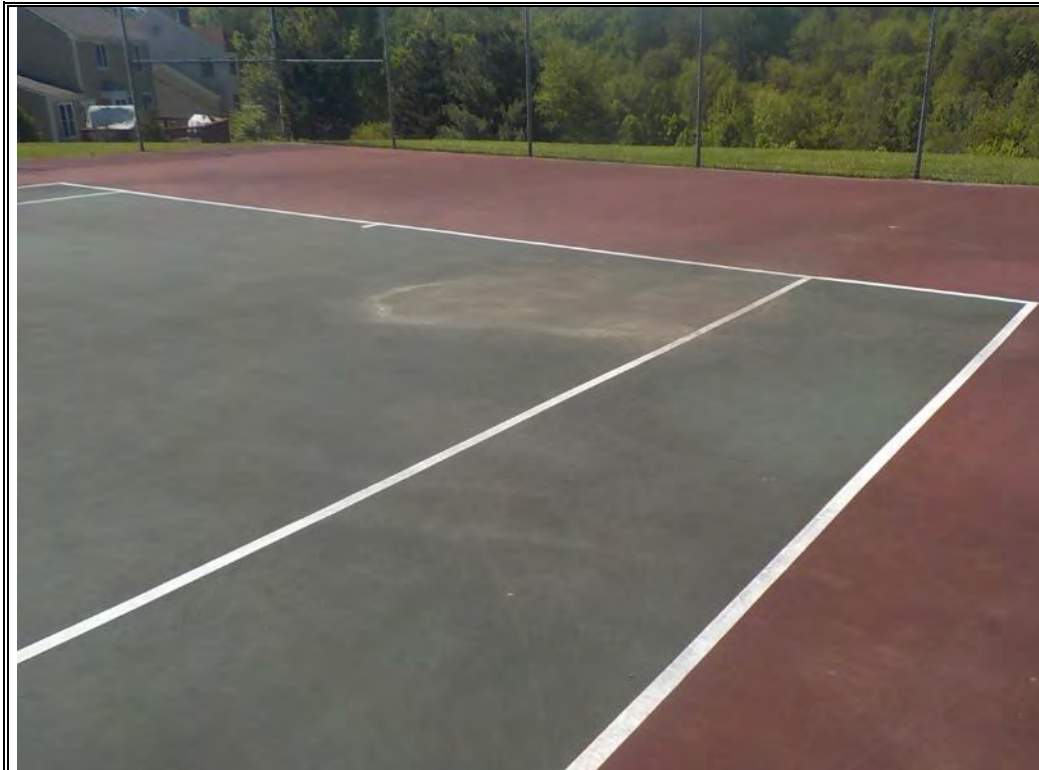
The color coat at the Summerfield tennis courts is worn and there is an apparent low spot in this area.

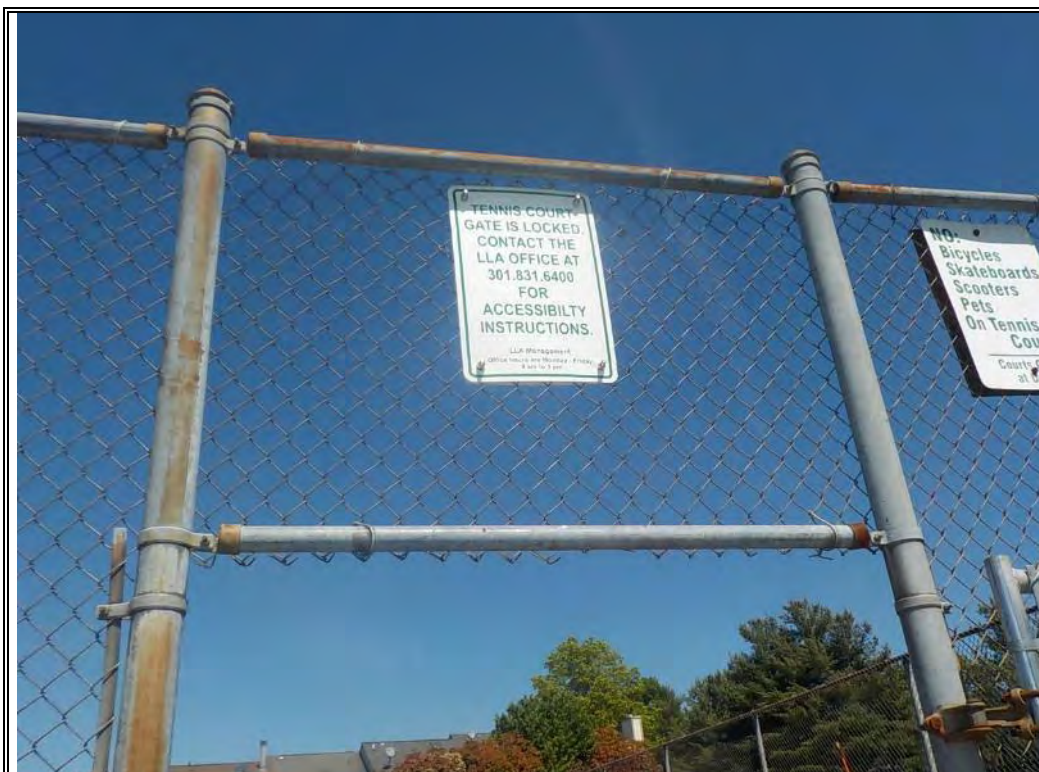
The Summerfield tennis court perimeter fencing is rusting in some areas.

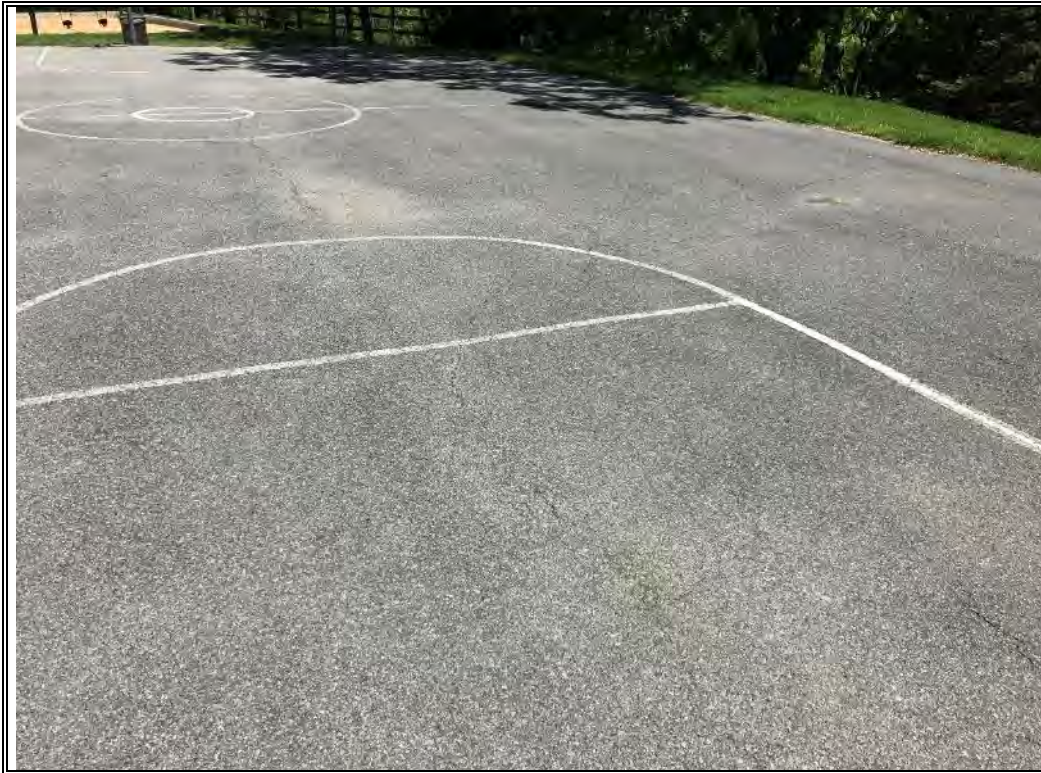
Photo Number
106

Description:
Some wear and
cracking on the
asphalt surface

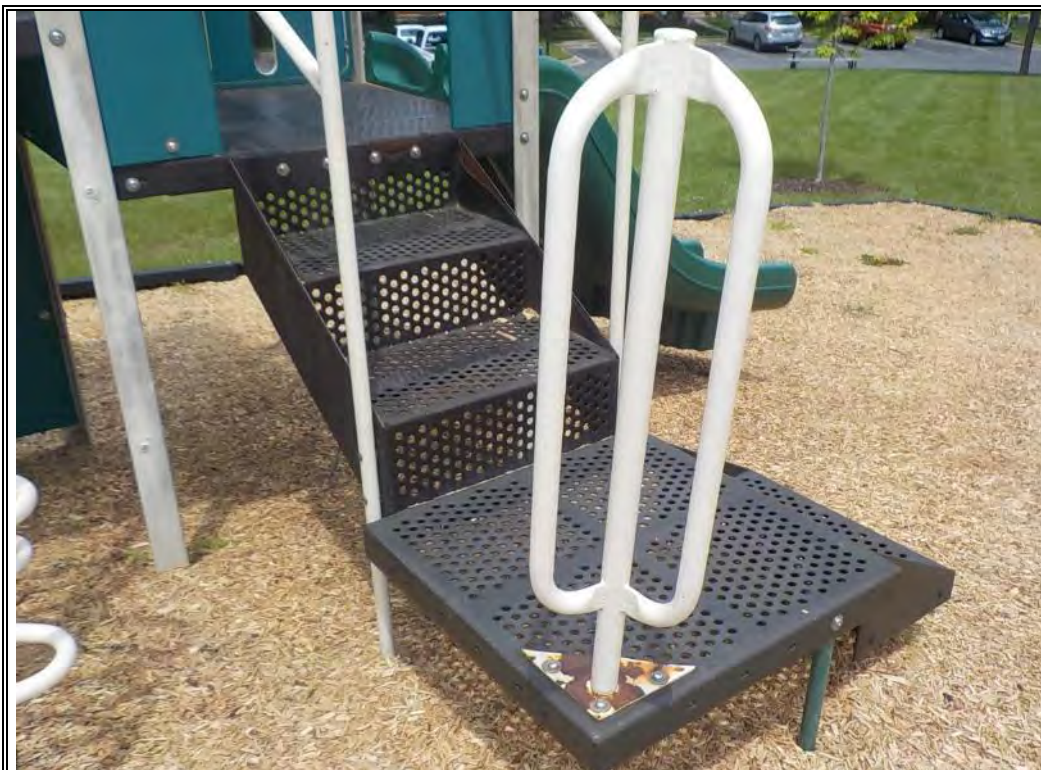
Some minor rust and deterioration at the older sites.

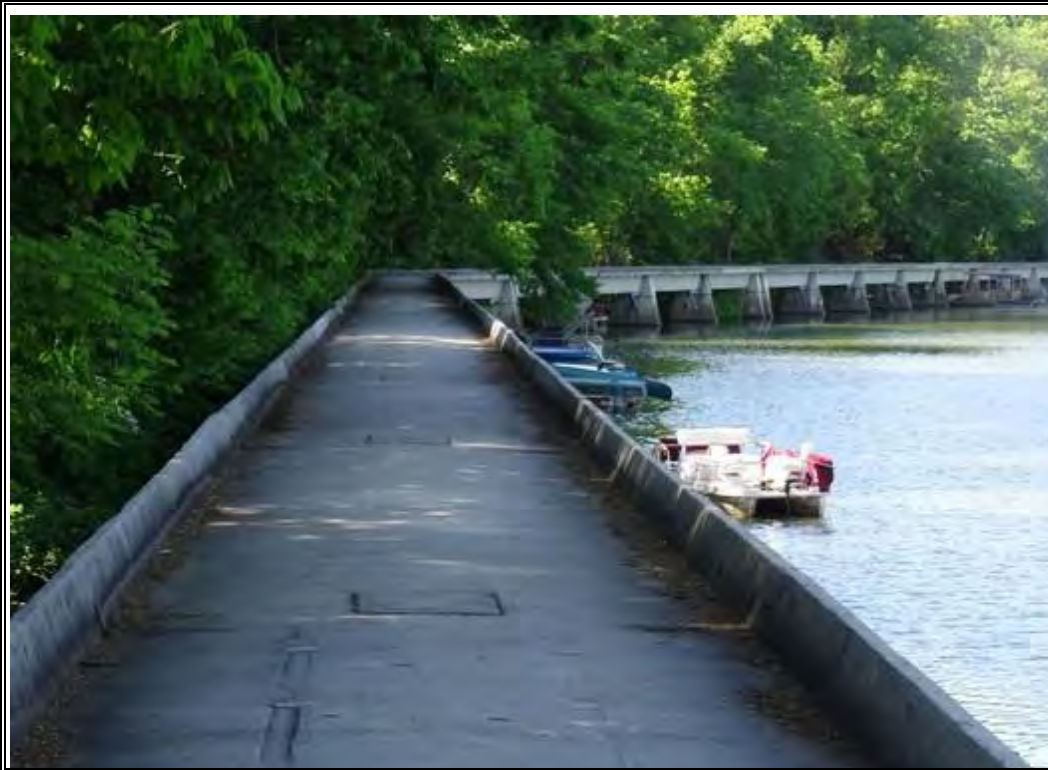
No railings were noted on either side of the esplanade bridge

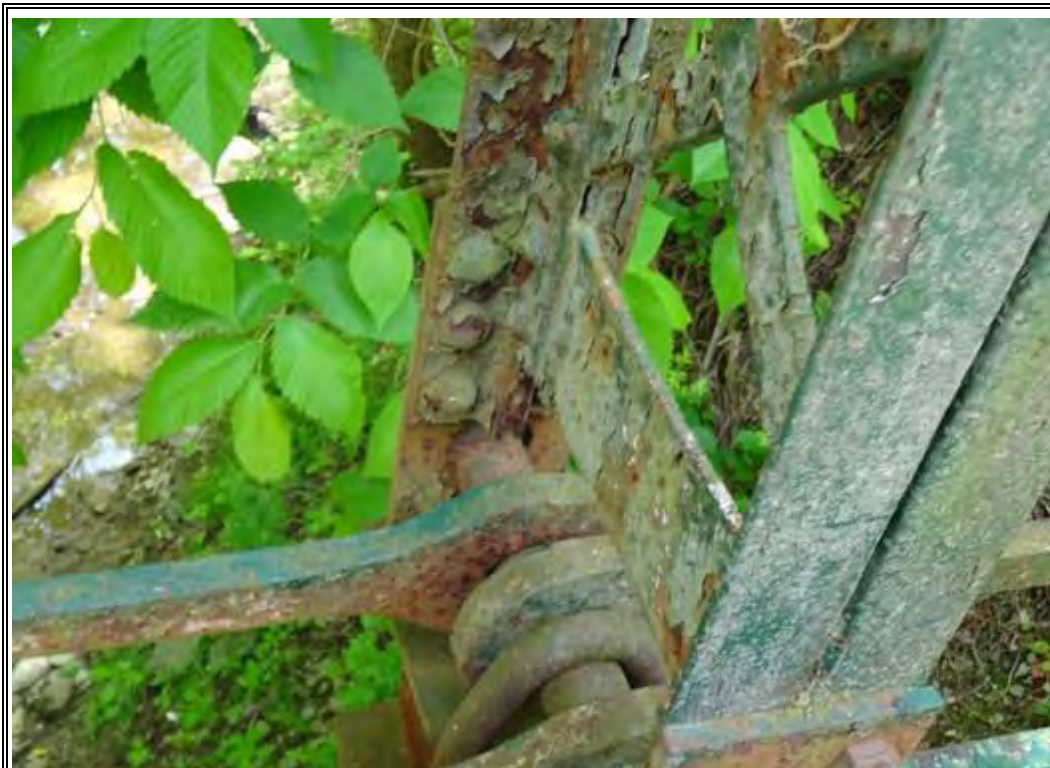
Peeled of steel structure paint and evidence of rust on the steel structure of Ben's Branch bridge

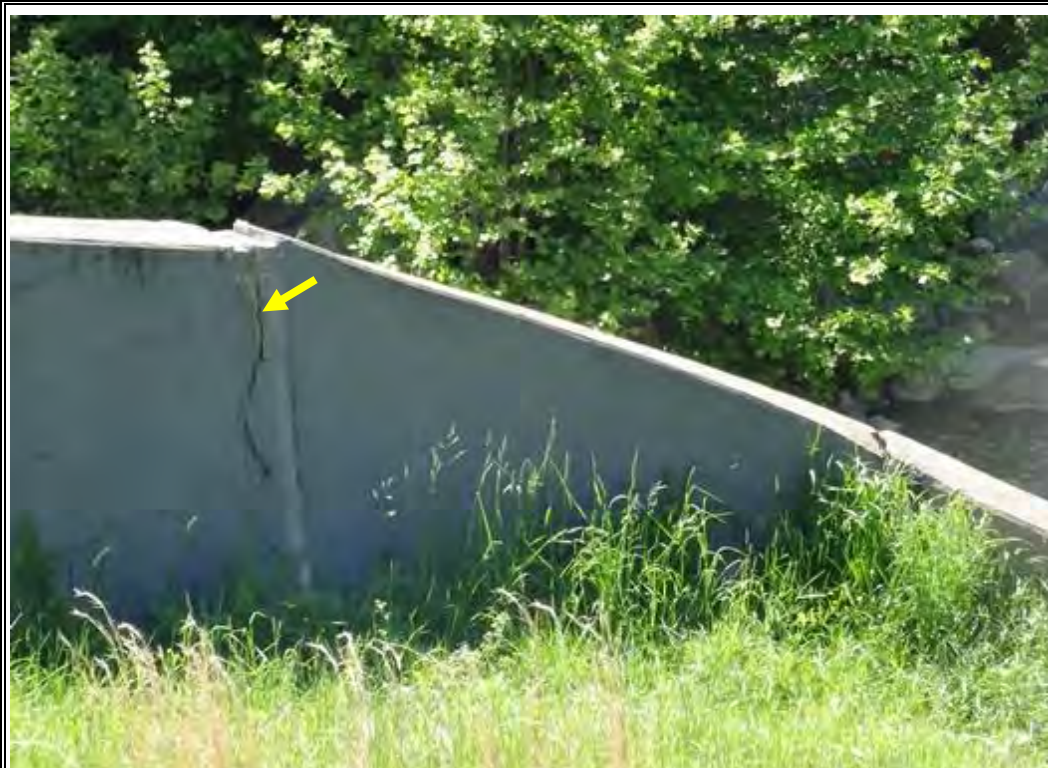
Cracks in the north
concrete wall of
Lake Linganore
spillway

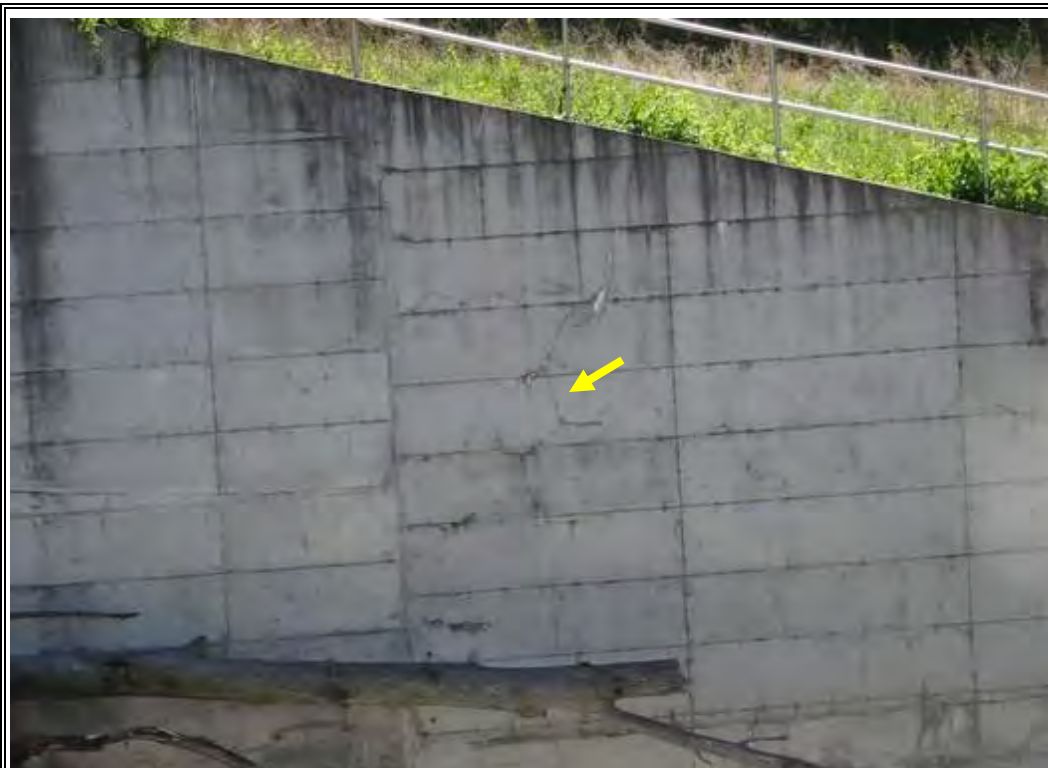
Several cracks
were noted in the
south concrete wall
of Lake Linganore
spillway
