STREAM RESTORATION DESIGN REPORT

WEST WINDS STREAM RESTORATION

NEW MARKET
FREDERICK COUNTY, MARYLAND

TCH
Job #: 2024-0317
Date: SEPTEMBER 2025
Rev: NOVEMBER 2025

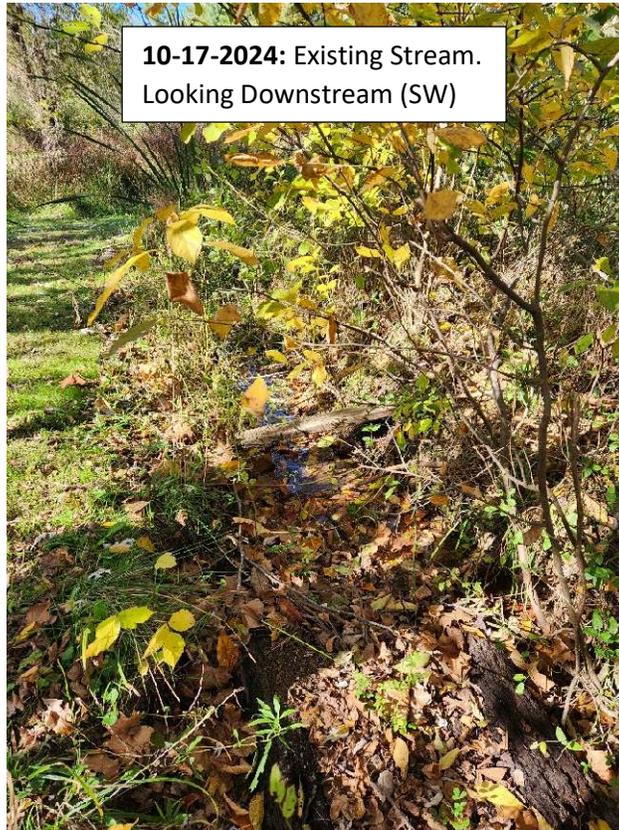
10-17-2024: Existing Stream.
Looking Downstream (SW)

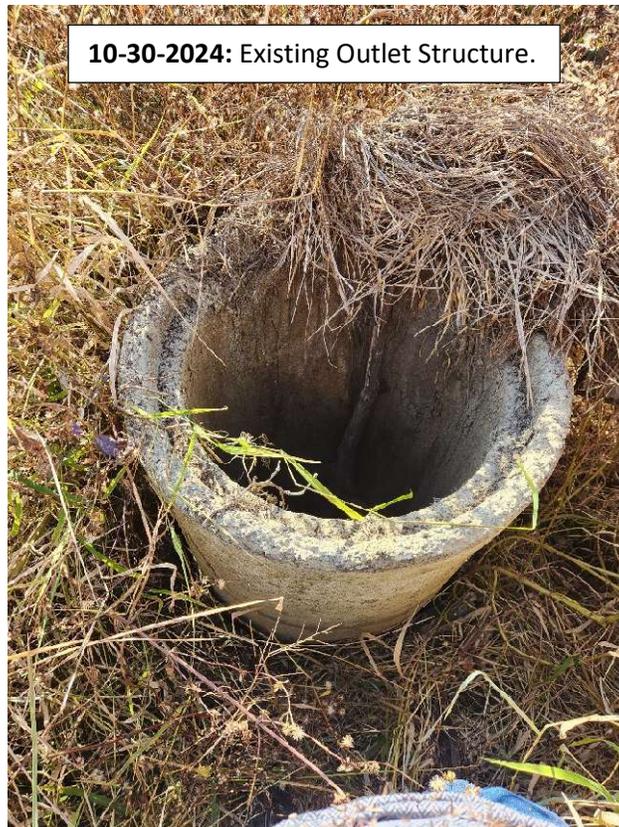
This project is based in the West Winds subdivision of the Lake Linganore Association within Frederick County, MD. Existing conditions describe an unnamed stream flowing into a drained pond with a collapsed outlet structure. This water flows through the outlet pipe into a sinkhole where it spills into an unnamed tributary to Ben's Branch. The project proposes to connect these streams by removing a section of pond berm, creating a stream channel through the existing natural valley, and matching downstream grades with a series of converging step pools. This stream was designed using multiple forms of data collection, such as field and aerial surveys in conjunction with regional curves and a multi-stage channel design to ensure stability. All wetland impacts for the project will be mitigated with a 1:1 square footage ratio via wetland seeding mix. Any tree clearing areas will be mitigated through both planted live stakes along the stream banks, and future forestation planting by the property owner. There are no negative hydrologic or hydraulic impacts identified on any adjacent properties. See the associated H&H Report and Alternative Analysis for additional discussions on all aspects of the project.

10-30-2024: Existing Outlet Structure.

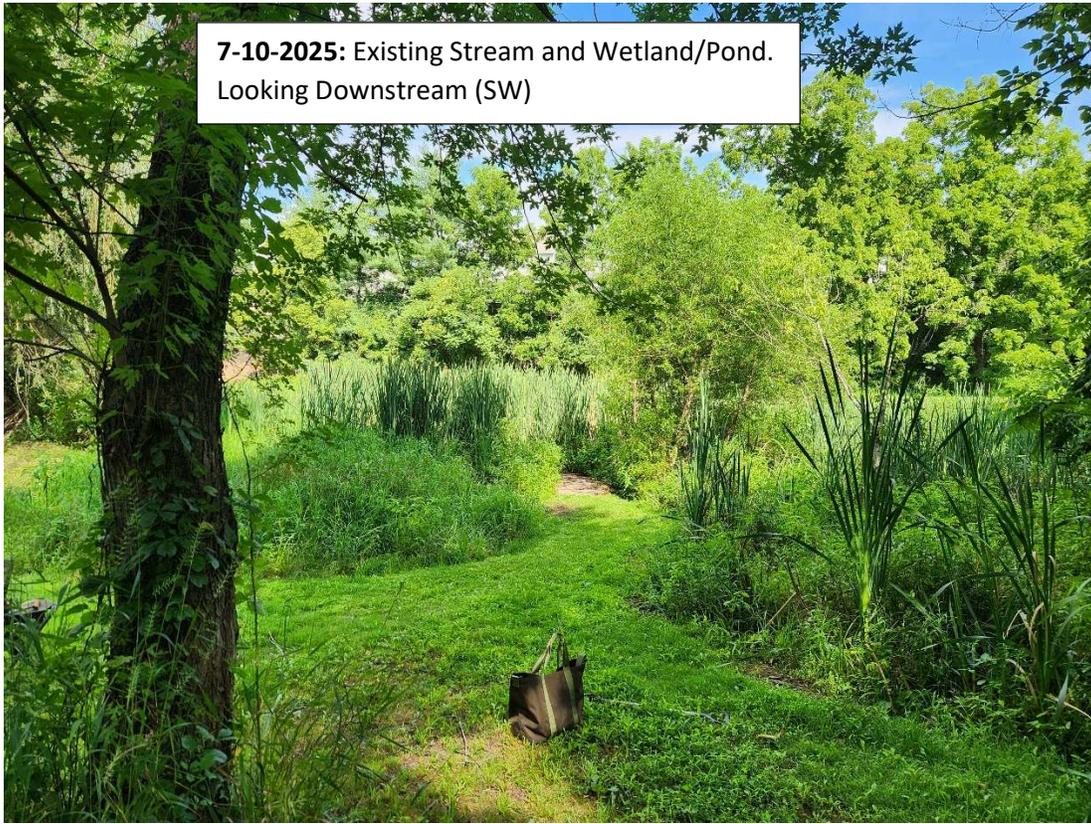
7-10-2025: Existing Stream and Wetland/Pond.
Looking Downstream (SW)

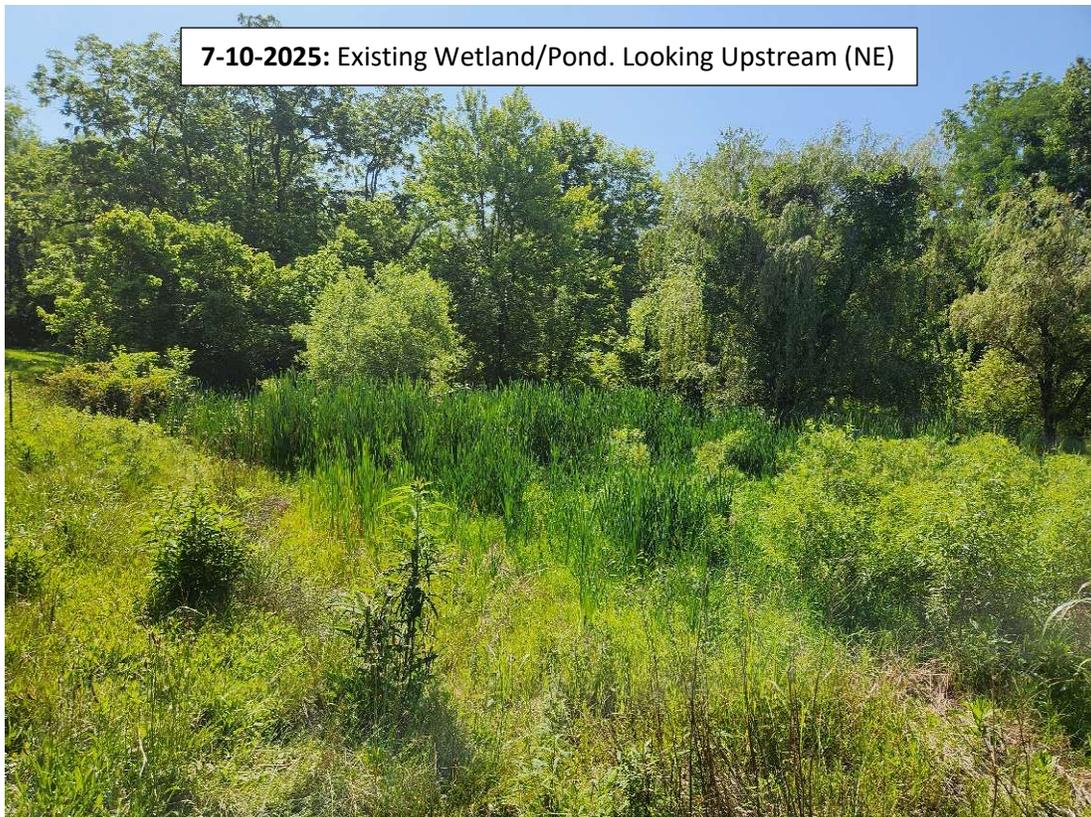
7-10-2025: Existing Wetland/Pond. Looking Upstream (NE)

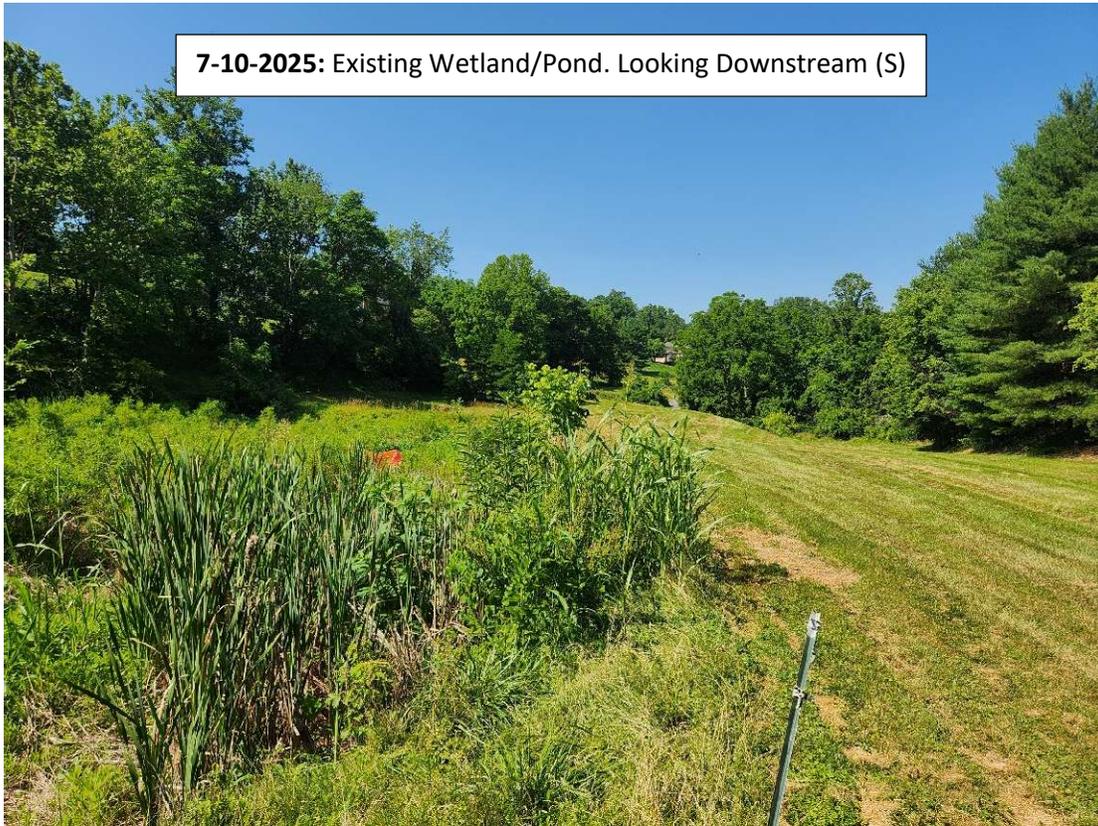
7-10-2025: Existing Wetland/Pond. Looking Downstream (S)

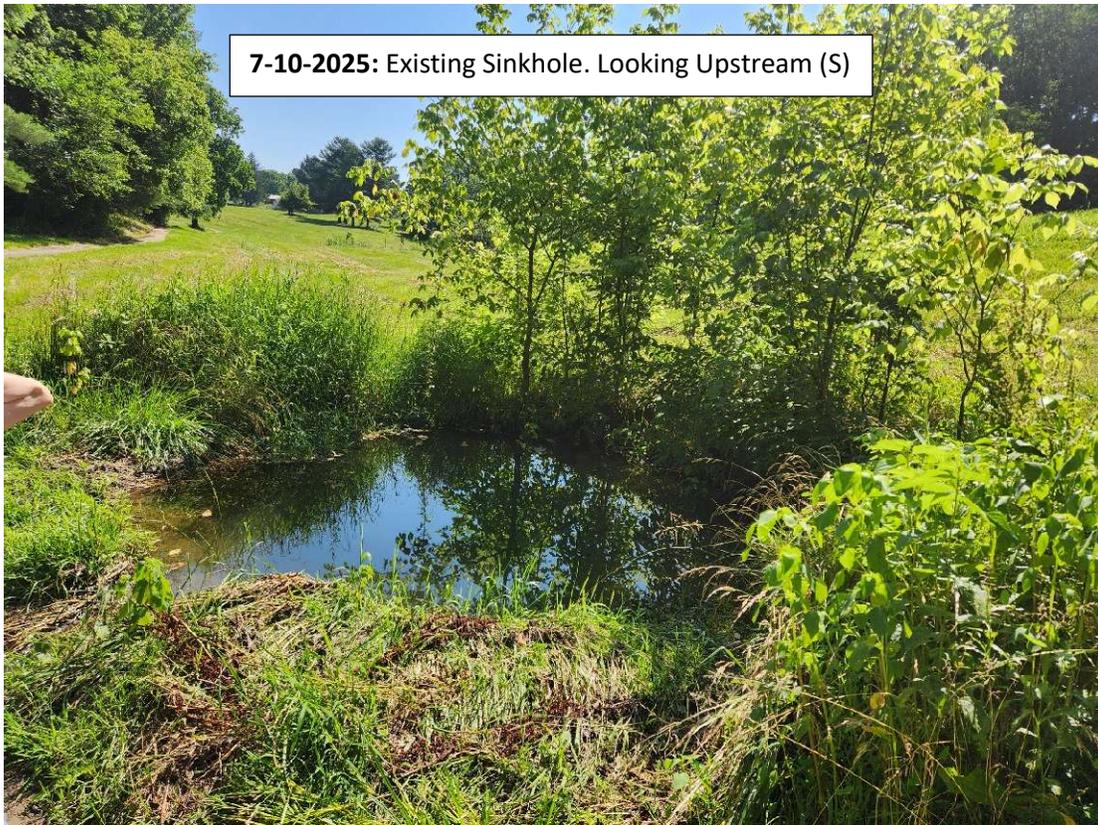
7-10-2025: Existing Sinkhole. Looking Upstream (S)
