RESERVE FUND STUDY LAKE LINGANORE ASSOCIATION

LAKE LINGANORE ASSOCIATION

Criterion-Harbor Engineers

November 2, 2017

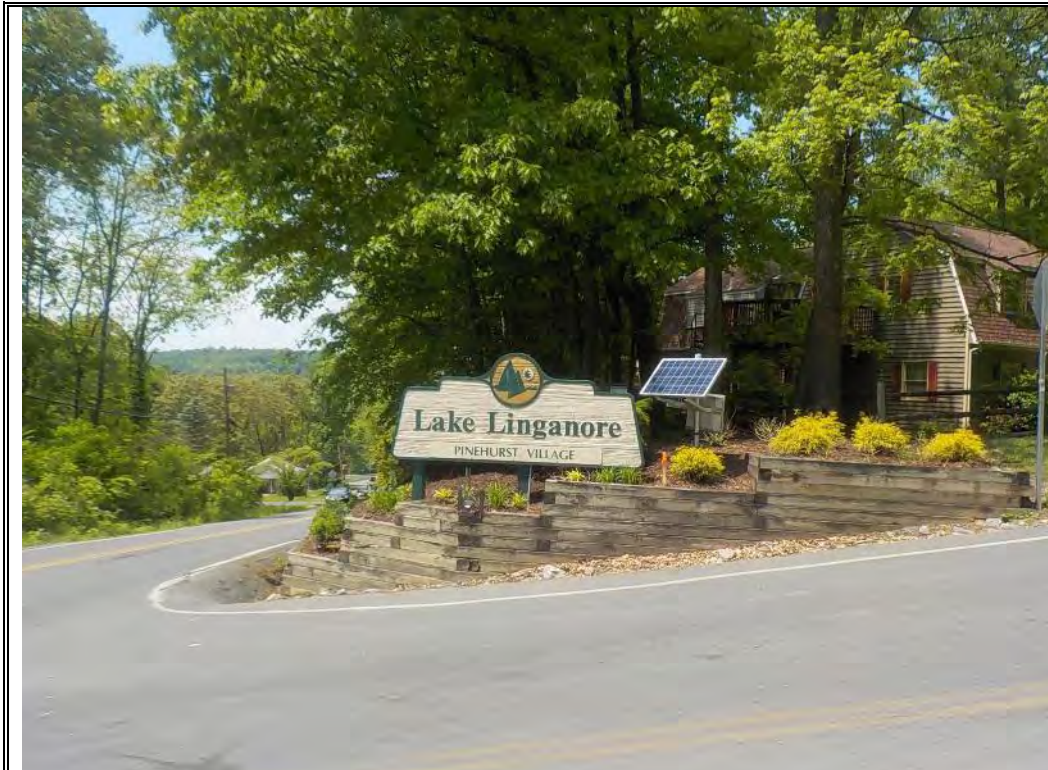
1

Typical wood sign and timber retaining wall located at the entrance to Pinehurst village

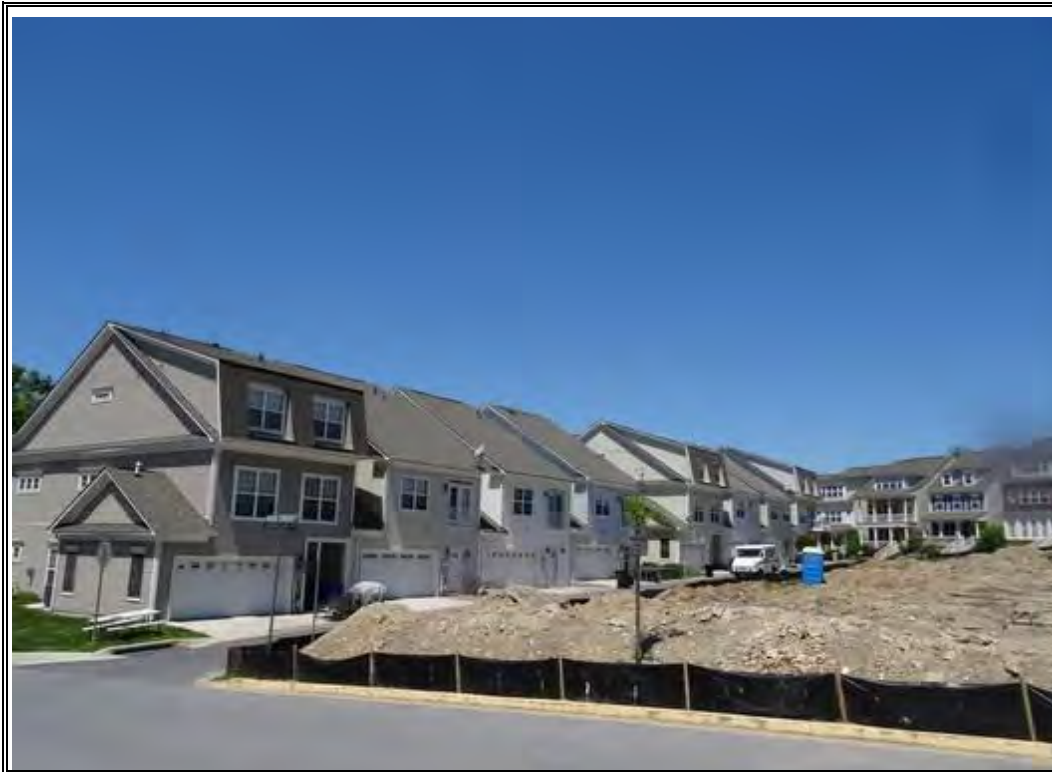
3

Audubon Terrace townhomes under construction

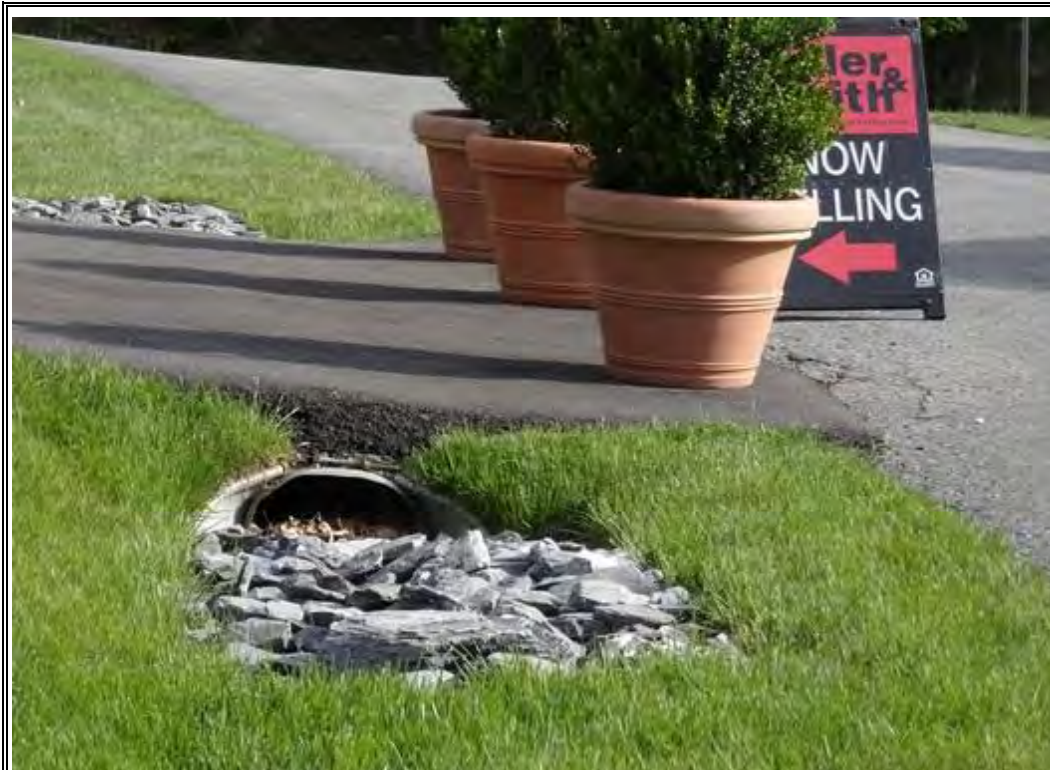
7

Aspen North:
Drainage culvert
under asphalt
driveway of home

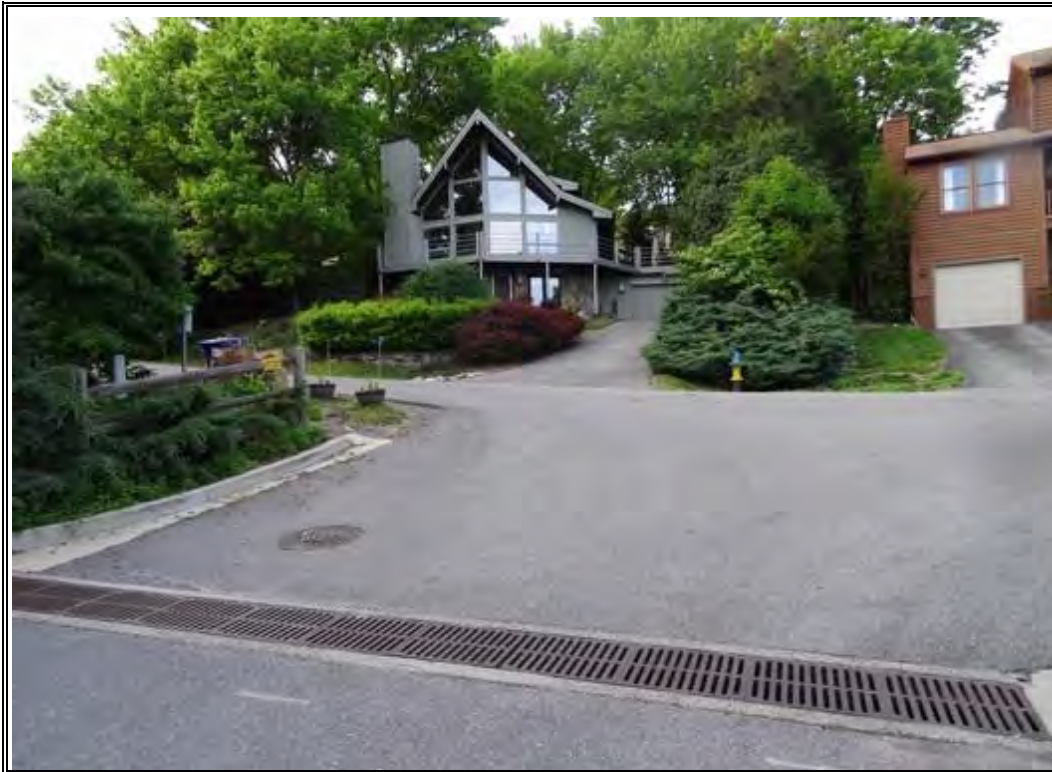
11

Coldstream village
roadways

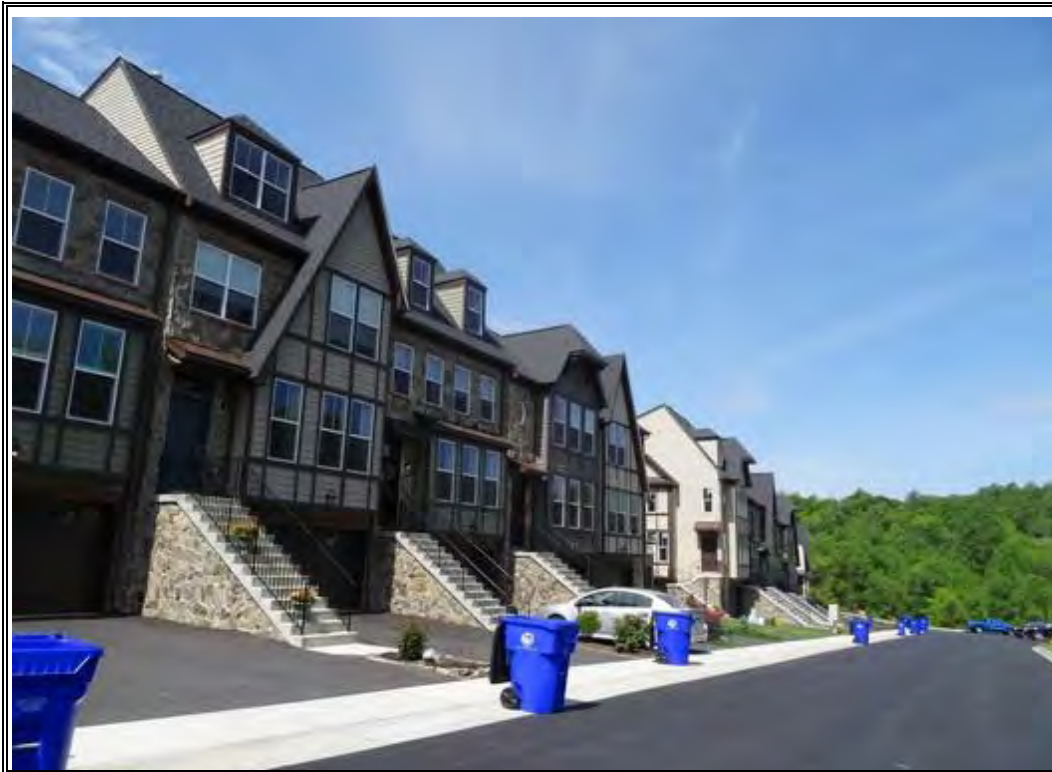
Photo Number
13

Description:
New roadways
along Woodlands
Preserve
Townhomes

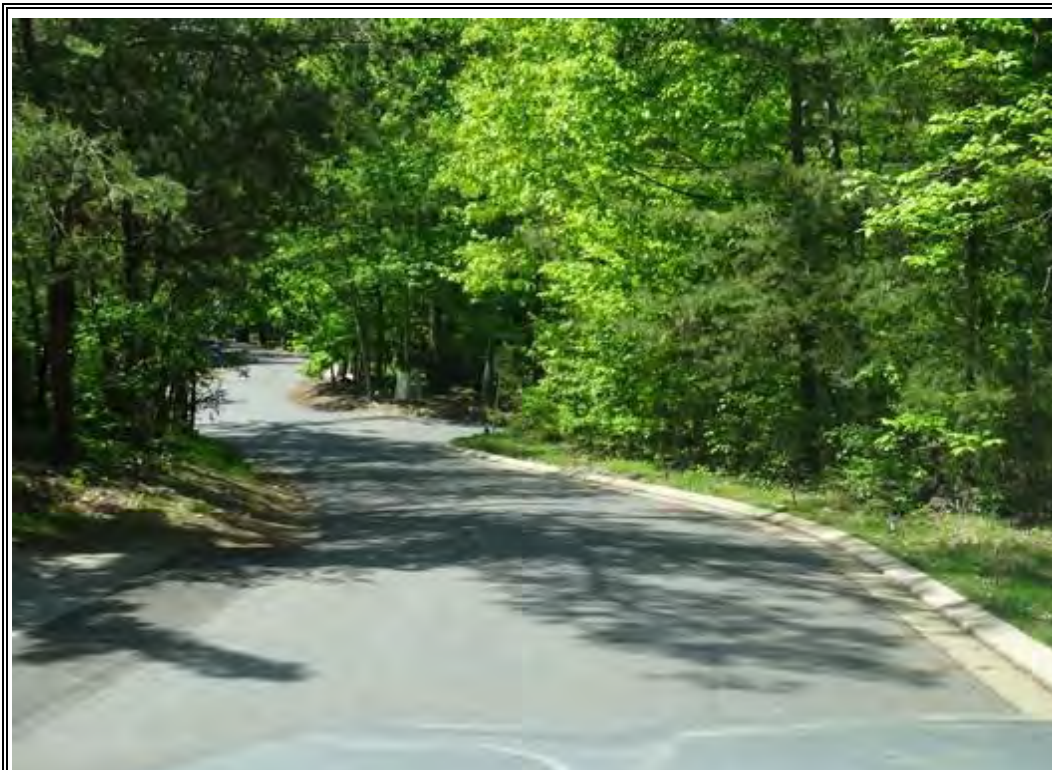
Photo Number
14

Description:
Balmoral village
roadways

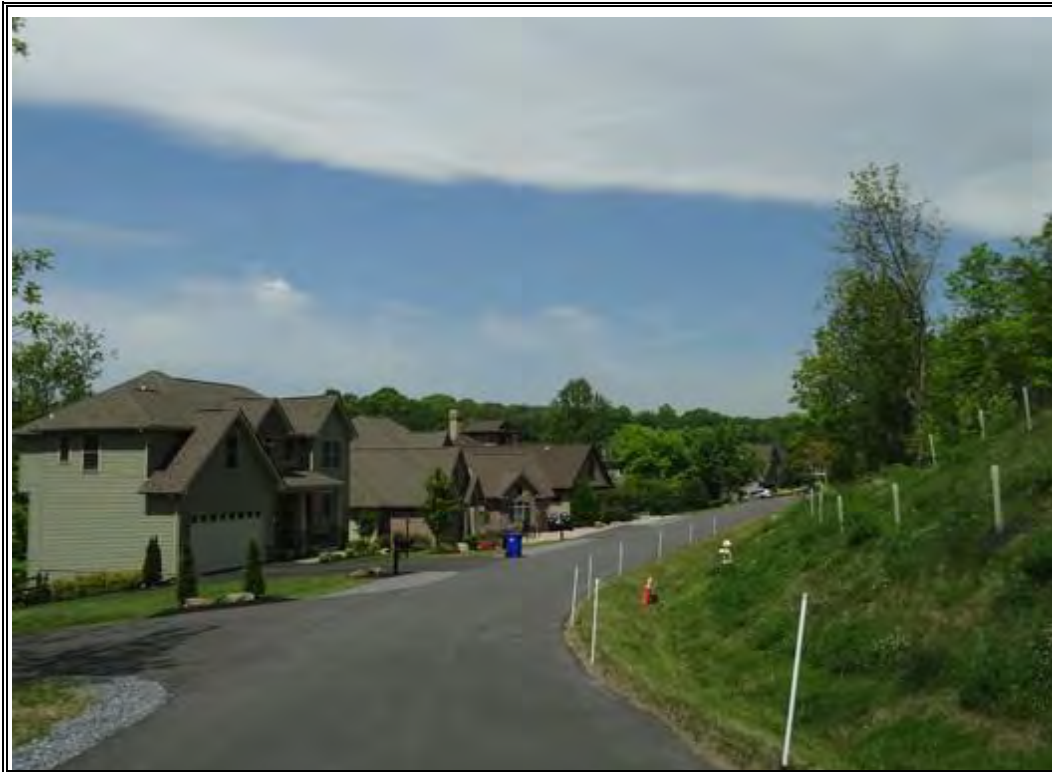
15

Nightingale village
roadways

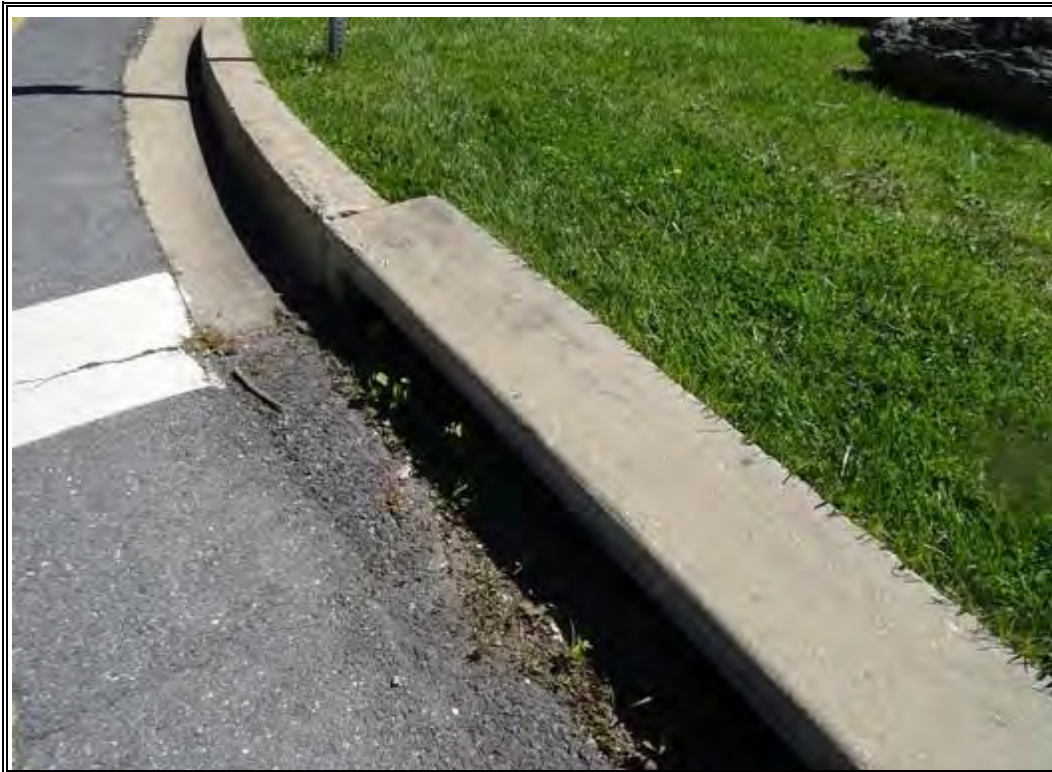
17

Storm drain along
Woodridge road

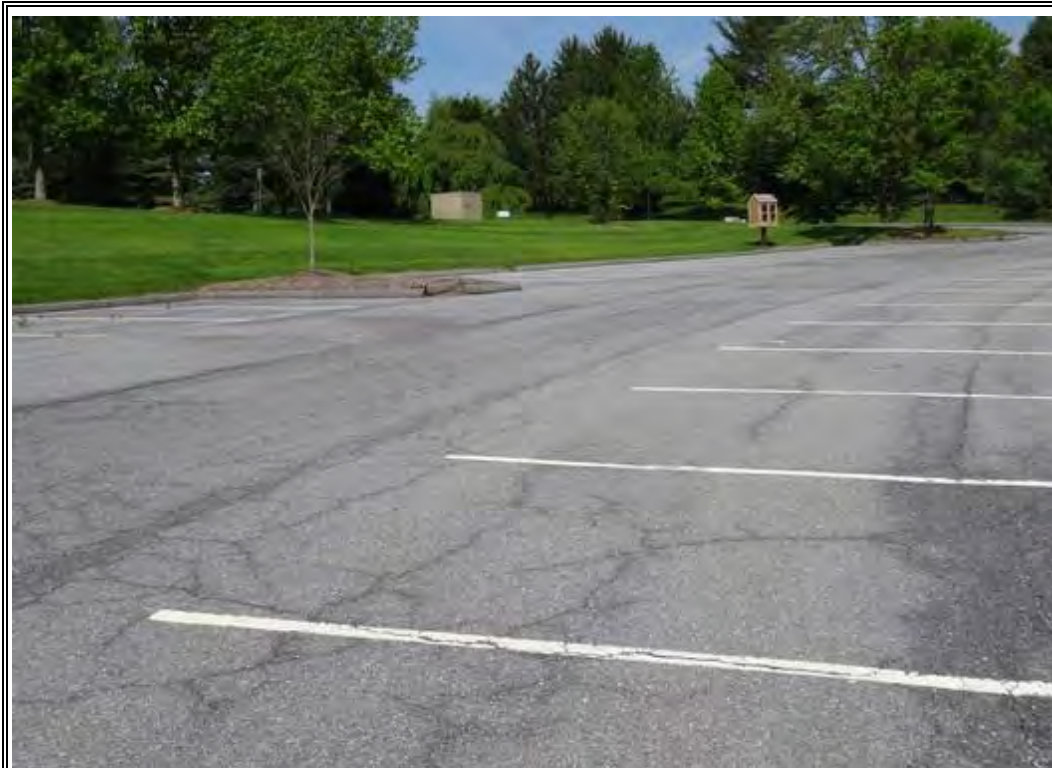
Photo Number
20

Description:
West Winds
village pool
parking lot

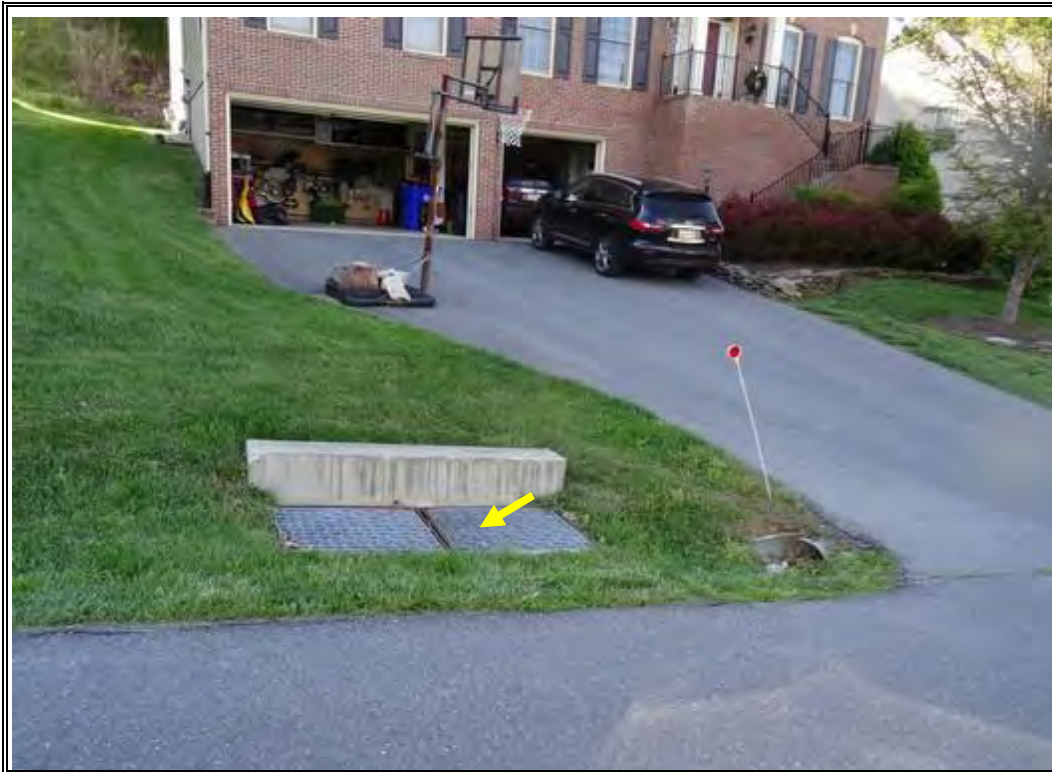
23

Typical view of storm drain catch basin in Woodridge village

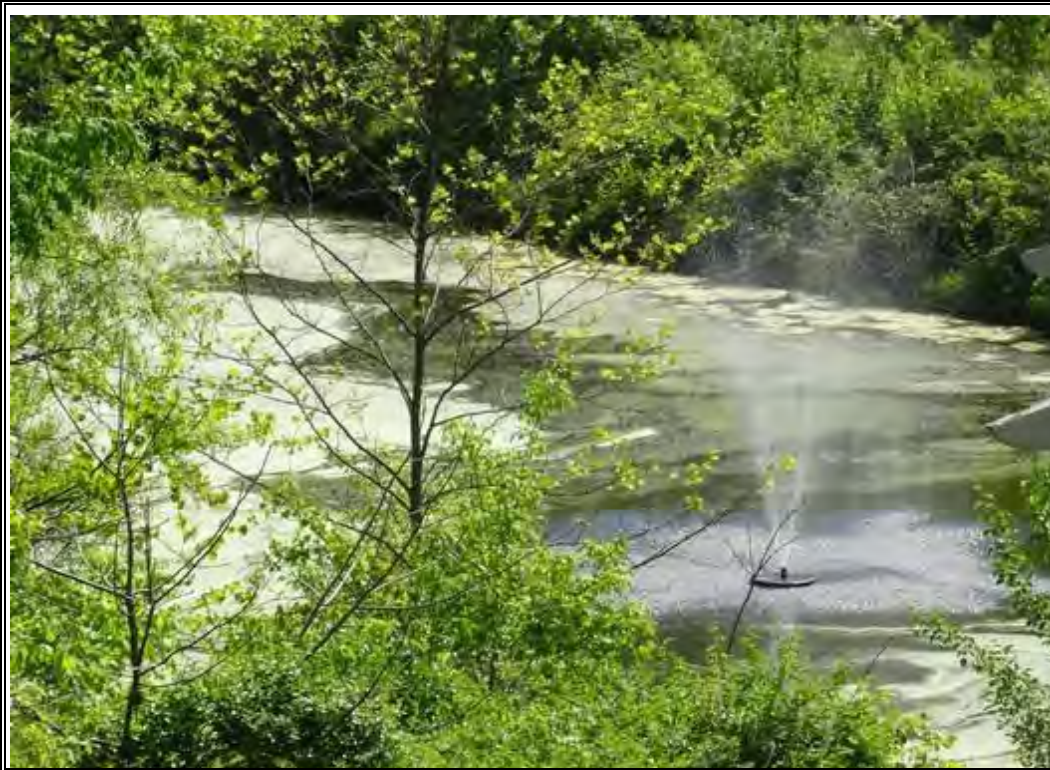
25

Storm water basin
in West Winds
village

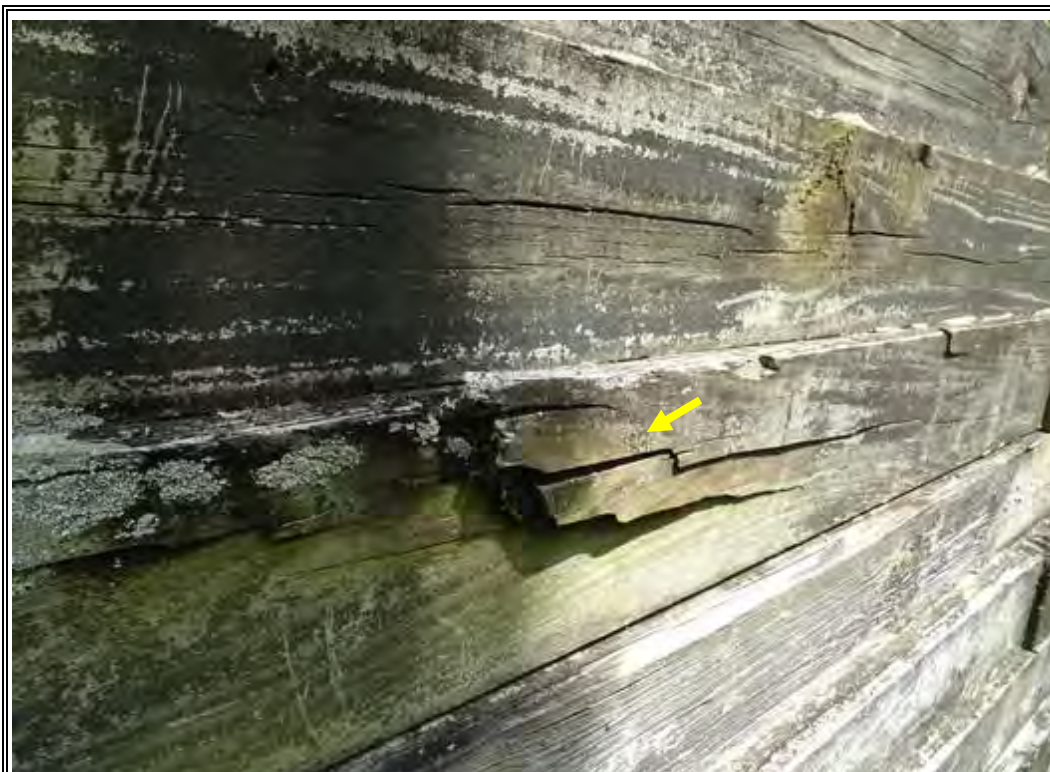
Timber log retaining wall in Summerfield village located on south side of Huckleberry Way:

Close-up view of splitting cracks in wood logs

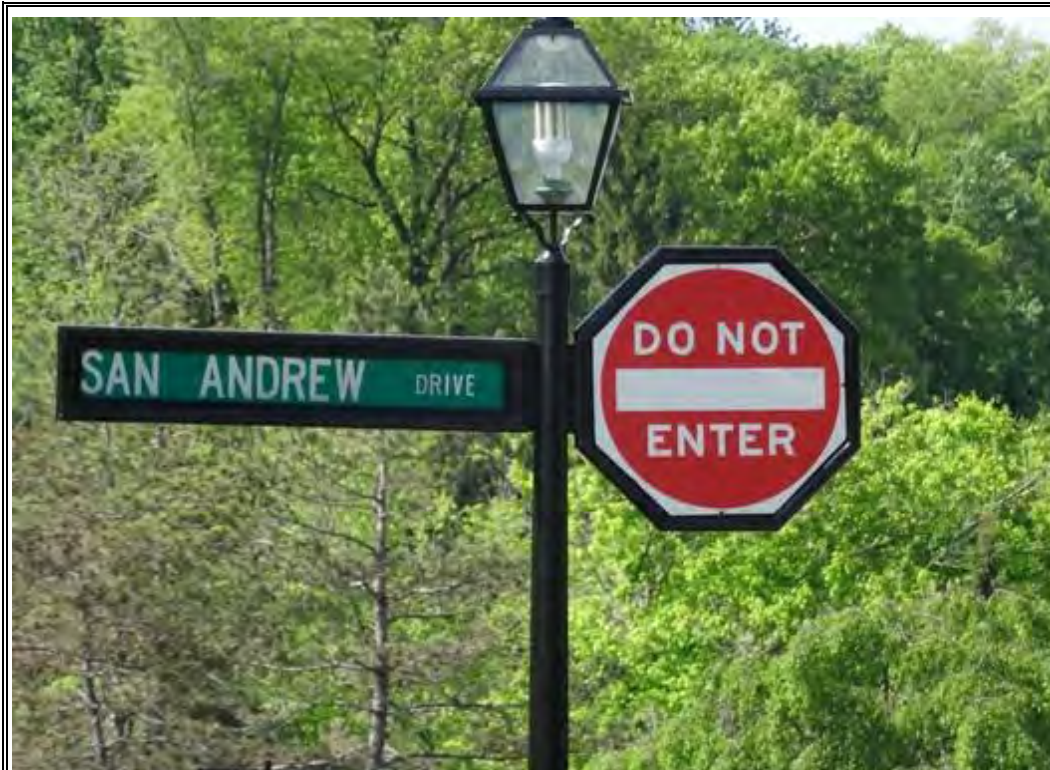
31

Typical street light fixture in West Winds village

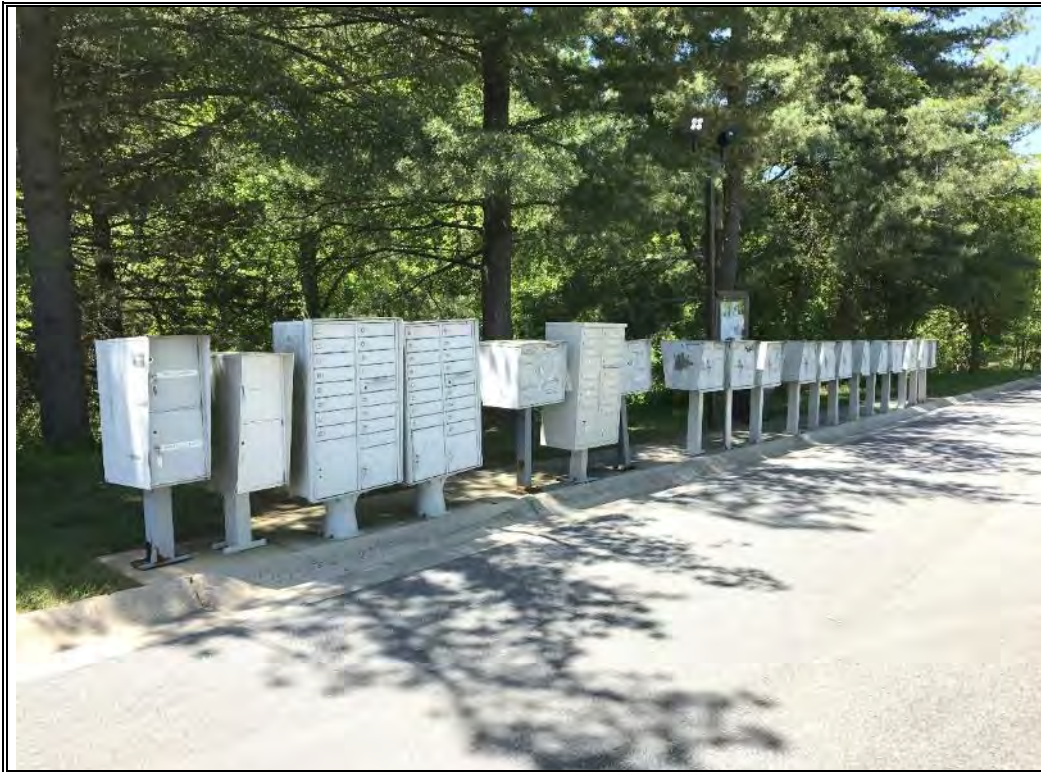
Typical cluster mailbox units which are provided for several of the villages

The mailbox units vary in condition and are replaced on an as needed basis.

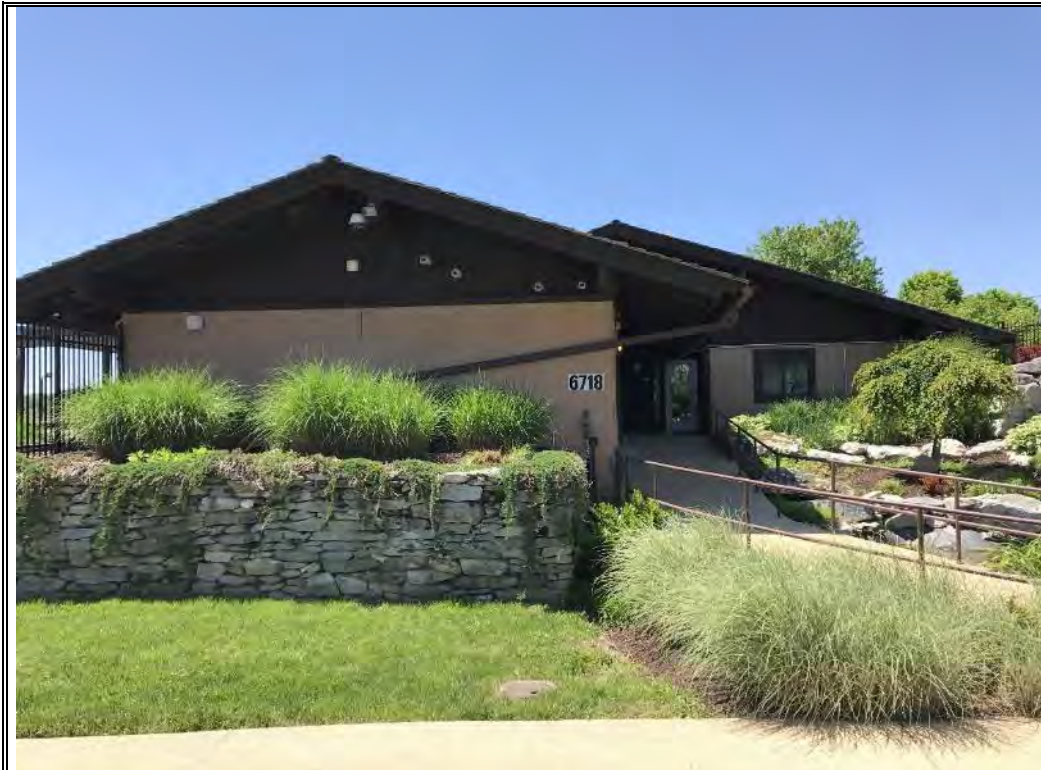
35

Side elevation and main management offices entrance of the Coldstream pool building

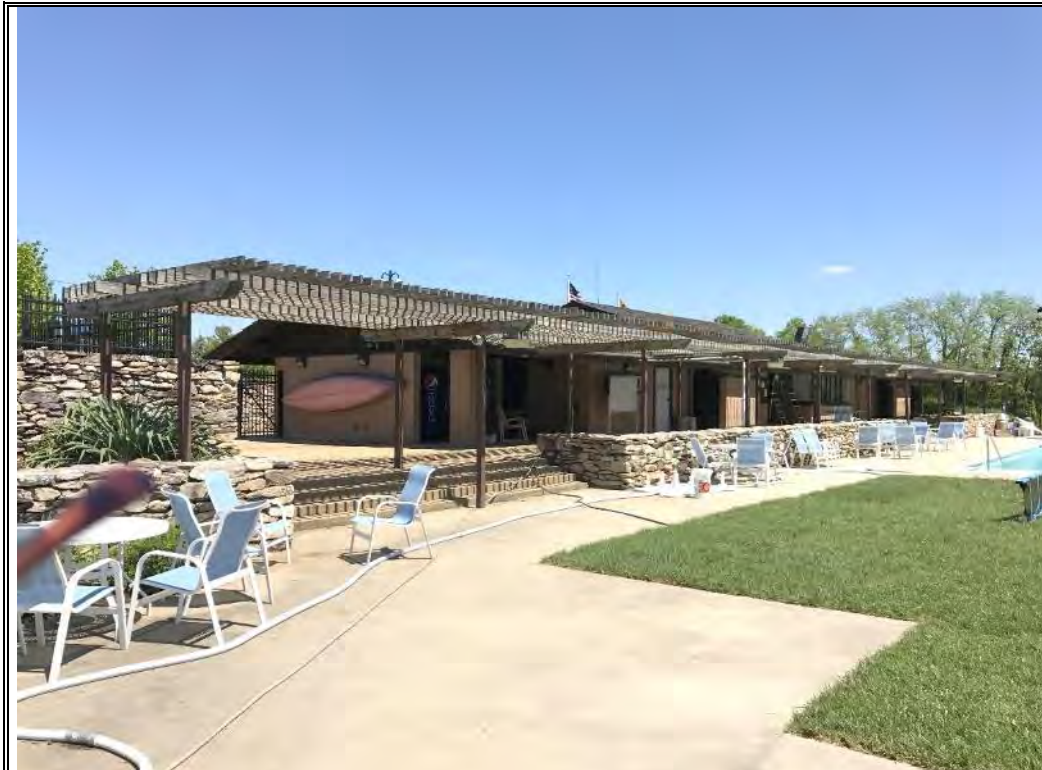
37

Front elevation of the Coldstream building

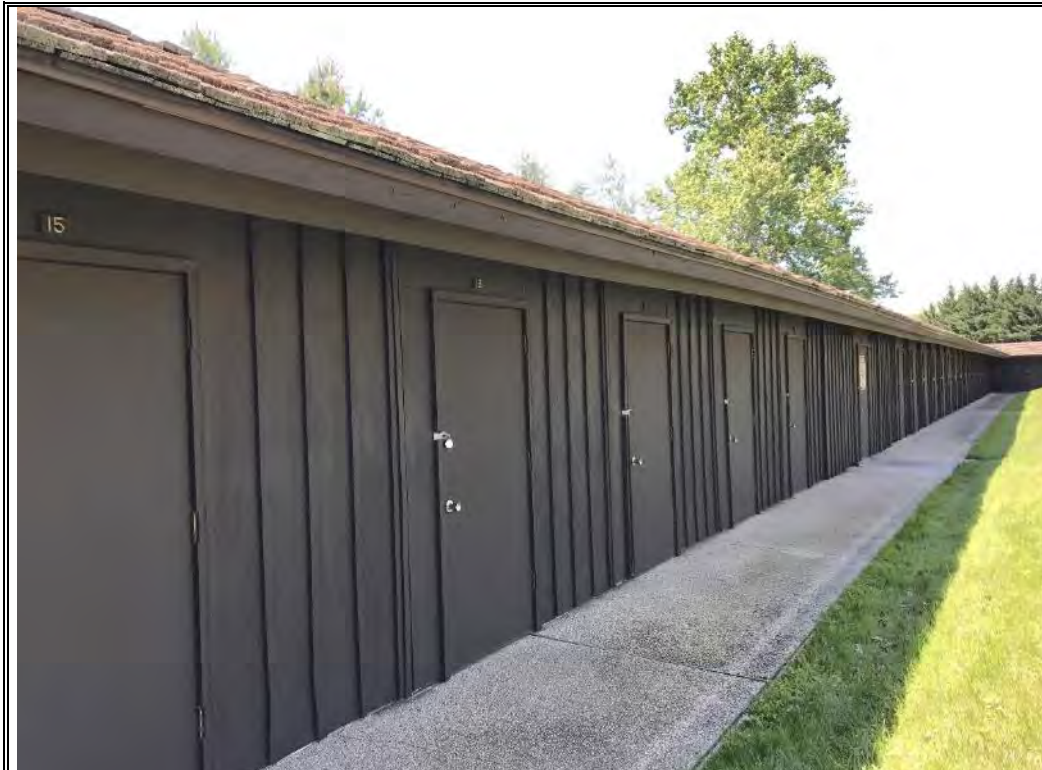
39

Front elevation of the Cabanas building which wraps around the Coldstream pool

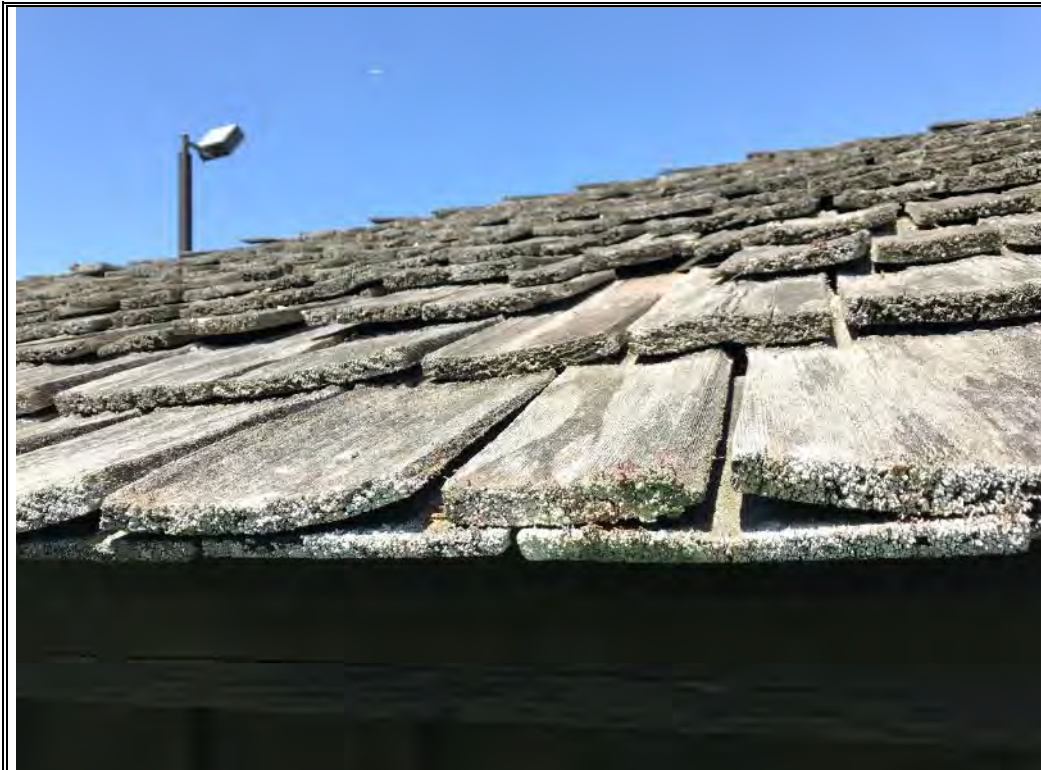
The Cooldstream building has a wood shake roof surface which is at the end of its useful life.

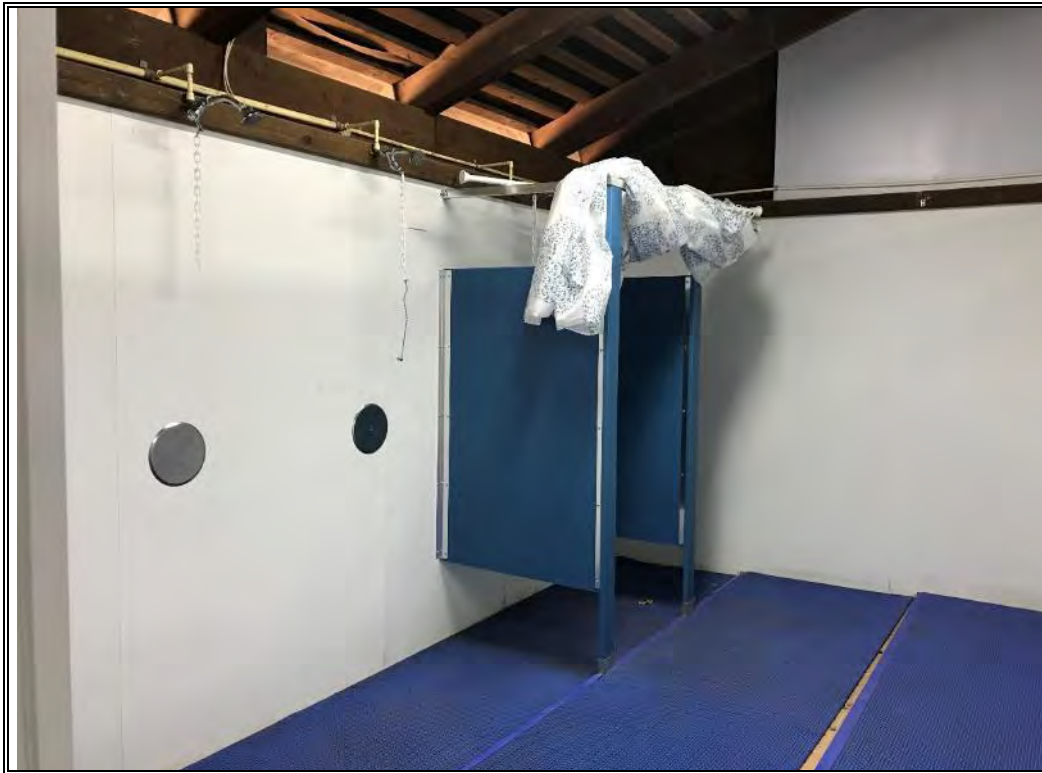
The Coldstream building has both men's and women's showers rooms for the swimming pool

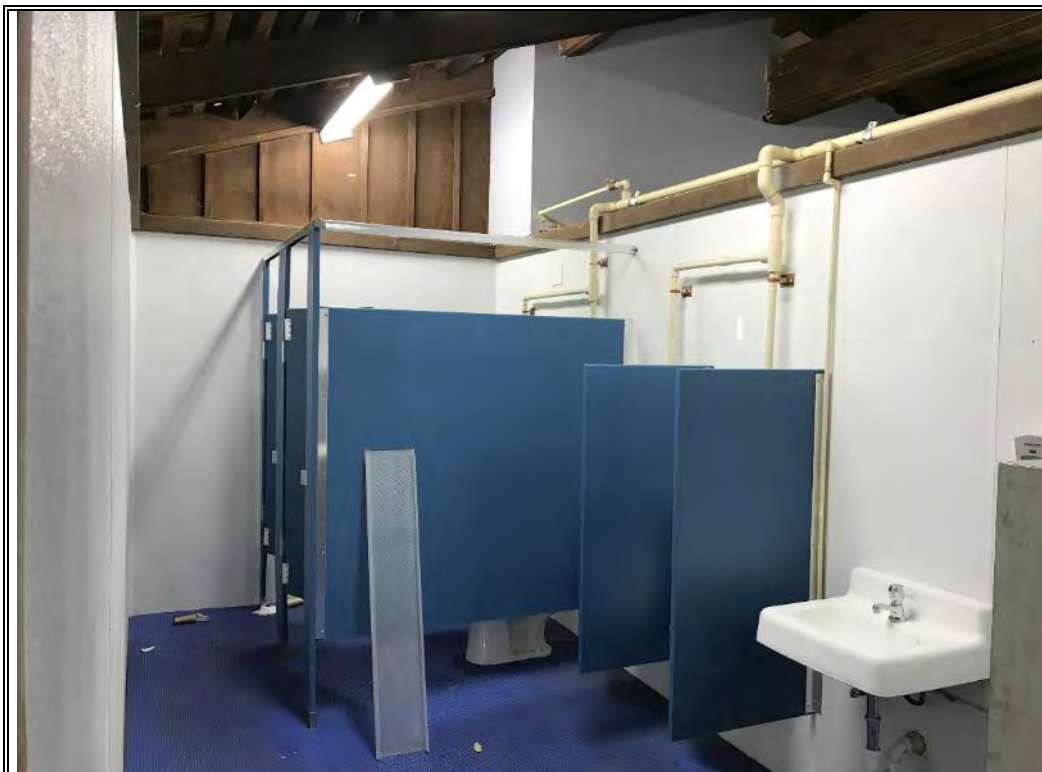
Photo Number
43

The Coldstream shower rooms were recently renovated with new wall finishes and floor finishes, as well as fixtures and toilet partitions.

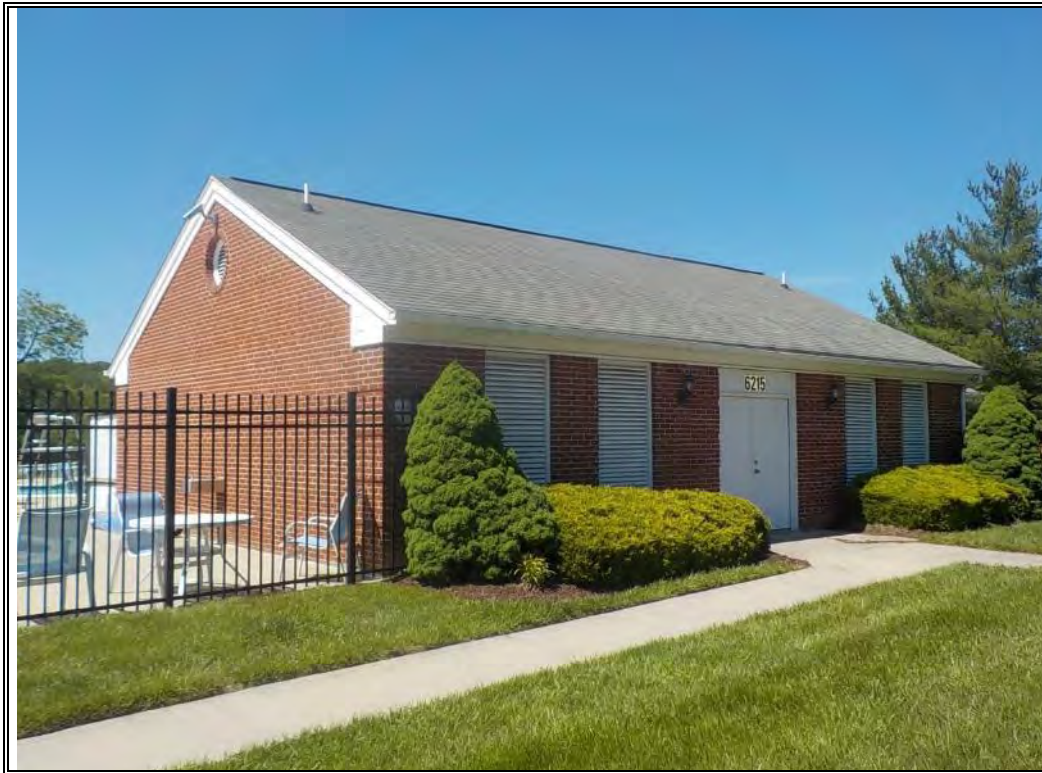
Rear elevation of the Summerfield swimming pool building

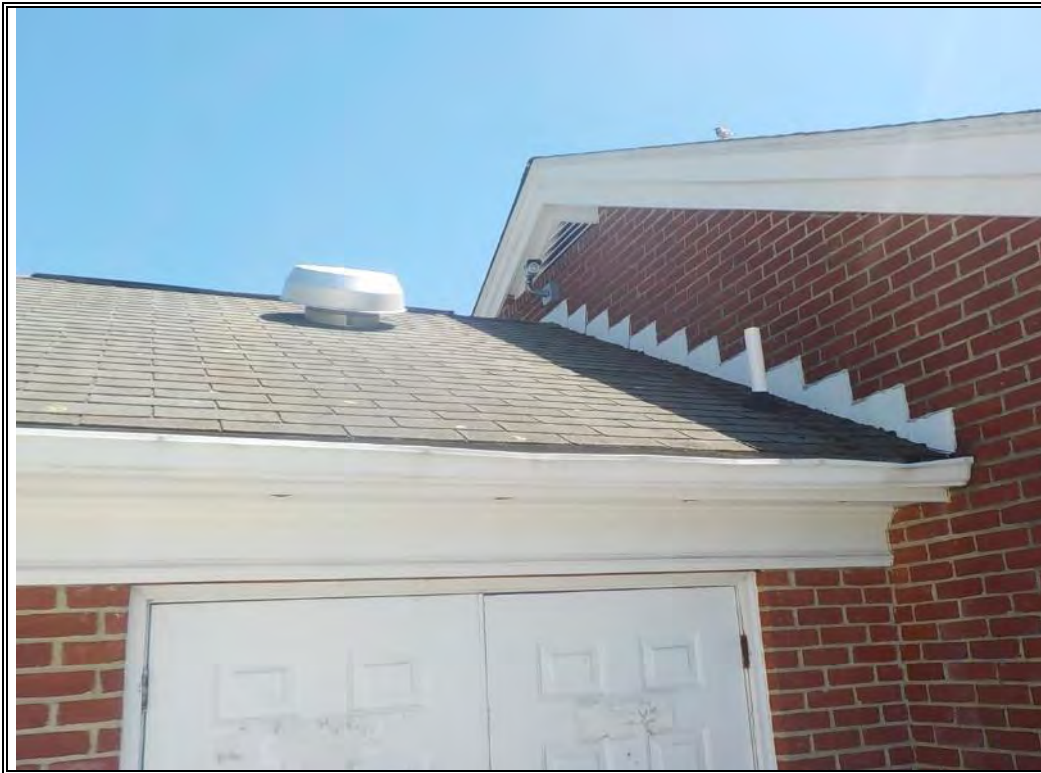
Summerfield pool building roof surface

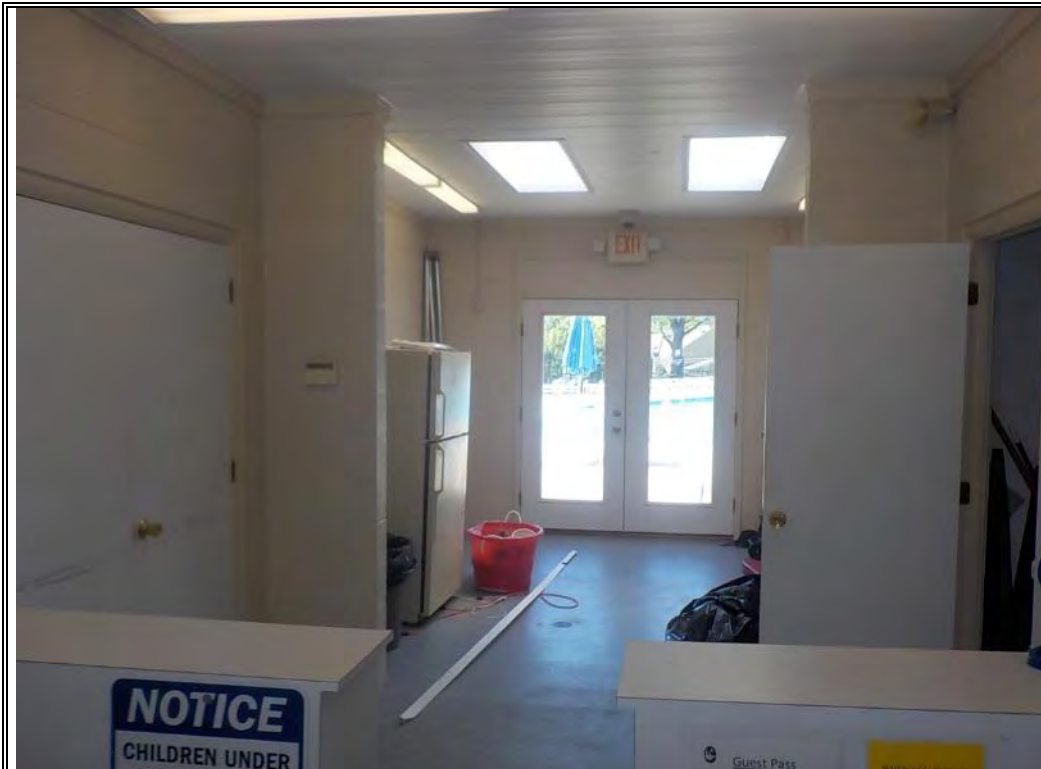
47

Summerfield pool building lifeguard room interior.

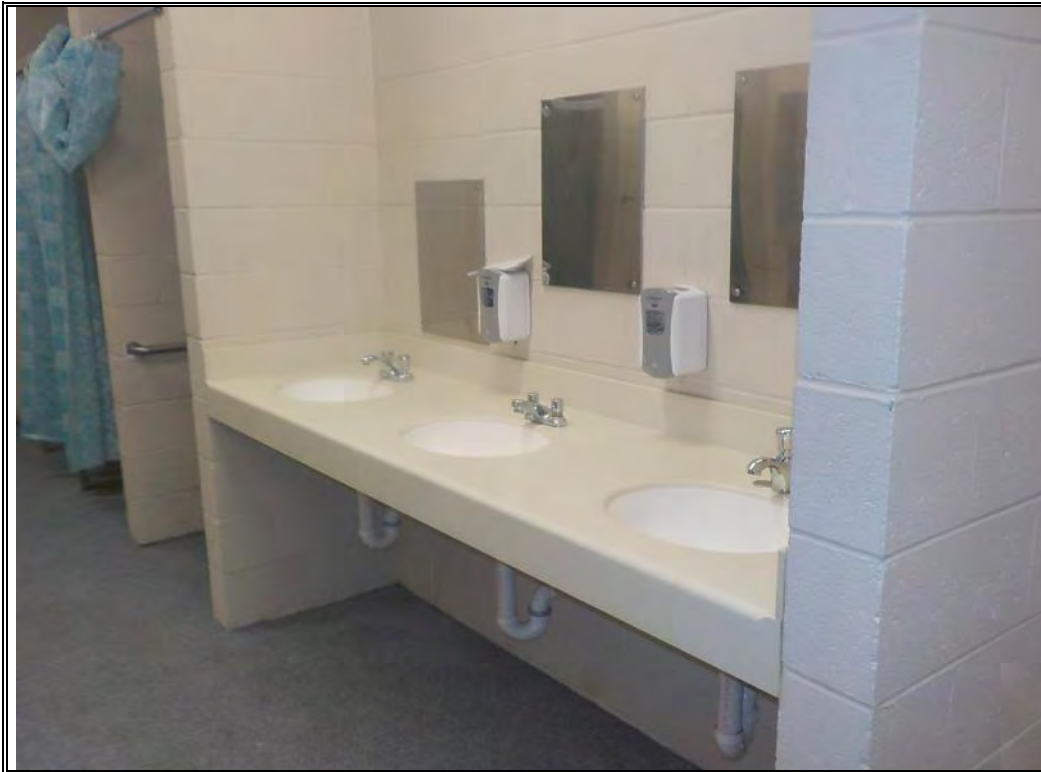
Summerfield
typical lavatories
and showers

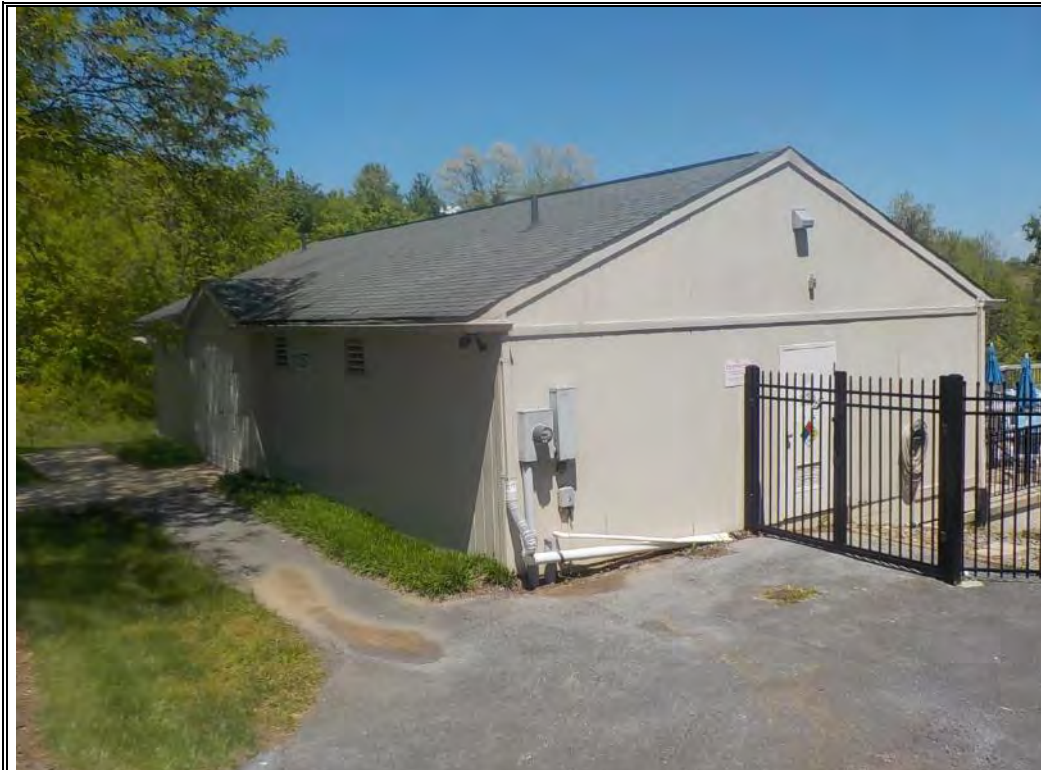
West Winds
building rear
elevation

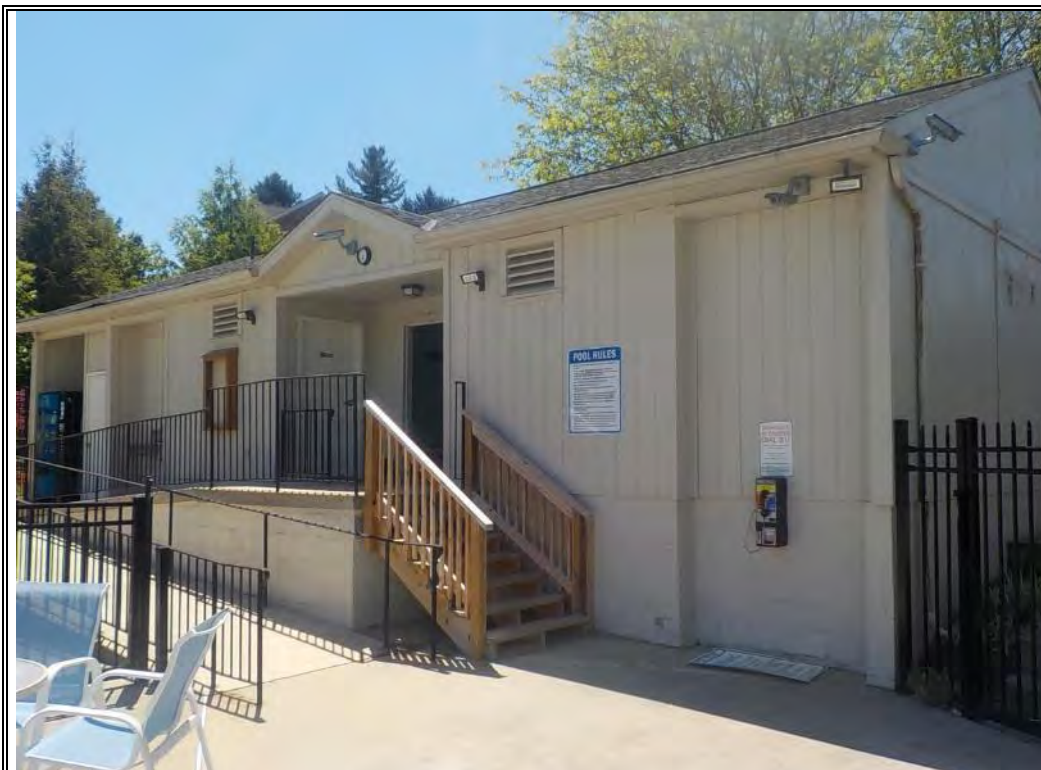
51

West Winds
building front
elevation

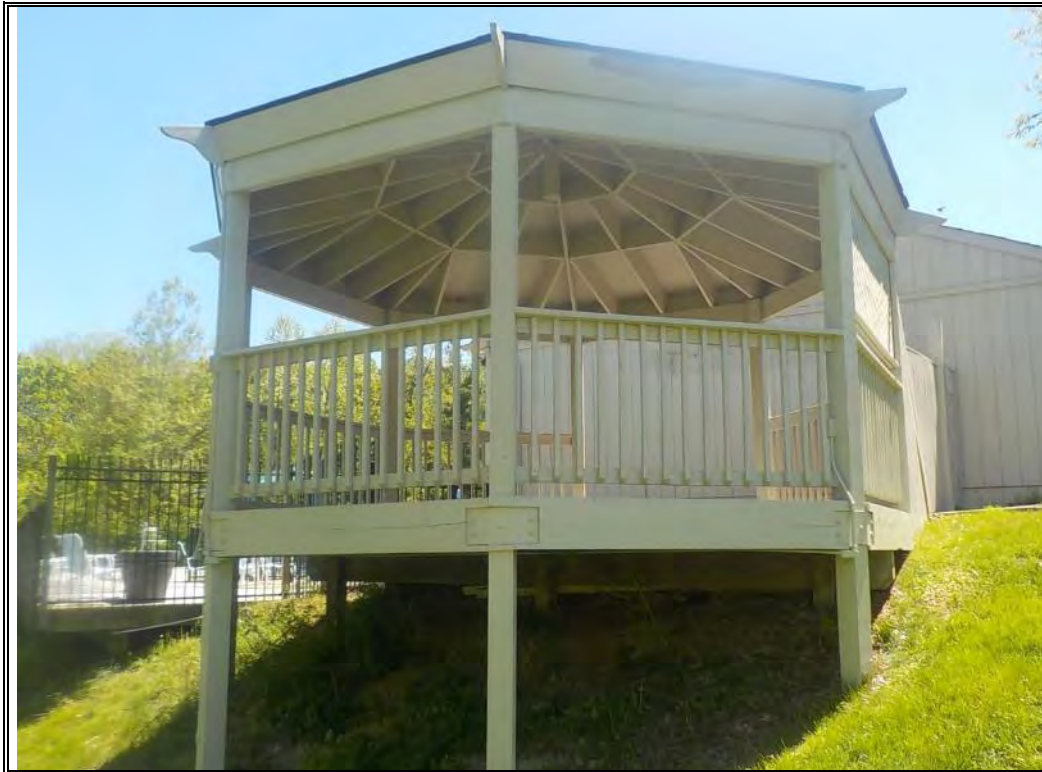
Wood framed gazebo structure located beside the West Winds pool building

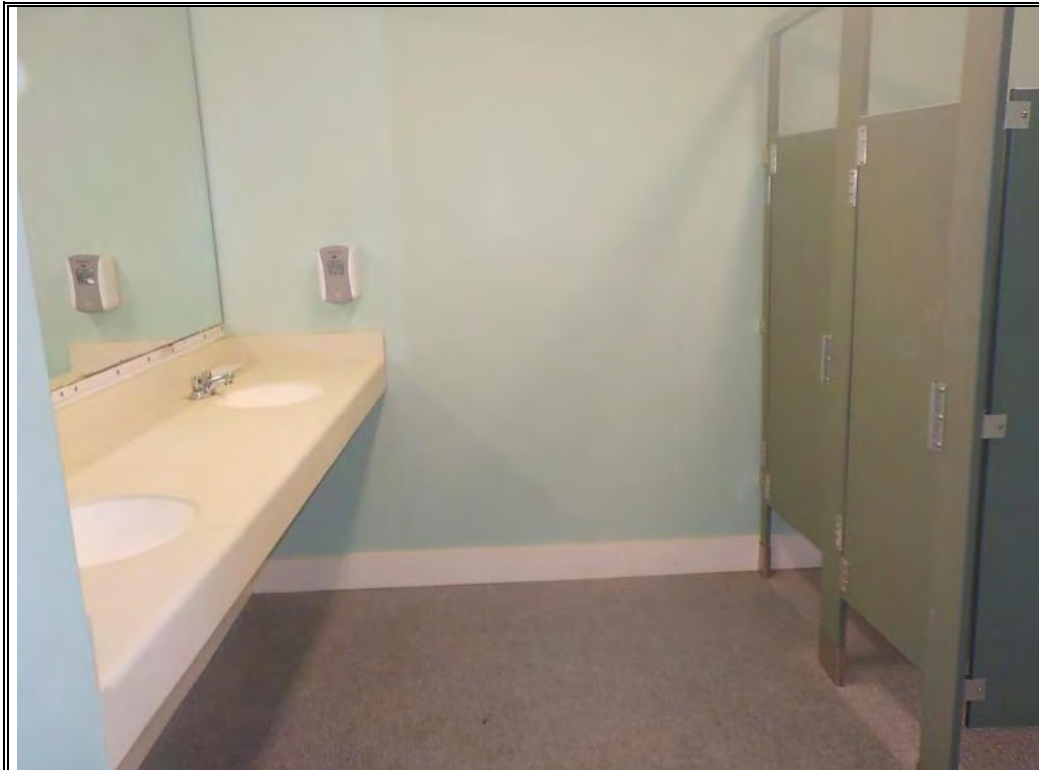
Typical West Winds building toilet room interior
