RESERVE FUND STUDY LAKE LINGANORE ASSOCIATION

LAKE LINGANORE ASSOCIATION

Criterion-Harbor Engineers

November 2, 2017

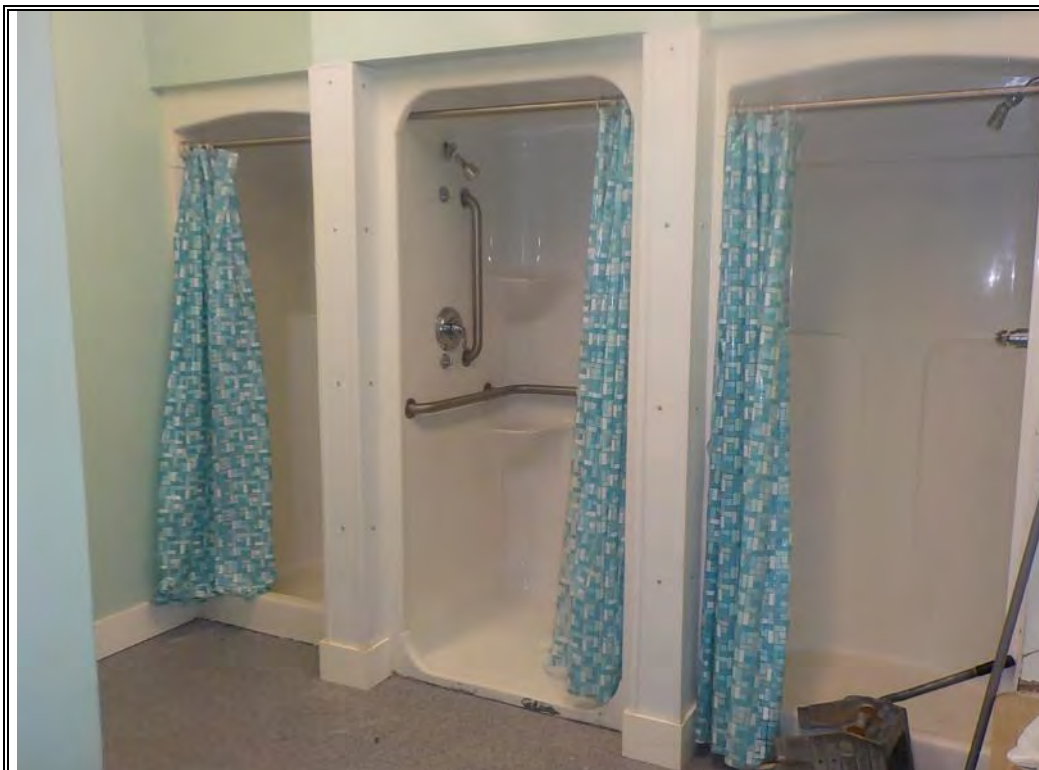
55

Typical West Winds building showers

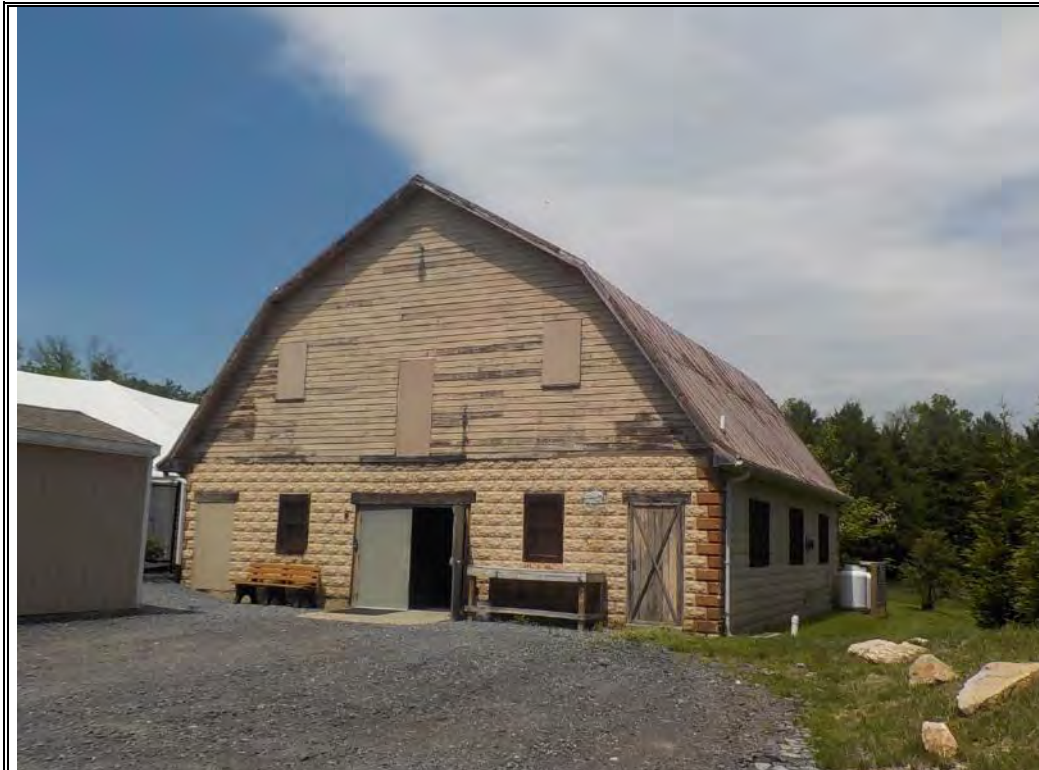
The Association maintains a partially restored barn for events and functions

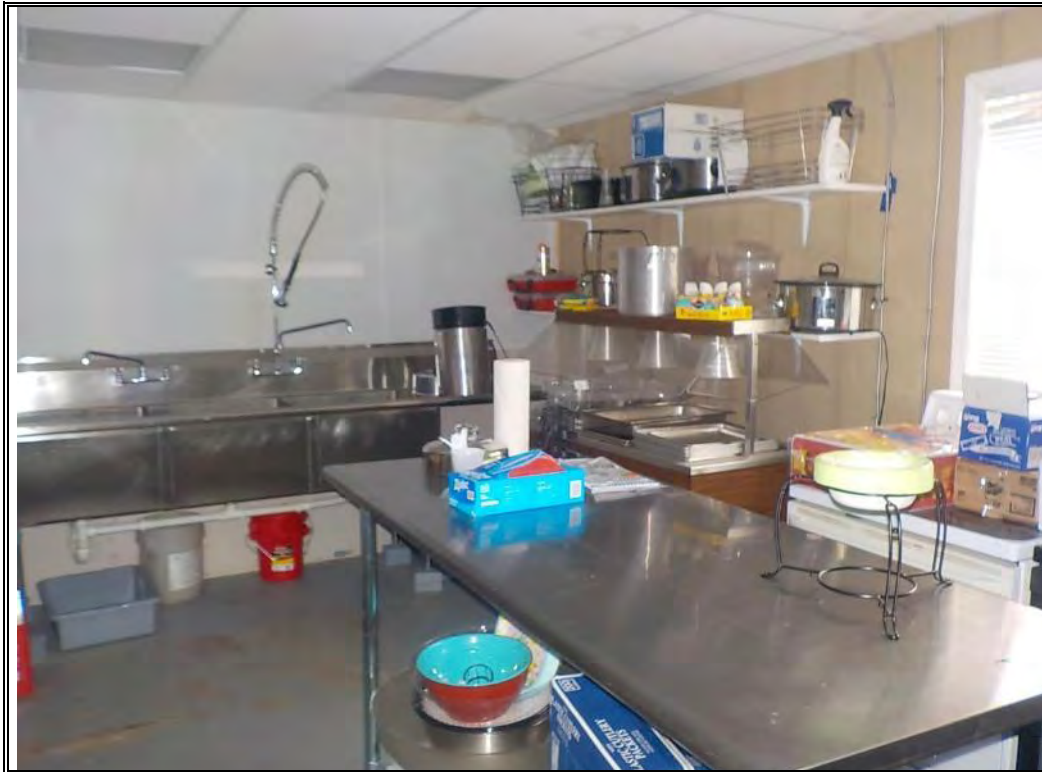
Interior view of the barn kitchen.

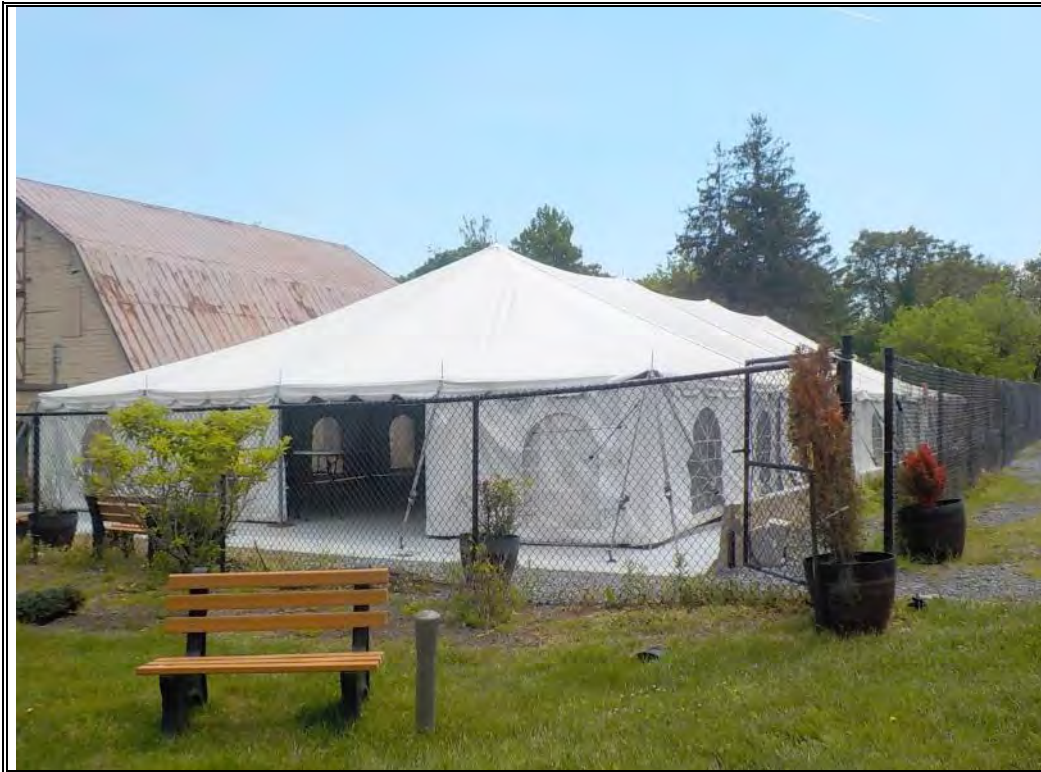
Outdoor tent structure located next to the barn

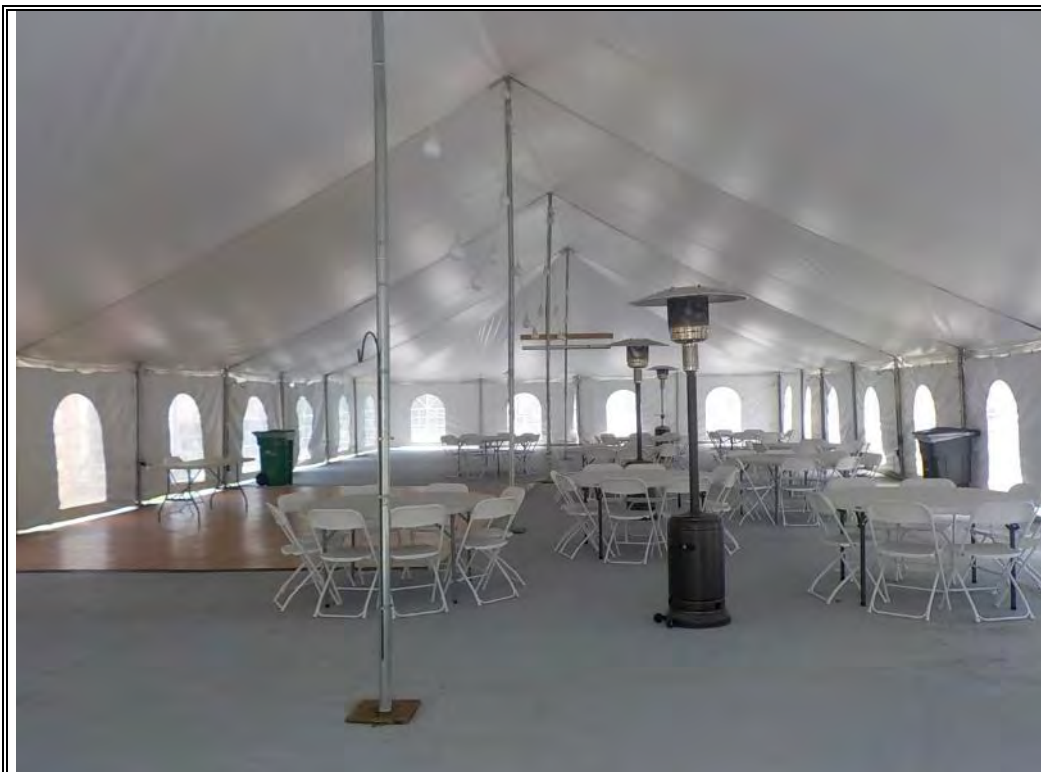
61

Interior view of the tent

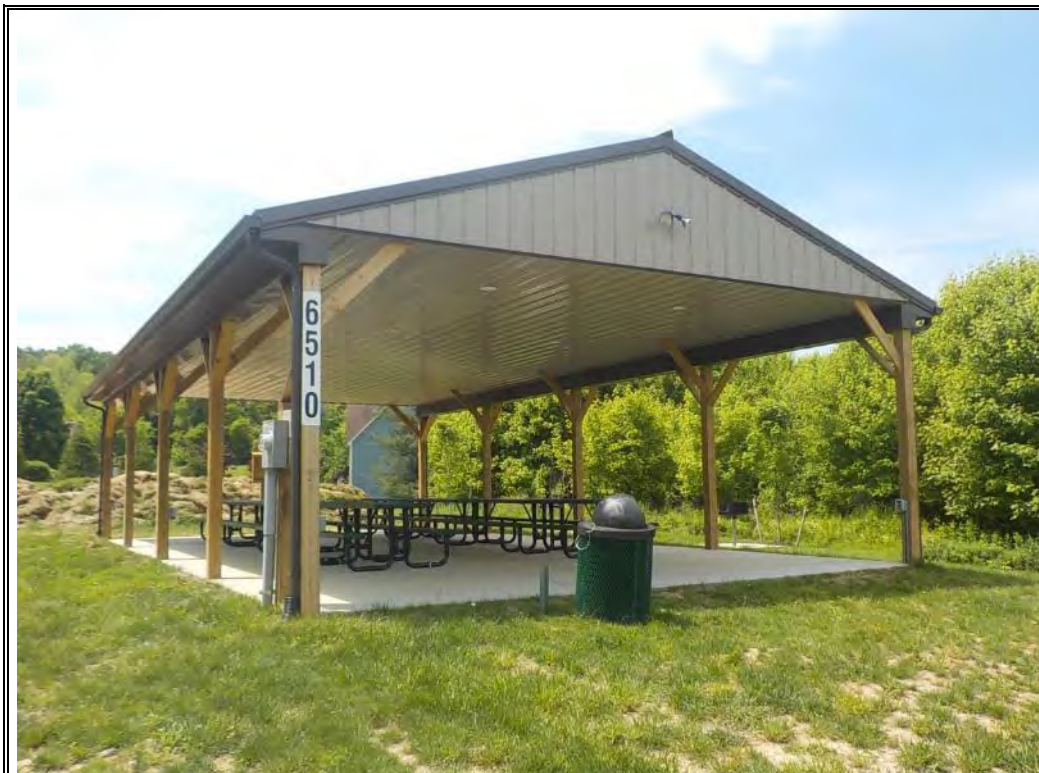
One of two picnic pavilions maintained by the Association.

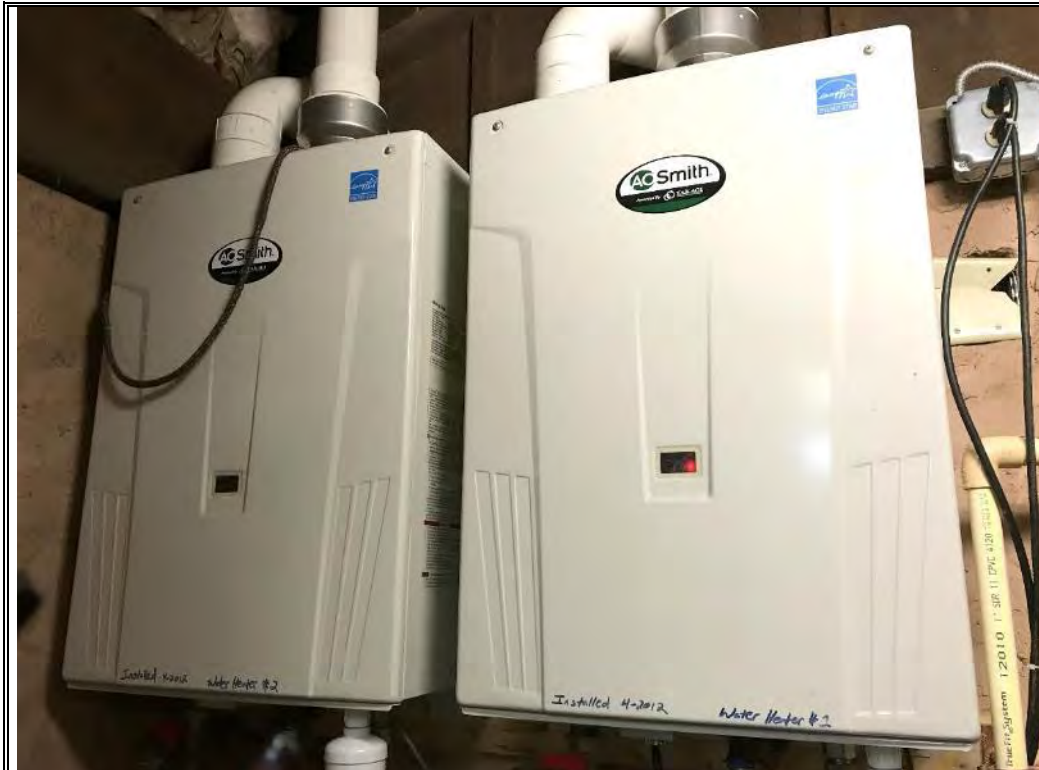
Propane, instantaneous water heaters serve the Coldstream shower rooms

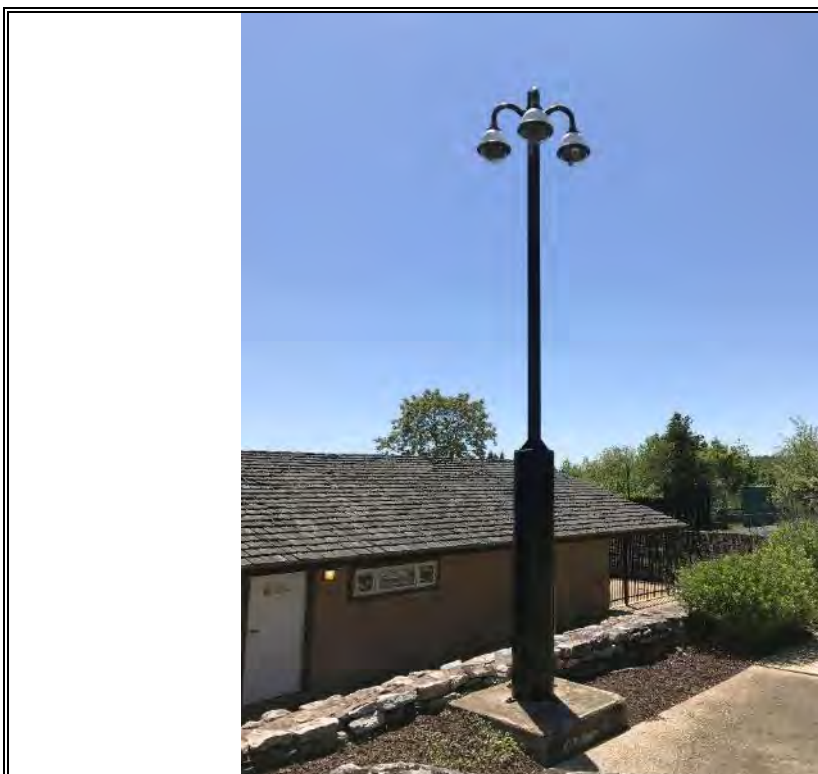
67

Pole mounted security cameras at the Coldstream facility

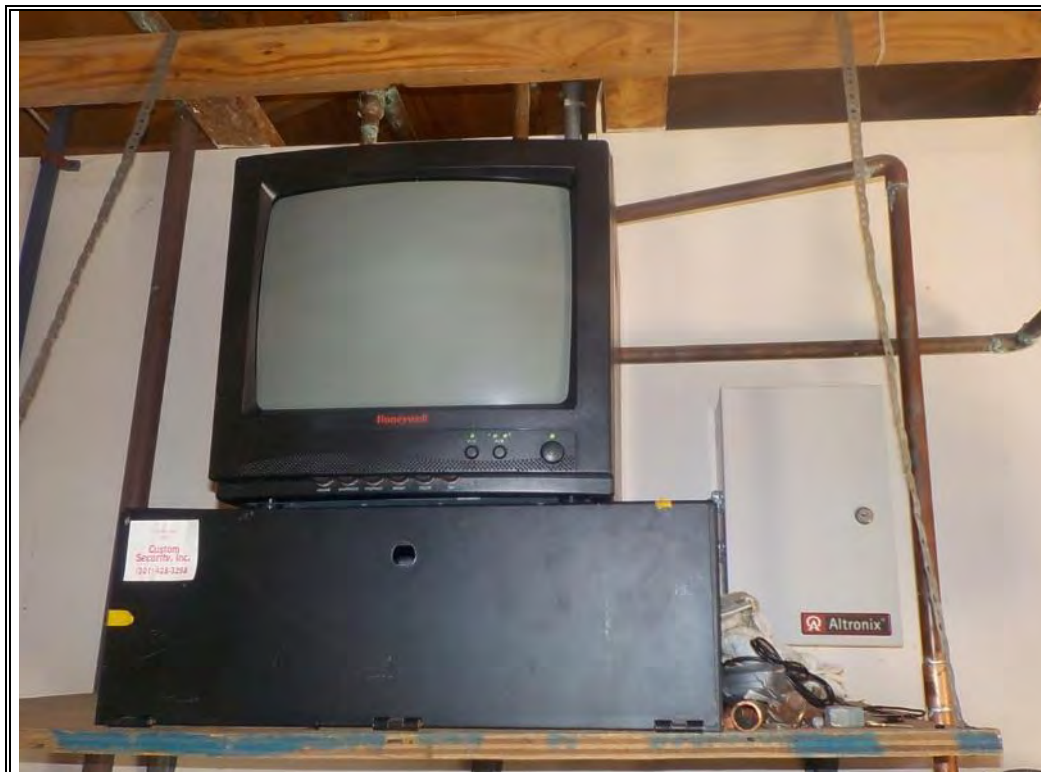
71

Video monitoring system at West Winds (typical of the swimming pool facilities)

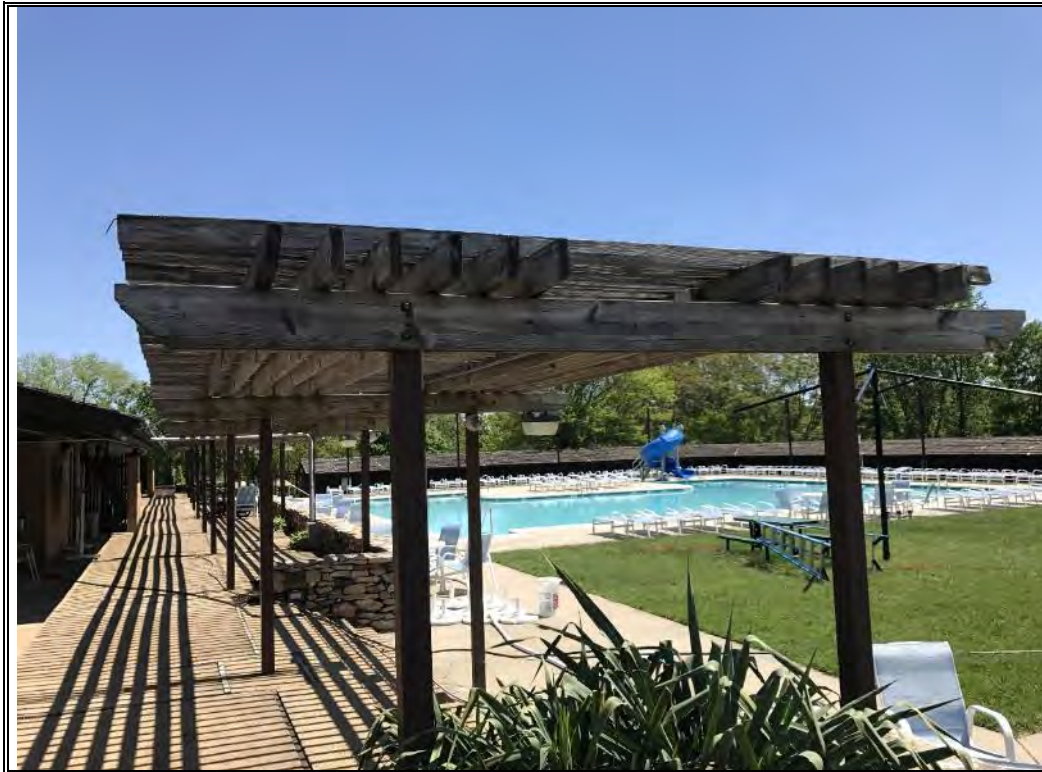
The Coldstream swimming pool has a large wood pergola structure

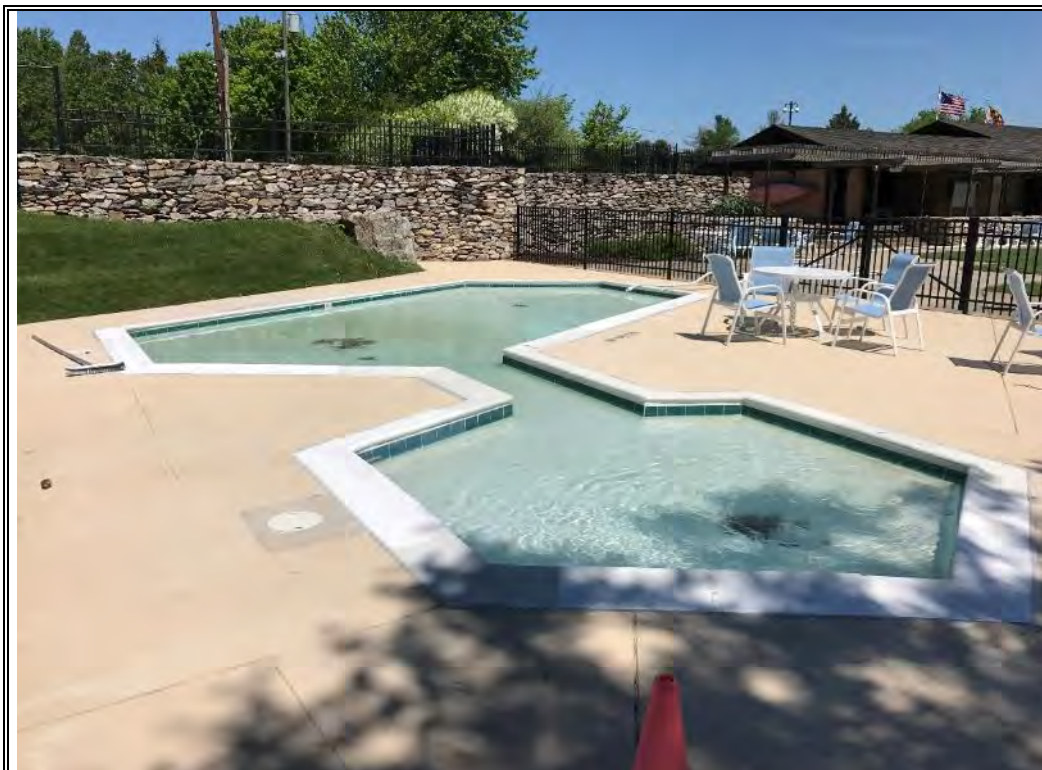
73

Coldstream wading pool

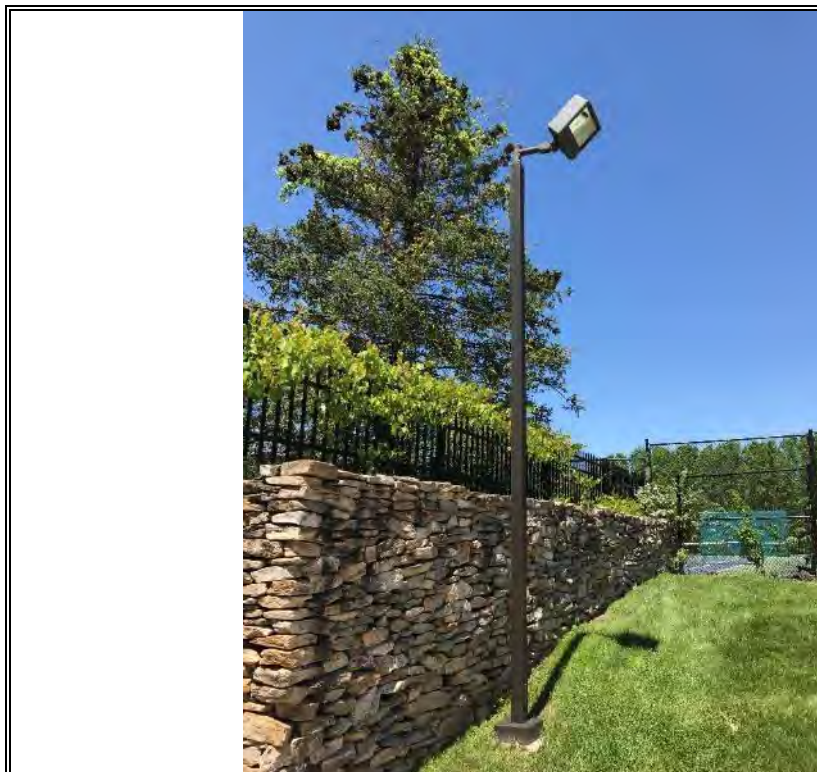
77

The Coldstream
pool has metal
exterior pole
lighting and
several stacked
stone walls

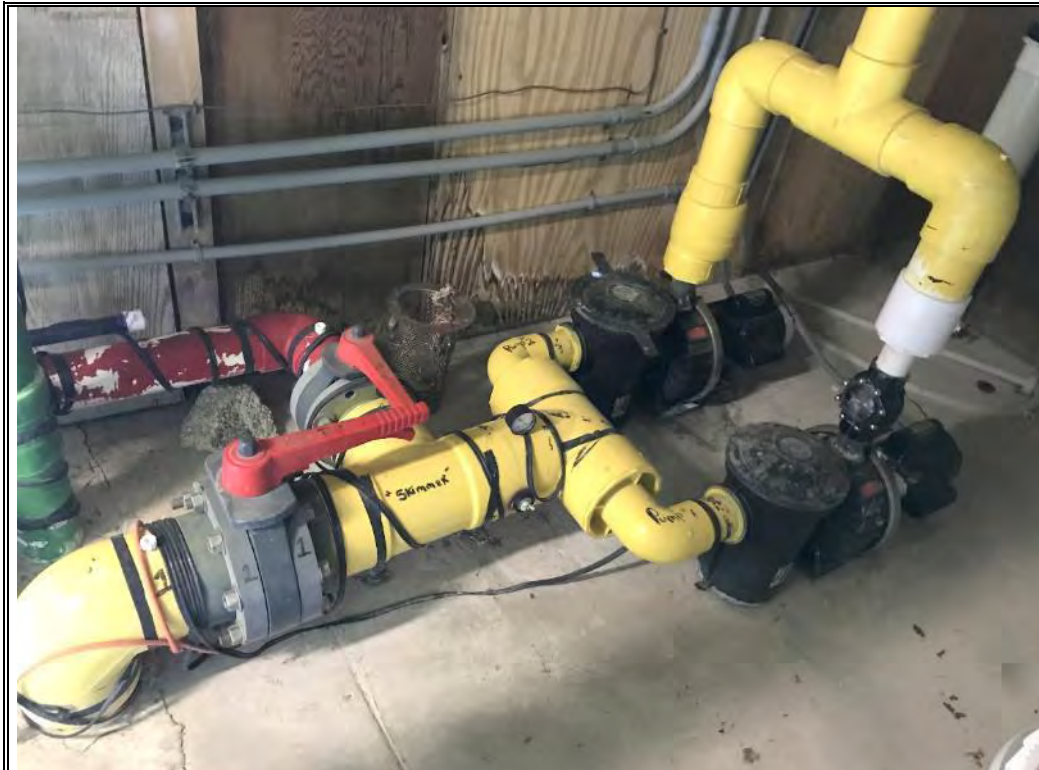
Coldstream pool circulation pumps located in the Caanas building

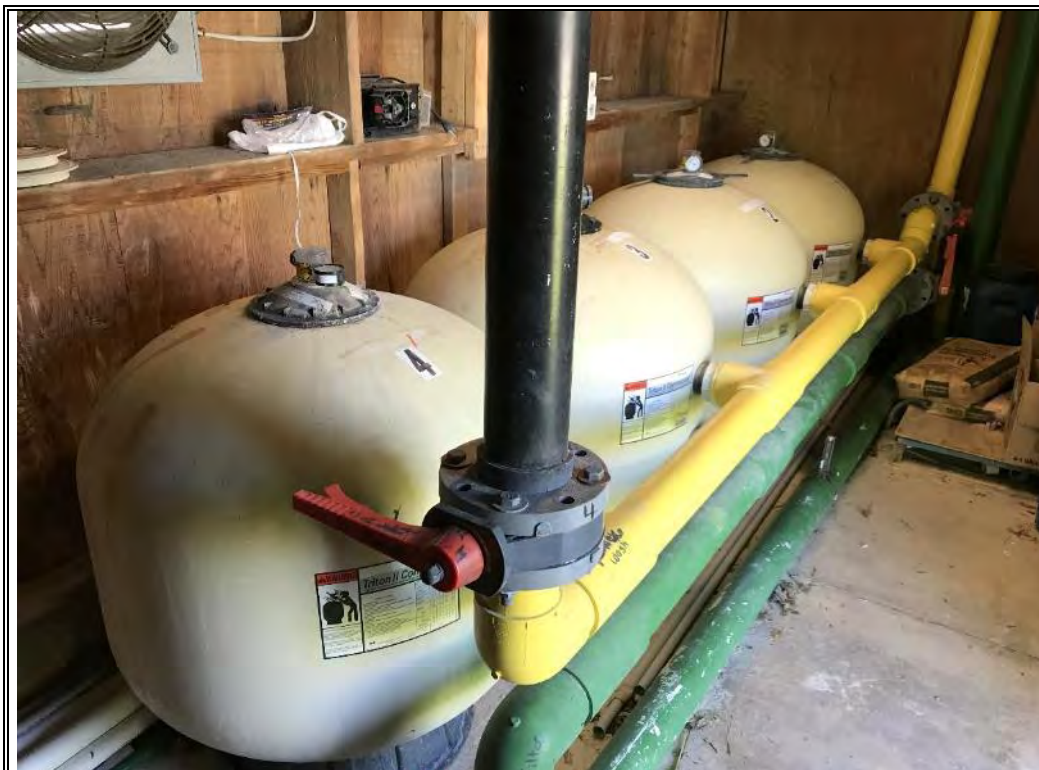
Photo Number
79

Coldstream pool sand filters

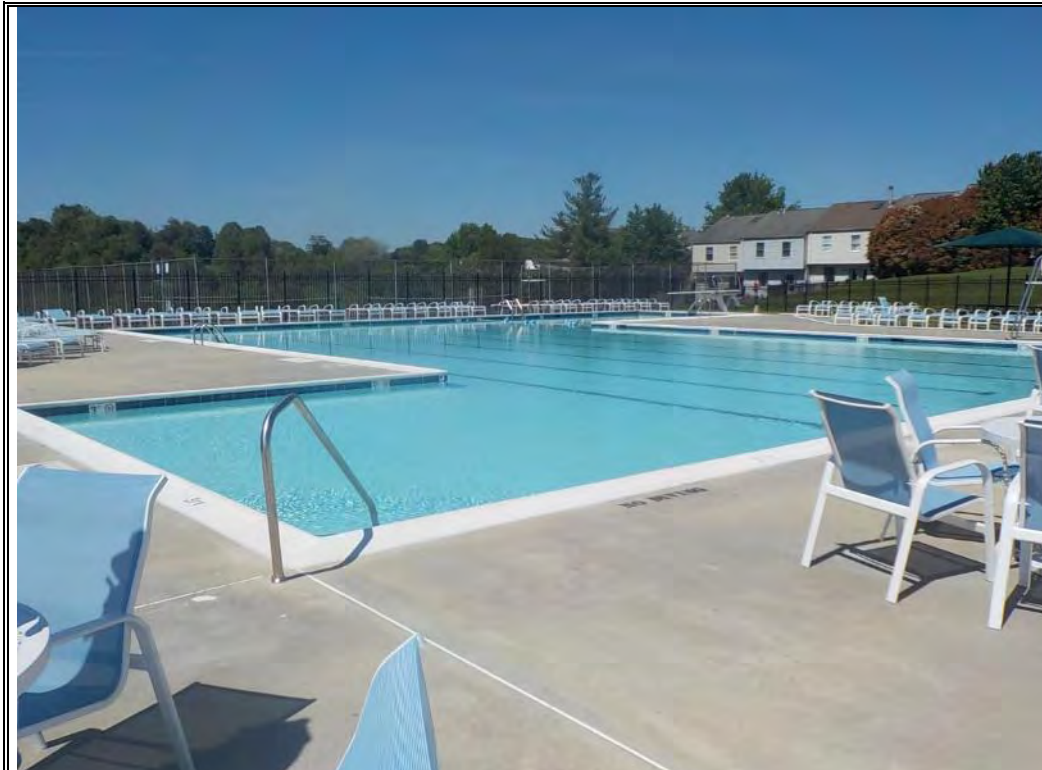
Summerfield
swimming pool

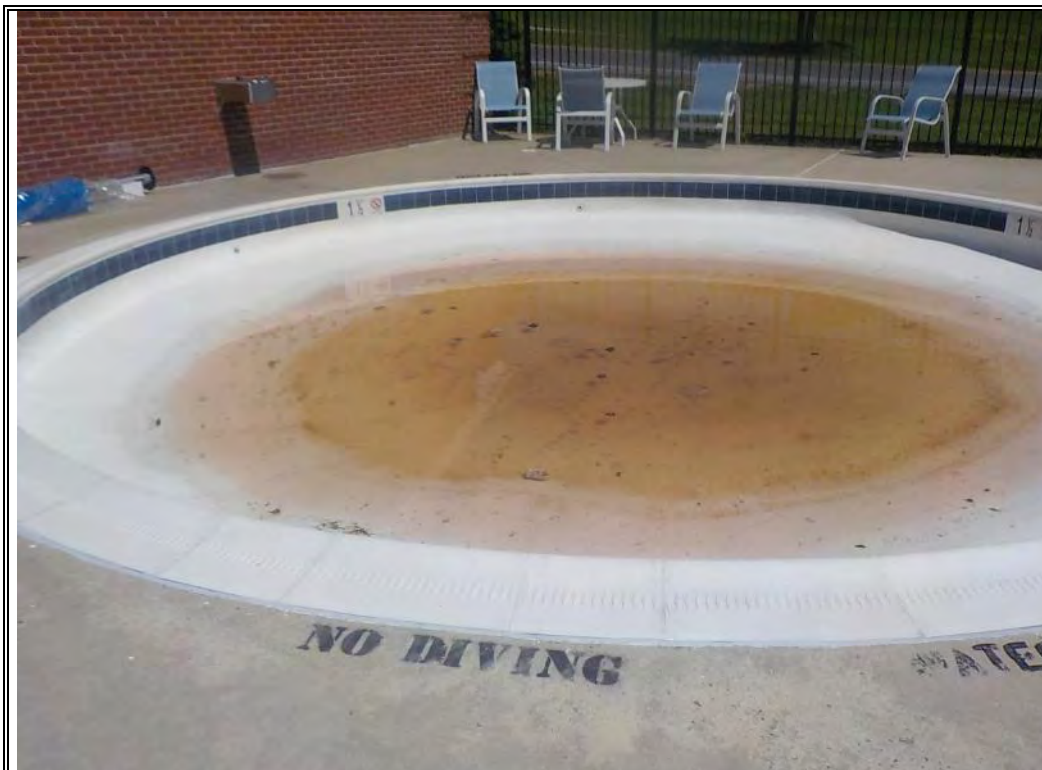
81

Summerfield
wading pool

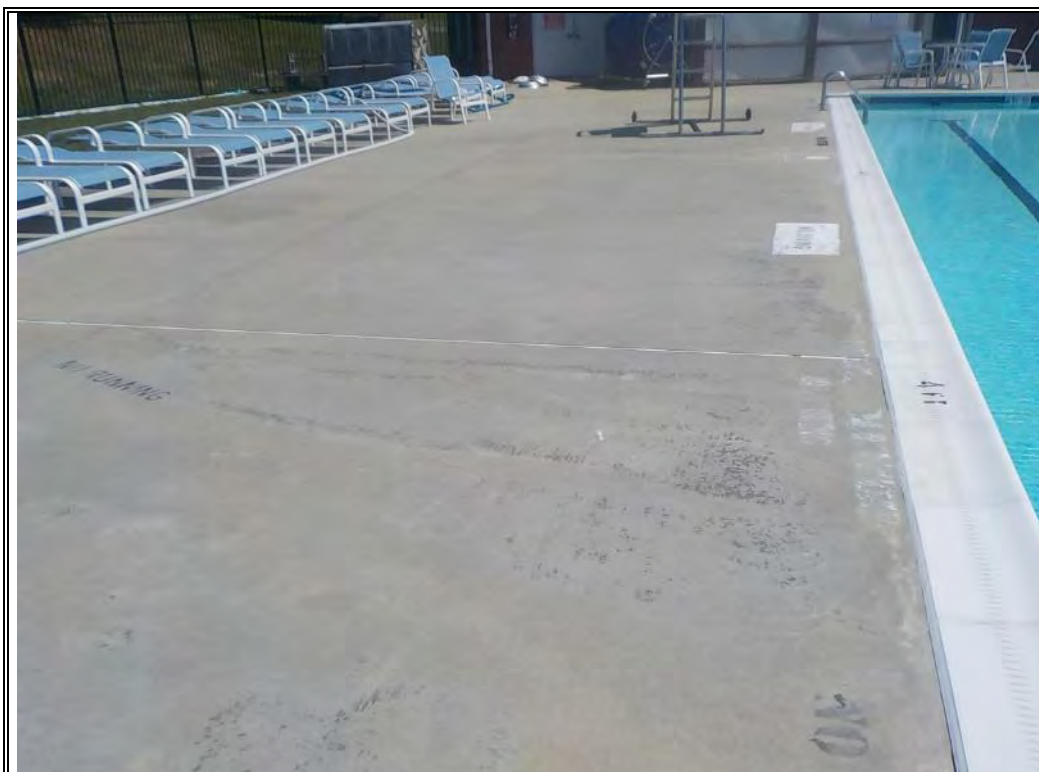
83

Summerfield pool
concrete deck

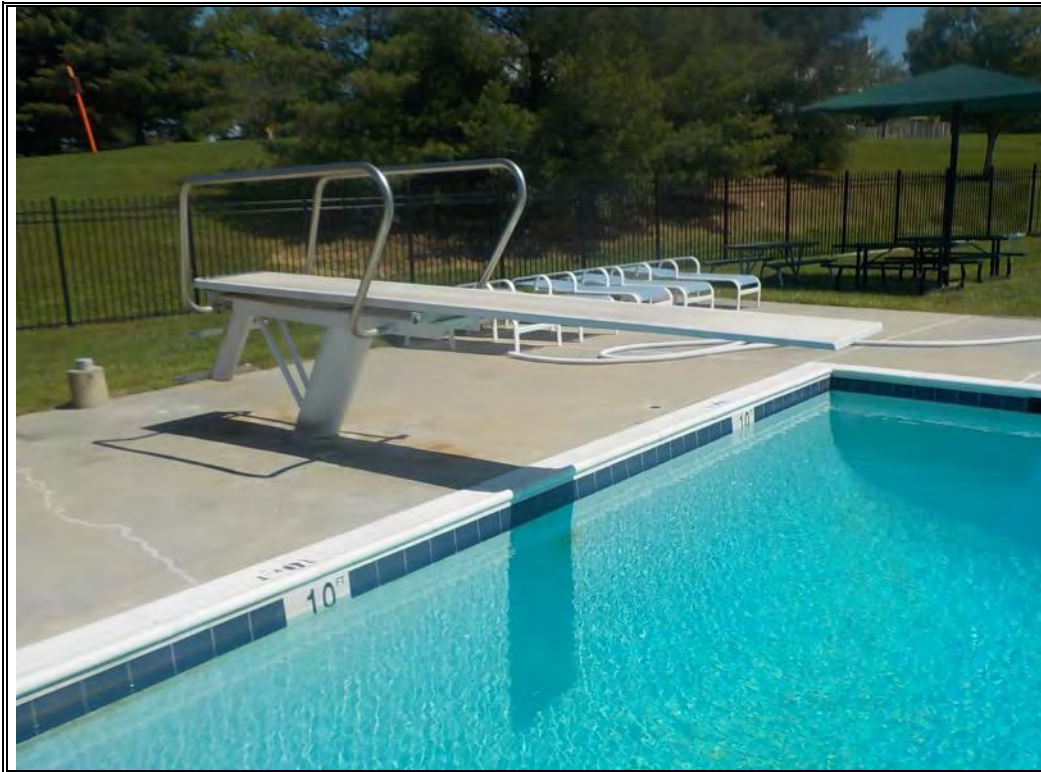
Summerfield pool
diving board

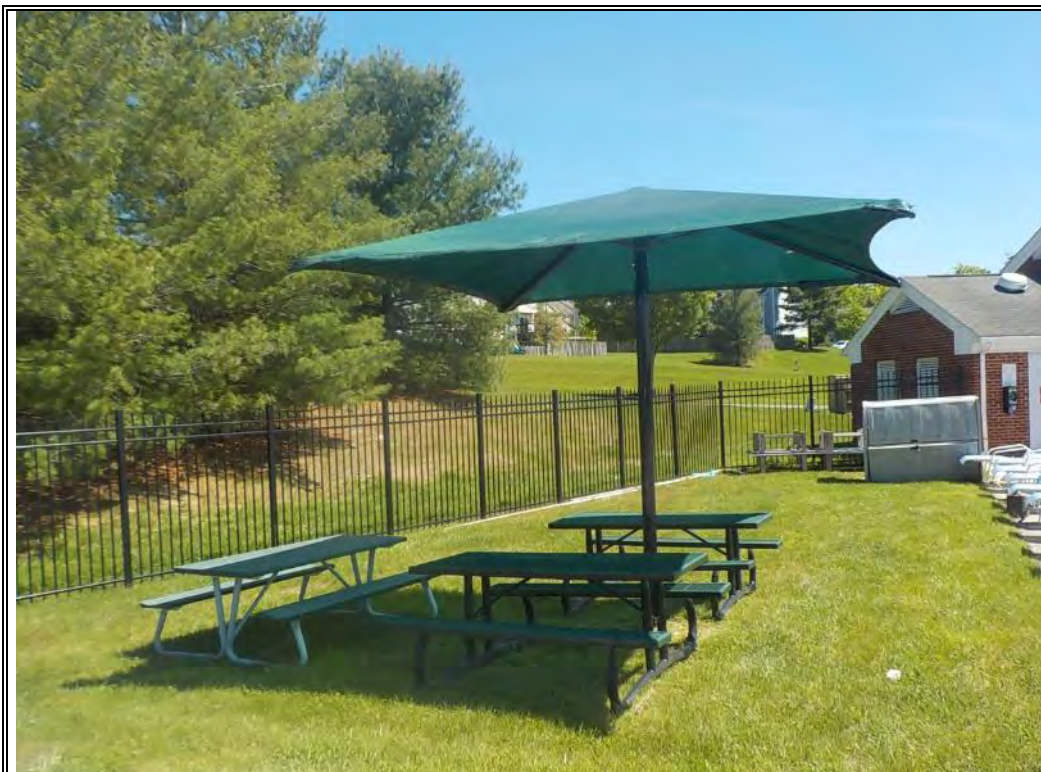
85

Large fixed
umbrella typical
of all pools

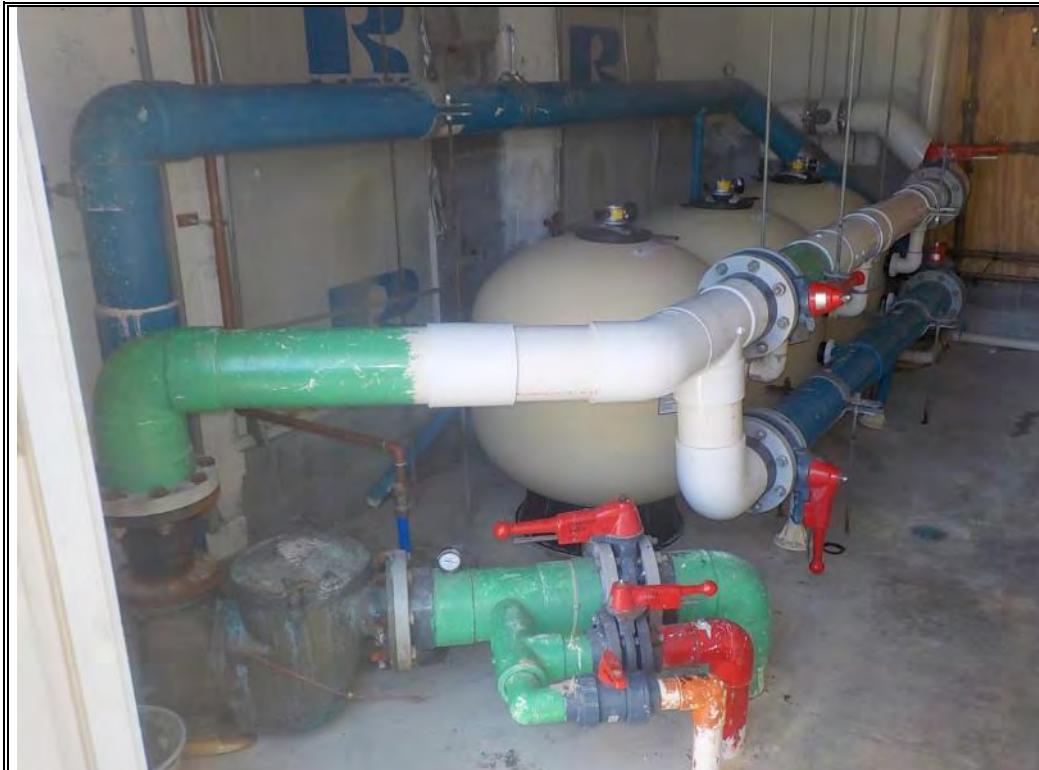
Description:
Summerfield pool
circulation pump
and sand filters

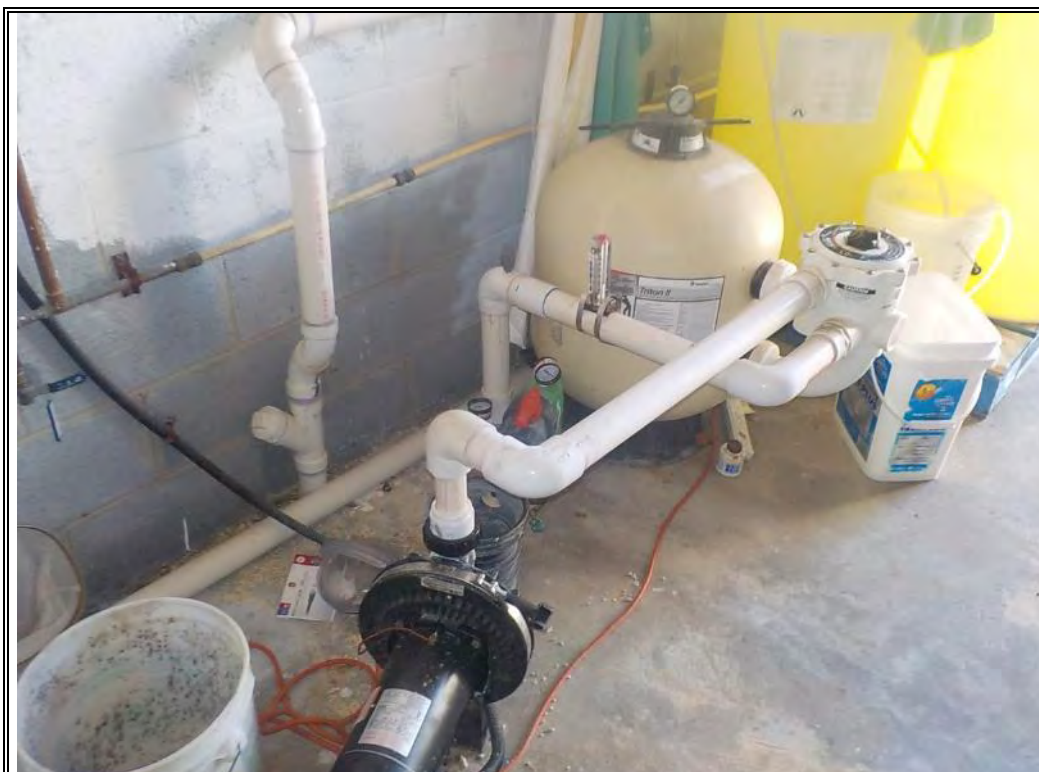
Photo Number
88

Description:
Summerfield
wading pool
equipment

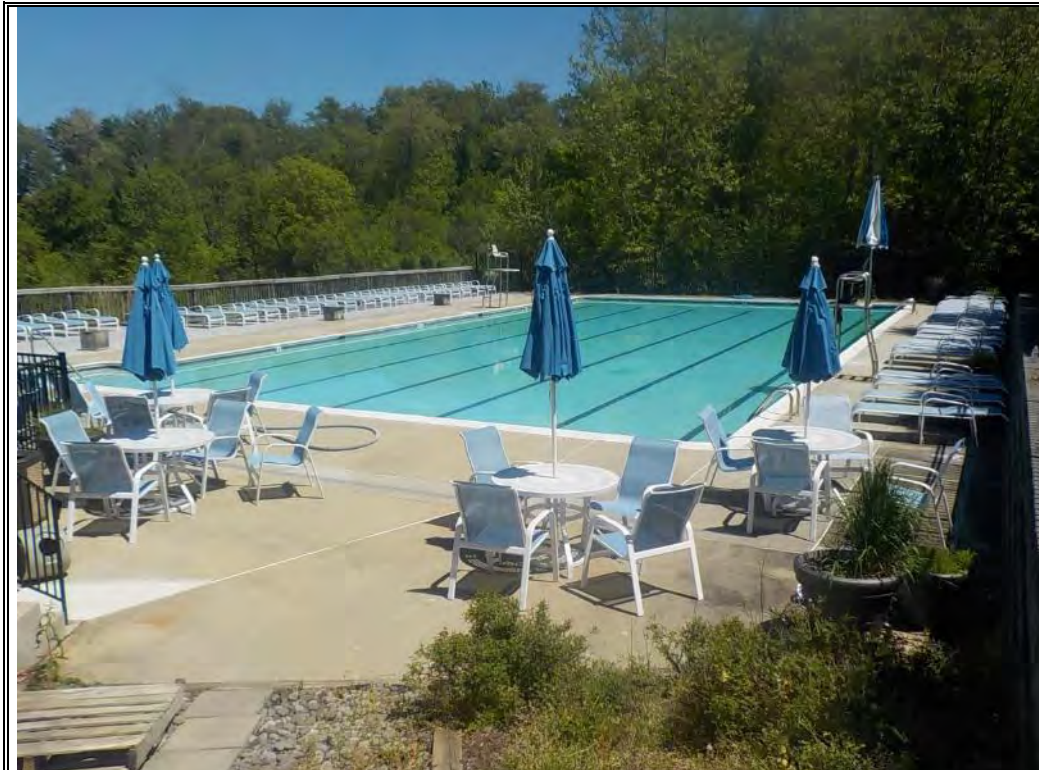
West Winds
swimming pool

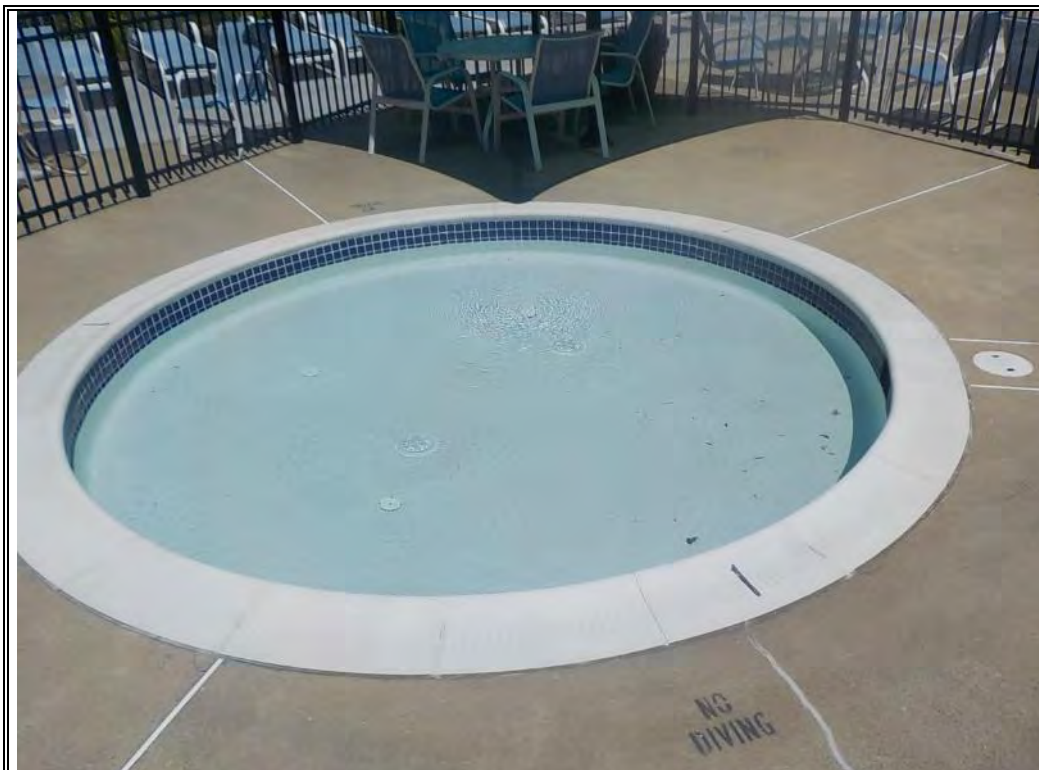
Photo Number
89

West Winds
wading pool

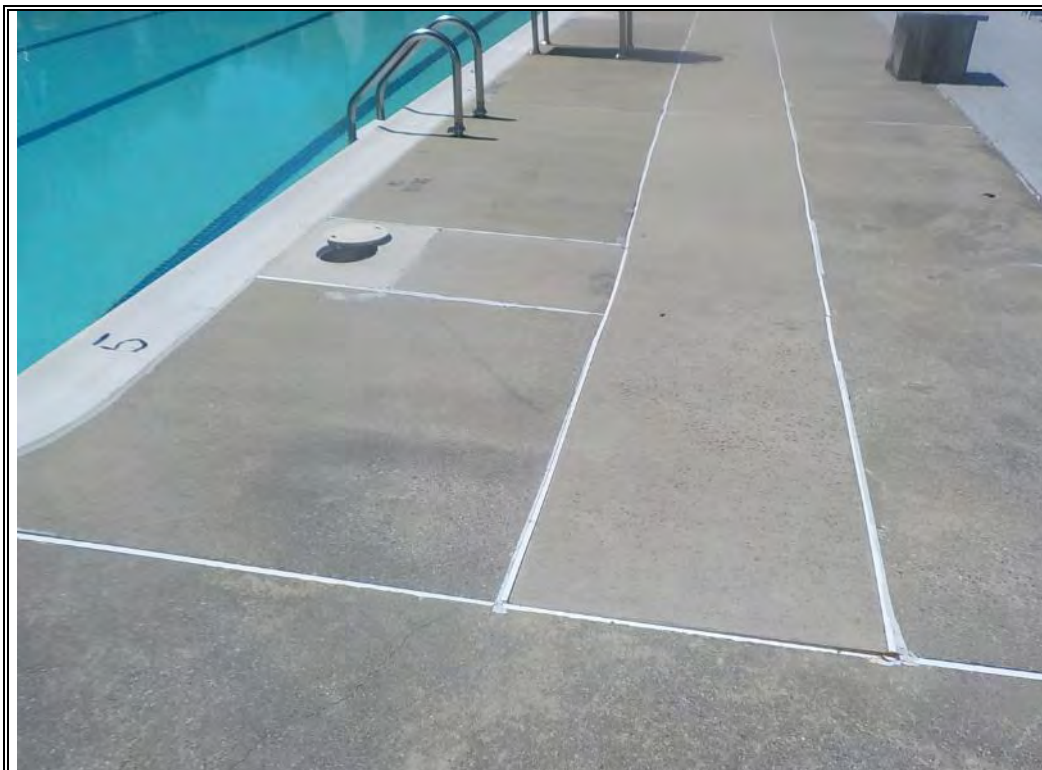
Photo Number

West Winds pool
concrete deck

Underground
circulation piping
was recently
replaced

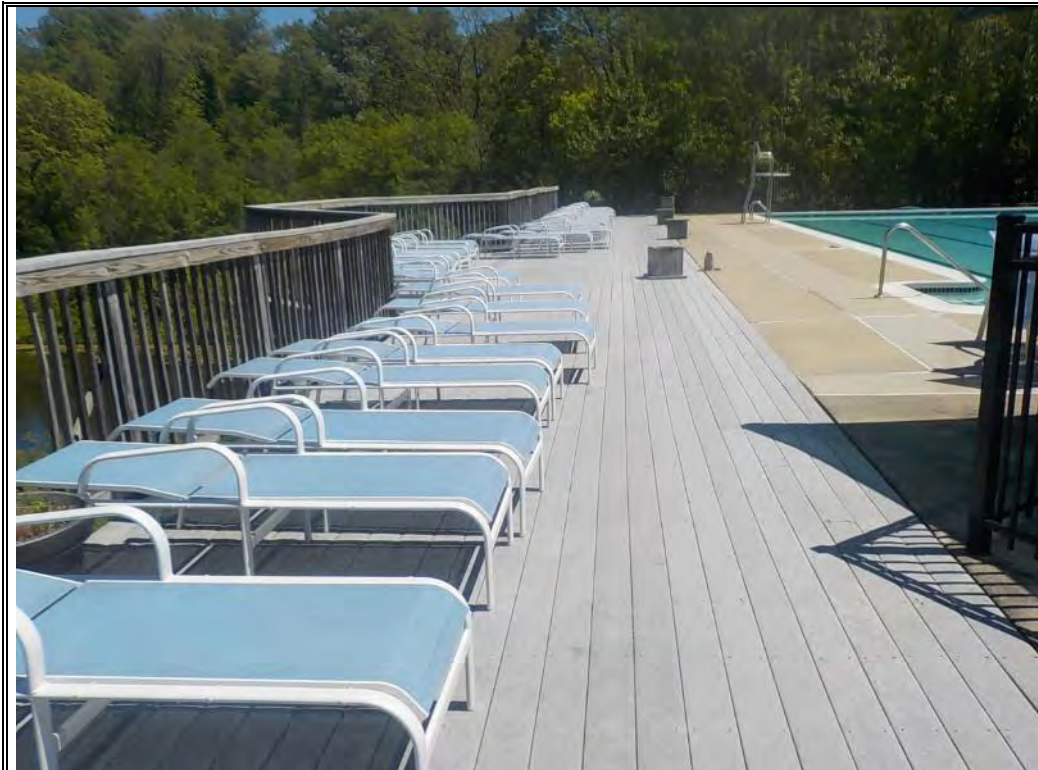
West Winds pool also has a wood deck.

The deck surface boards and railings are worn.

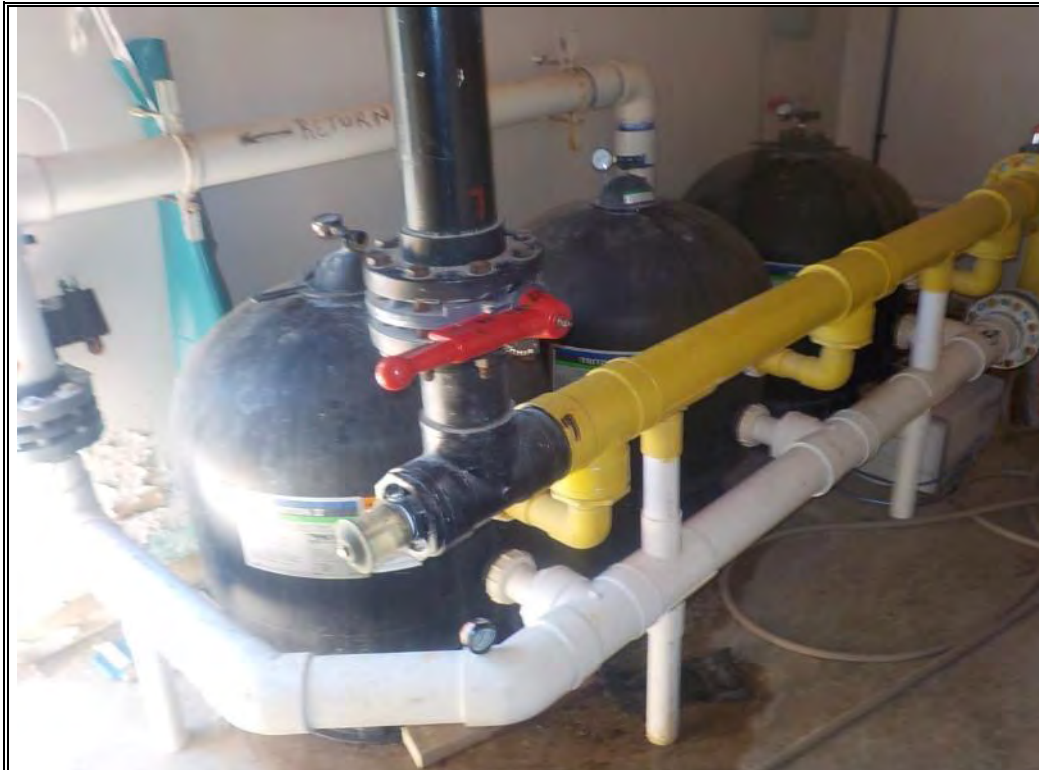
West Winds pool
sand filters

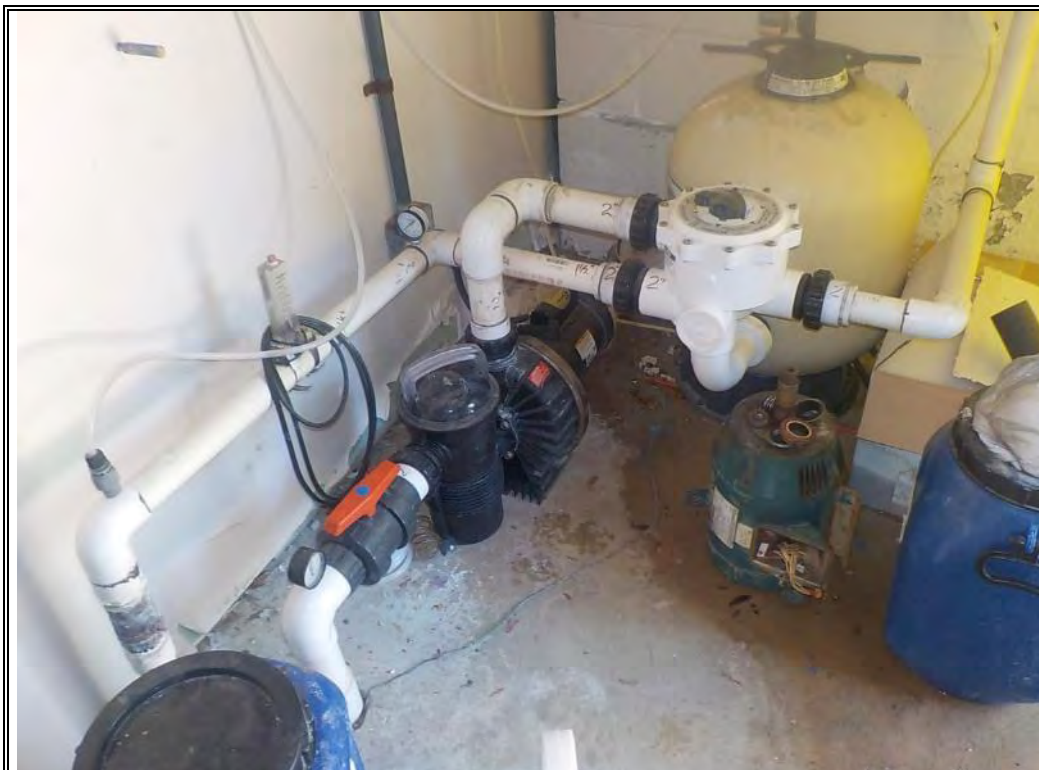
Photo Number
95

West Winds
wading pool
equipment

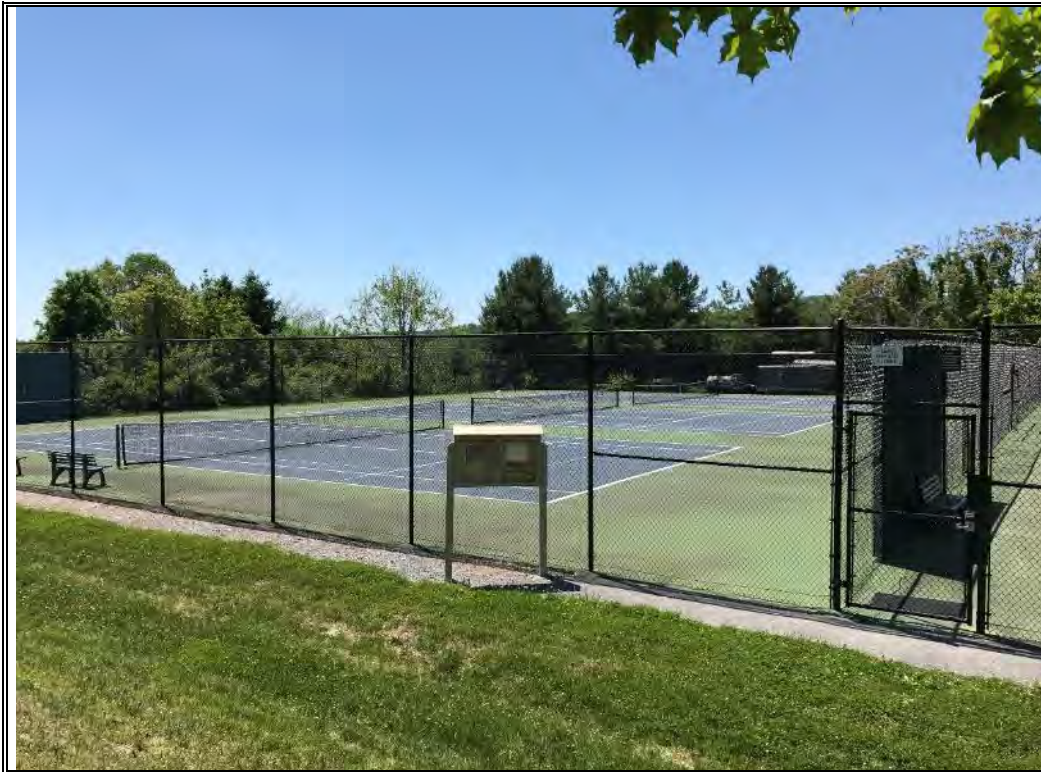
Coldstream tennis courts

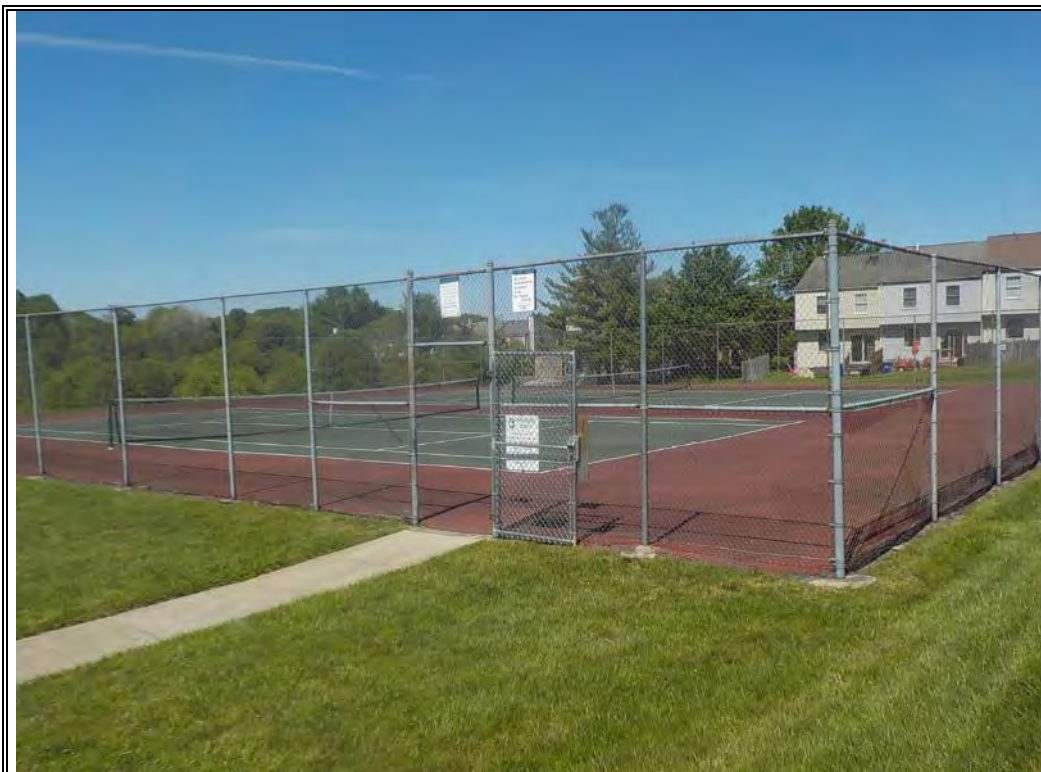
Photo Number
97

Summerfield tennis courts
