RESERVE FUND STUDY LAKE LINGANORE ASSOCIATION

LAKE LINGANORE ASSOCIATION

Criterion-Harbor Engineers

November 2, 2017

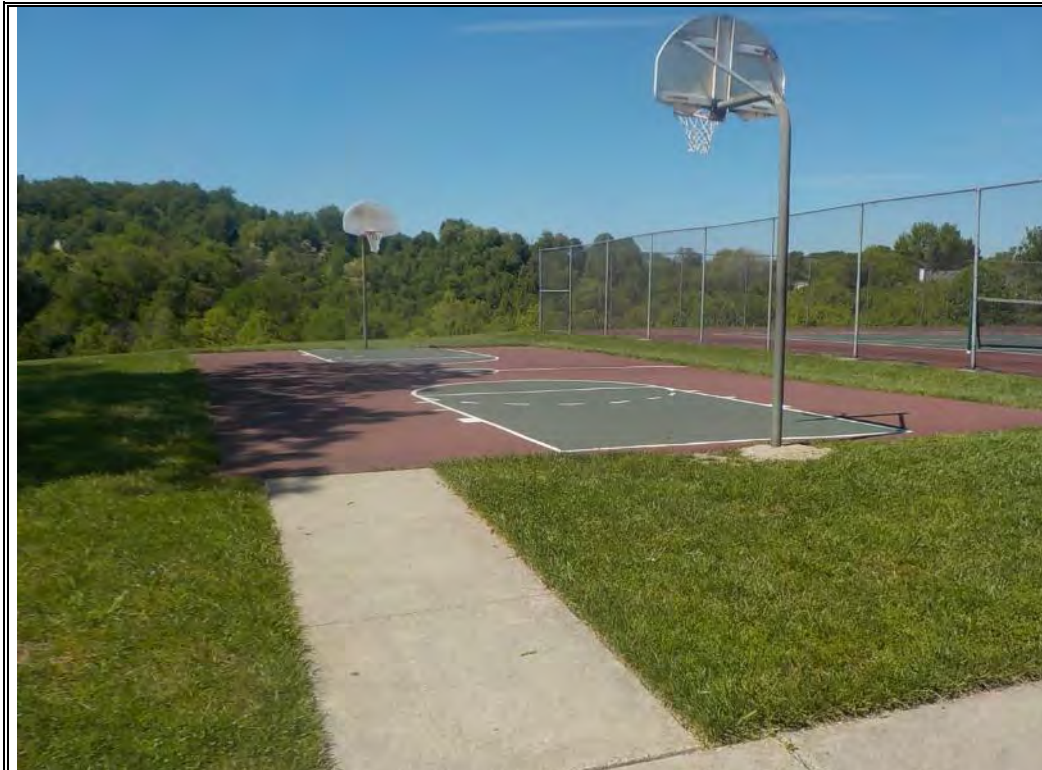
Summerfield
basketball court

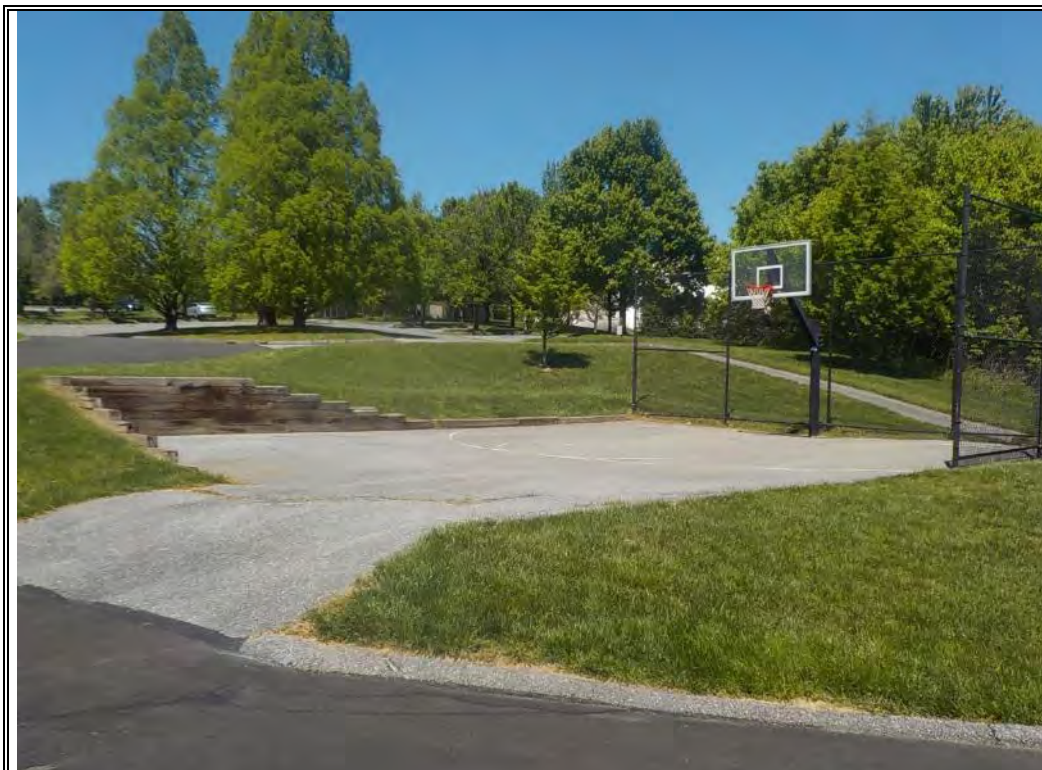
Photo Number

West Winds
basketball court
with wood
retaining wall

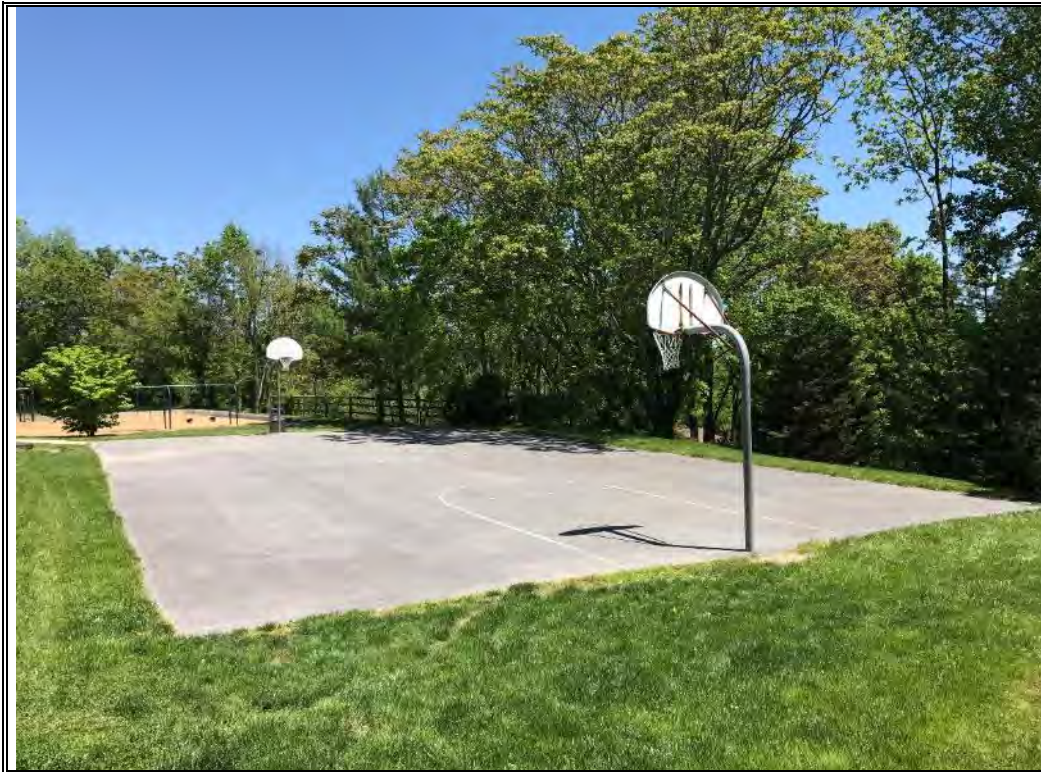
Description:
Coldstream
basketball court

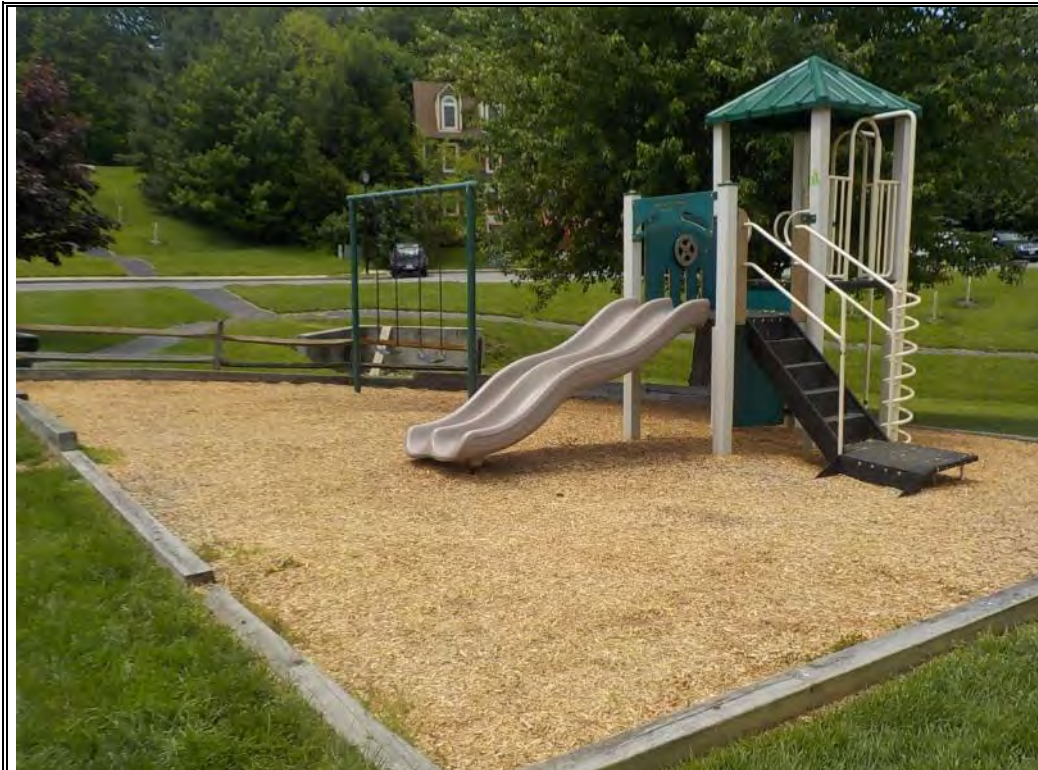
Description:
Typical equipment
for a small tot lot
(High Beach Ct.)

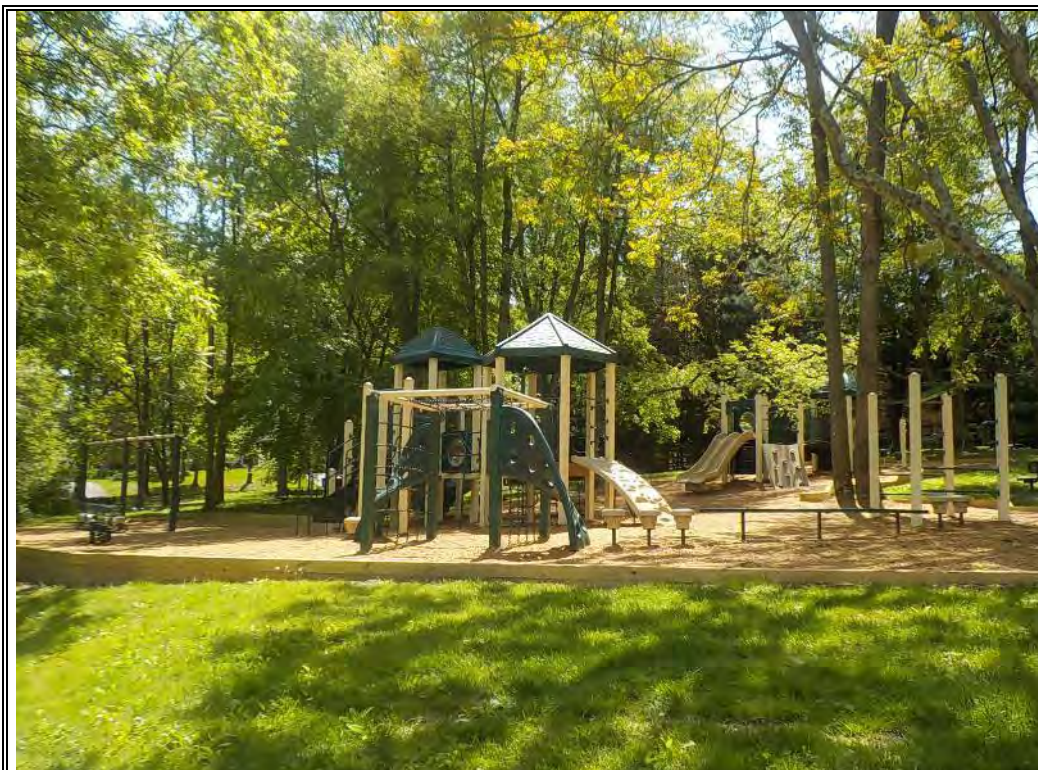
Photo Number
107

Description:
One of the larger
tot lots
(McFadden)

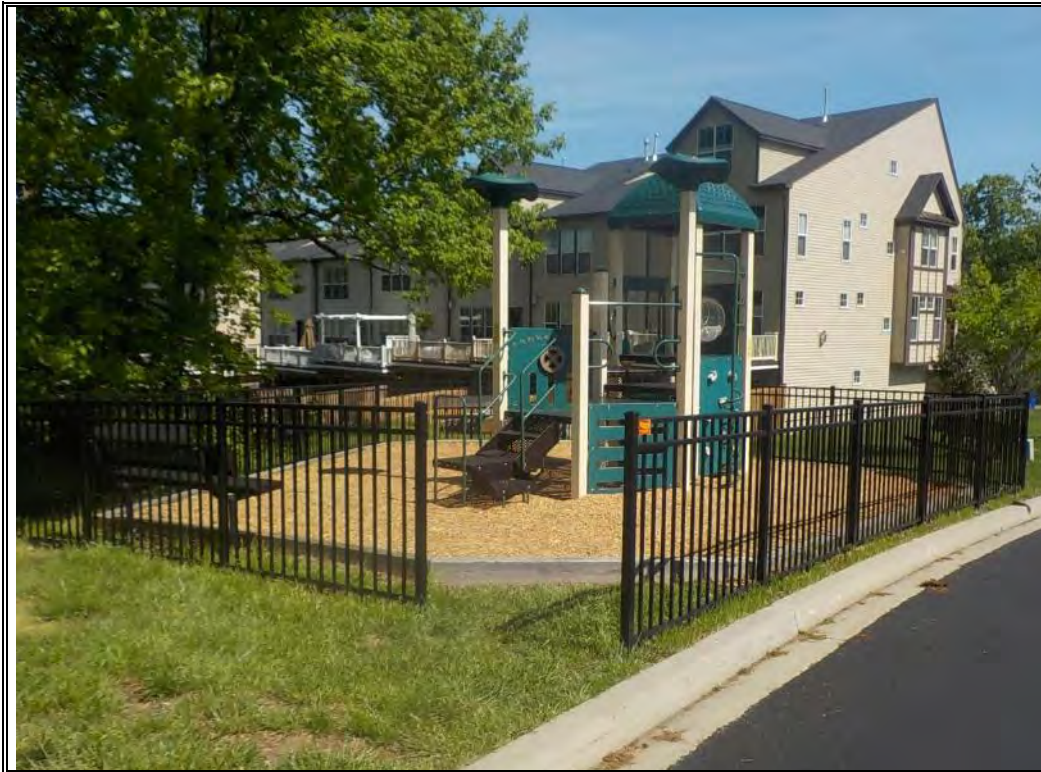
Woodland Preserve tot lot was recently completed

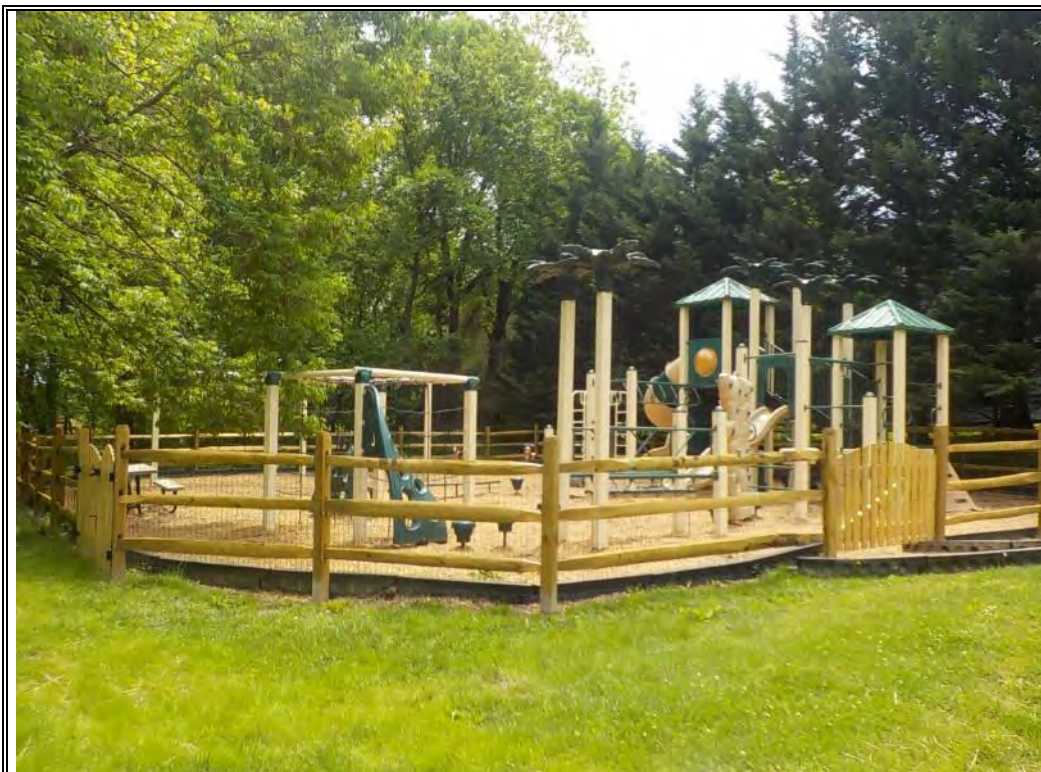
Photo Number

The perimeter fencing was recently replaced at the Twin Lake tot lot.

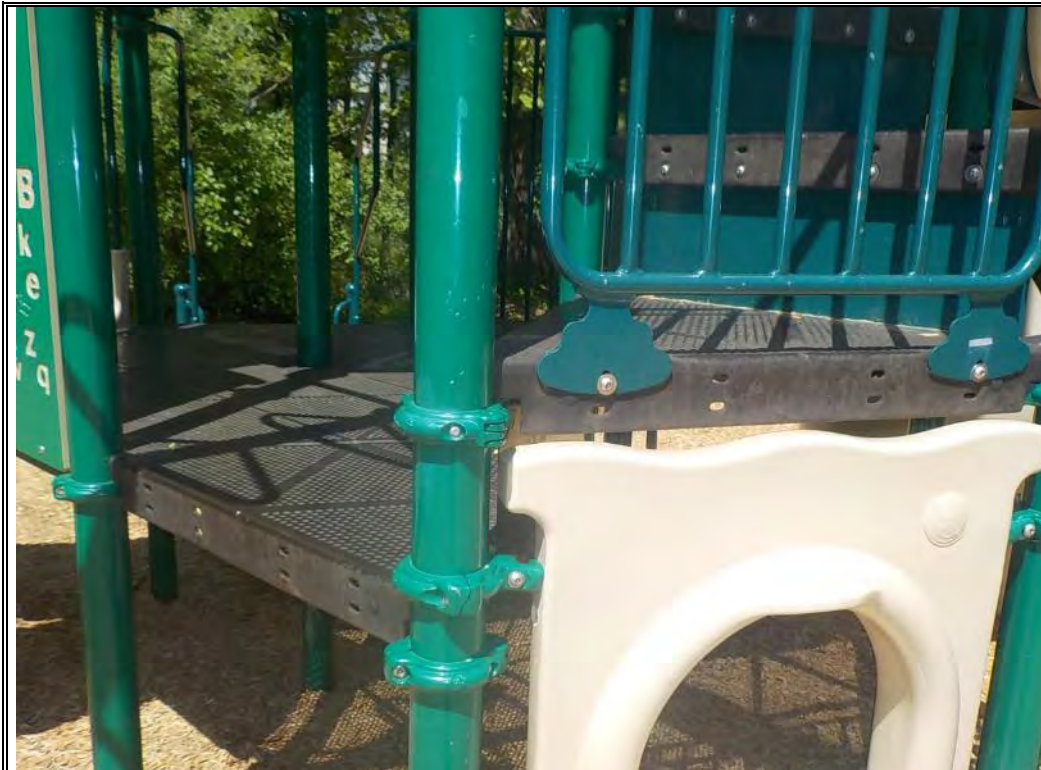
Most of the equipment is relatively new and in good condition.

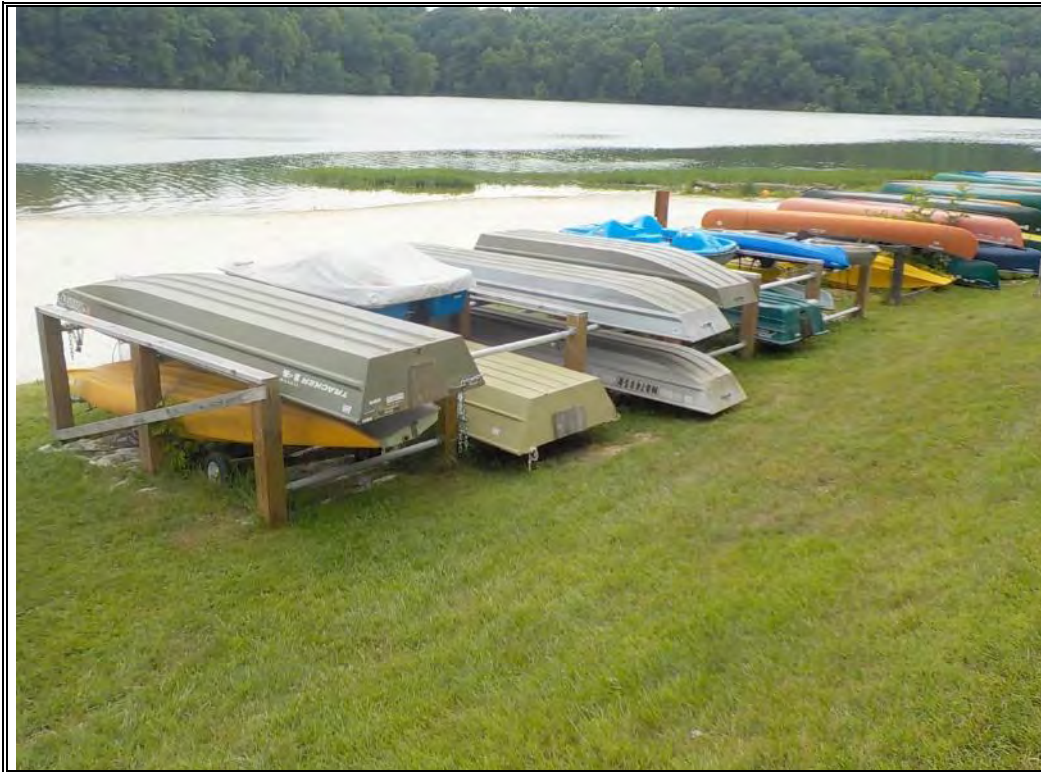
Wood framed boat racks are provide at all three public beach areas

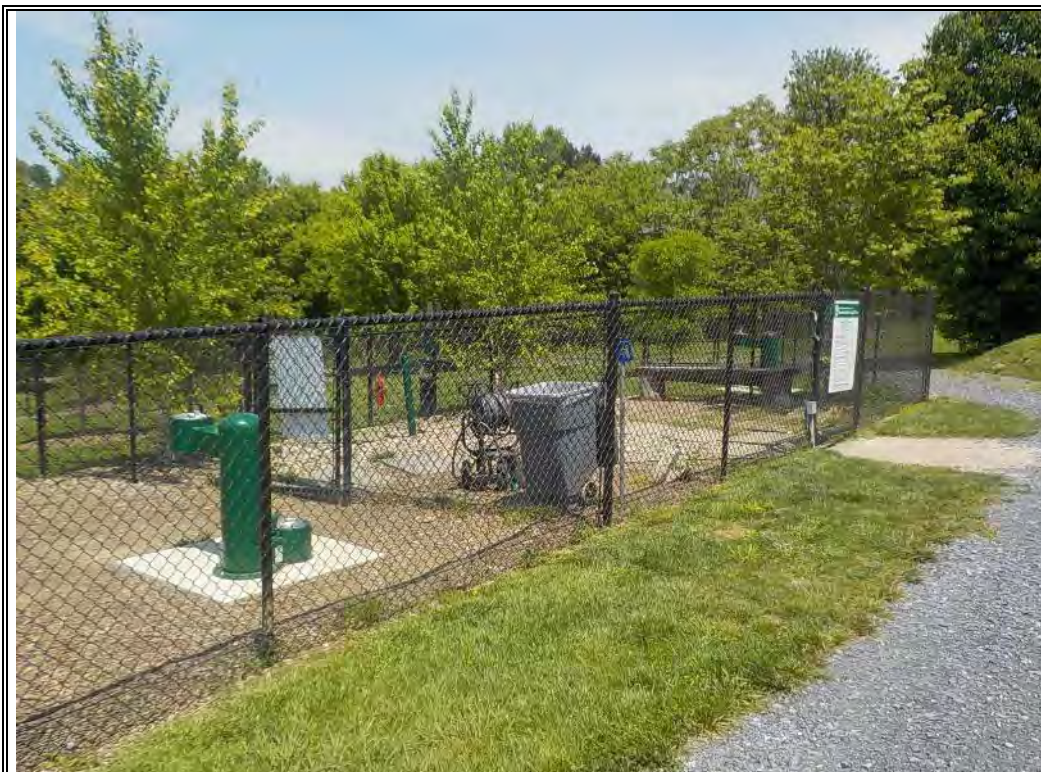
Photo Number

A large, fenced dog park was recently constructed

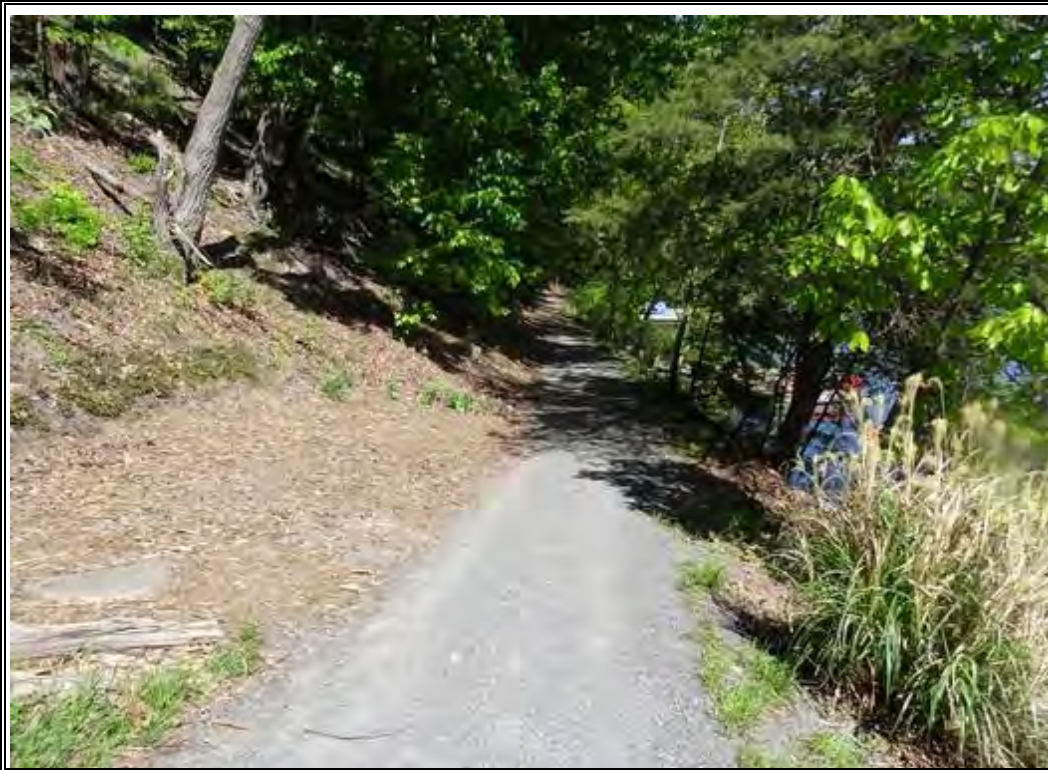
Asphalt paved trail located on north-west side of Lake Linganore

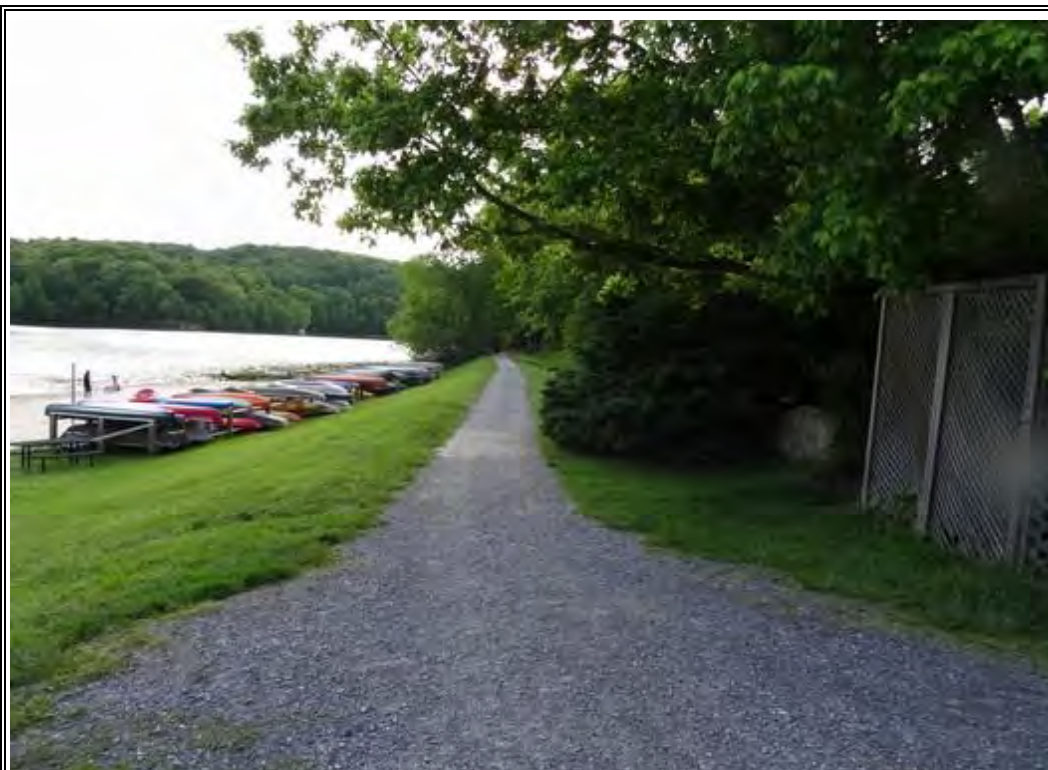
Photo Number

Crushed stone trail on north side of Lake Linganore as viewed along beach on south side of Coldstream village

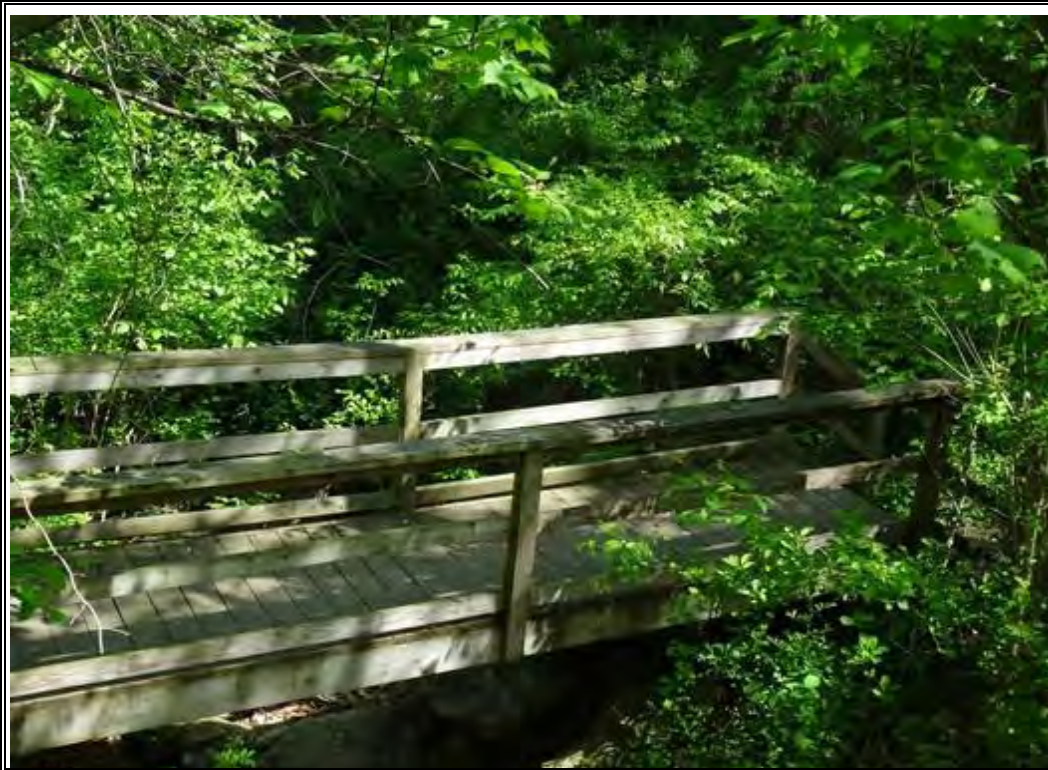
Wood bridges
along trails as
viewed in West
Winds village

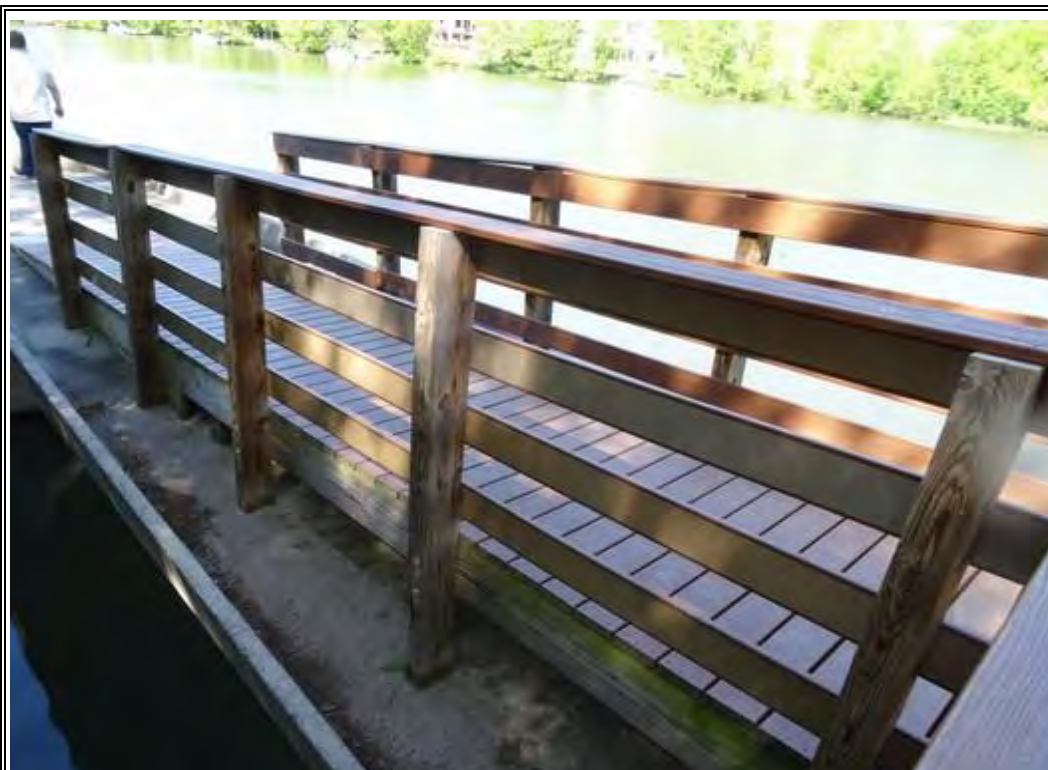
Photo Number

Wood deck on
south side of
esplanade bridge

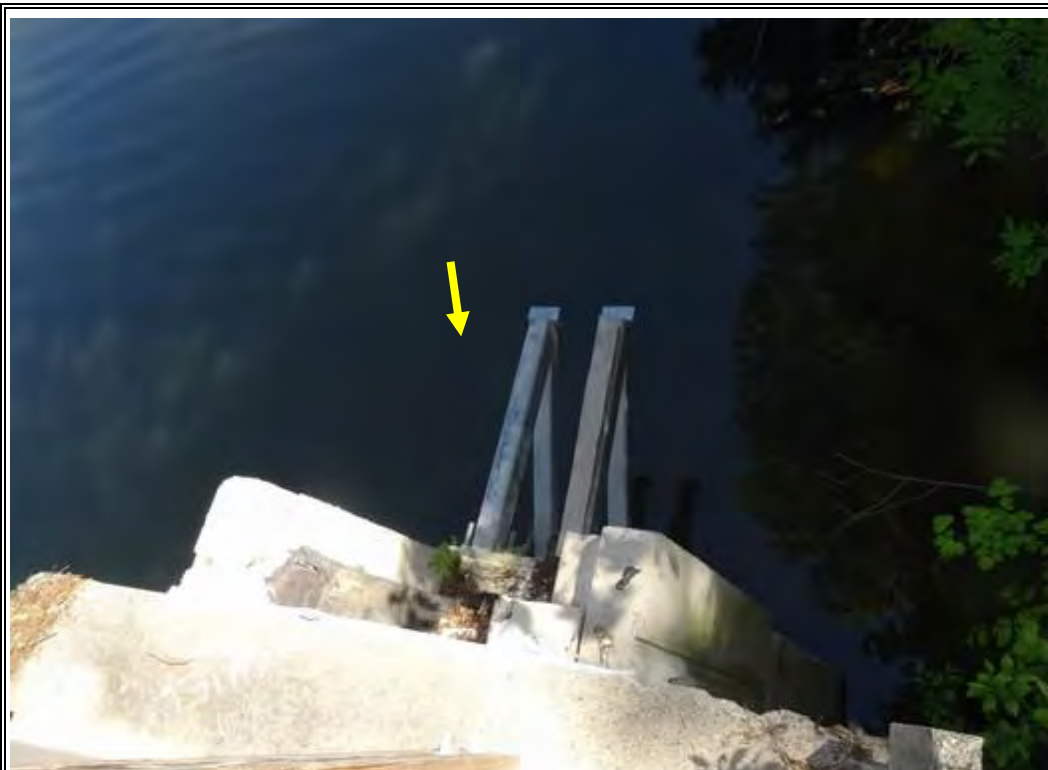
Photo Number

A section of esplanade concrete bridge that was demolished in the past

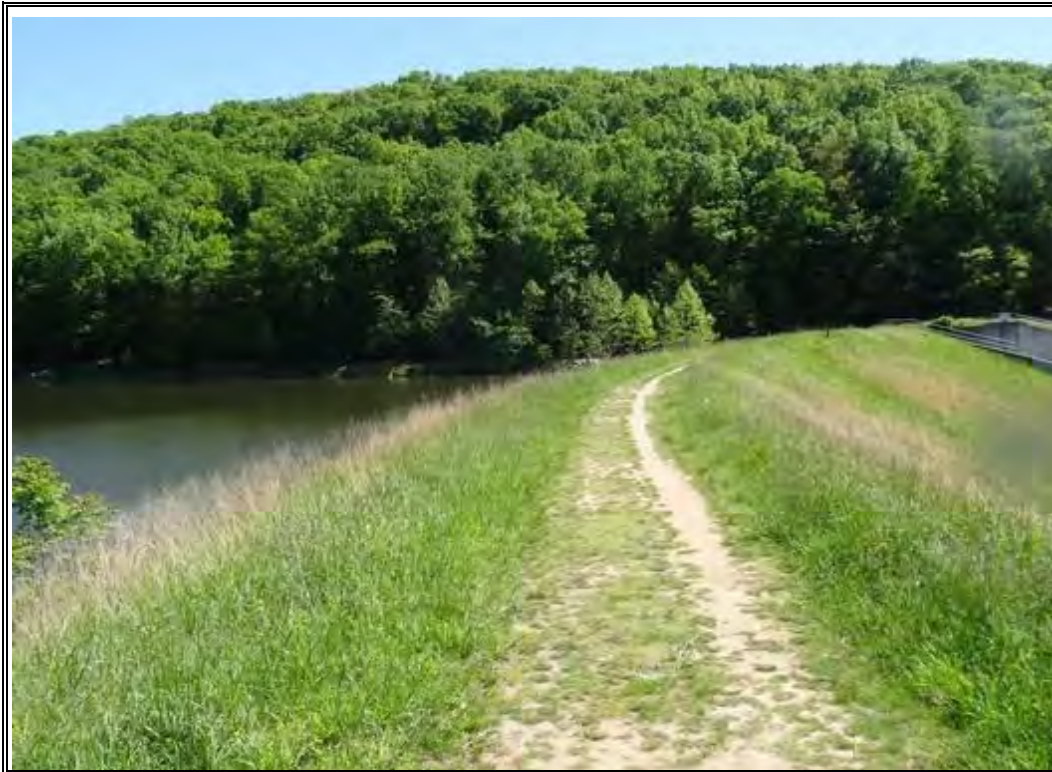
Dam embankment
and spillway on
west side of Lake
Linganore

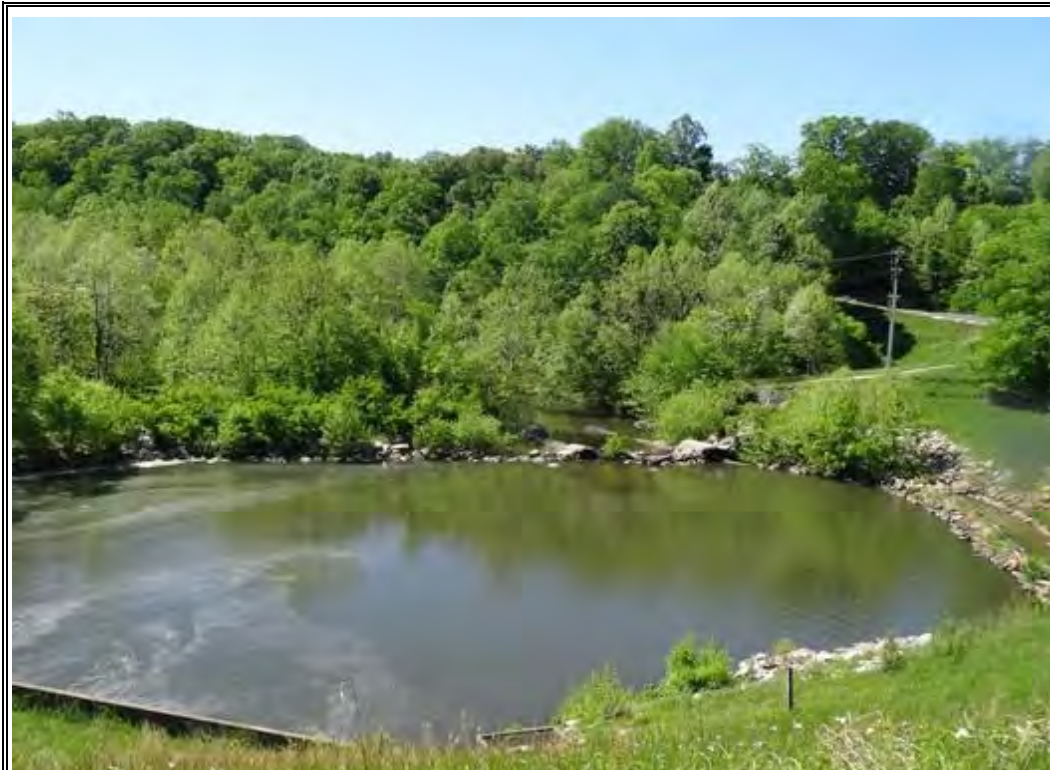
Stilling basin at
bottom of Lake
Linganore spillway

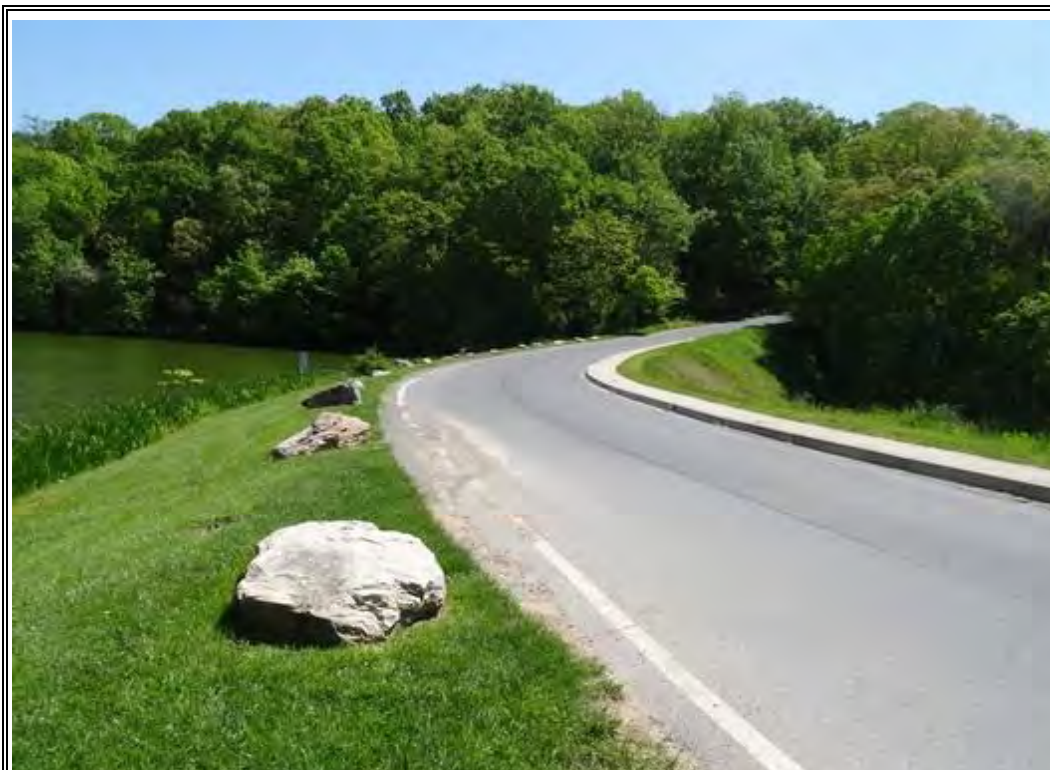
Photo Number

Eaglehead Drive
over the dam
embankment
located on the
south side of Lake
Merle

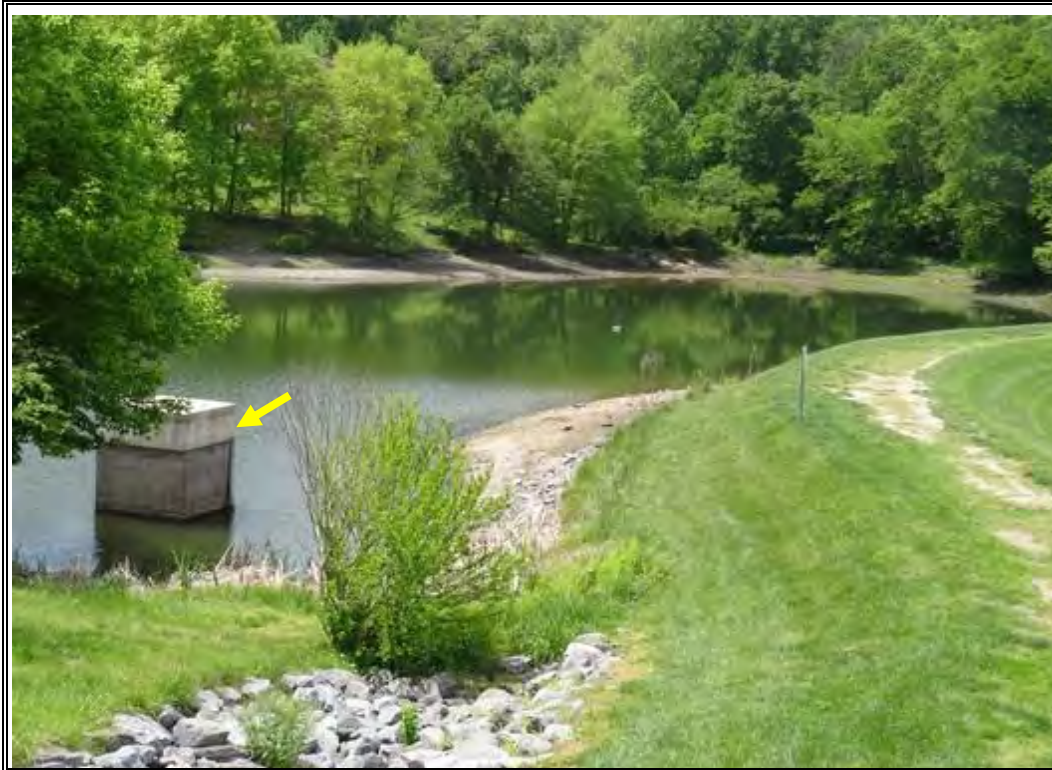
Lake Anita Louise
outlet riser

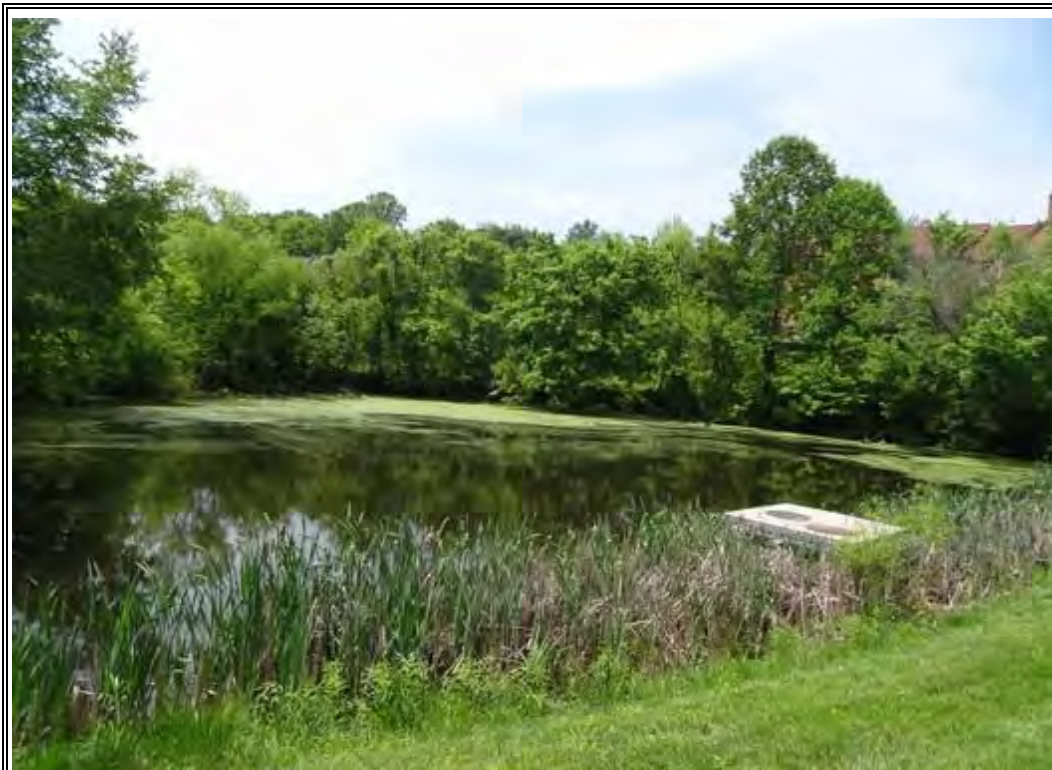
Photo Number

Pond in Pinehurst
village

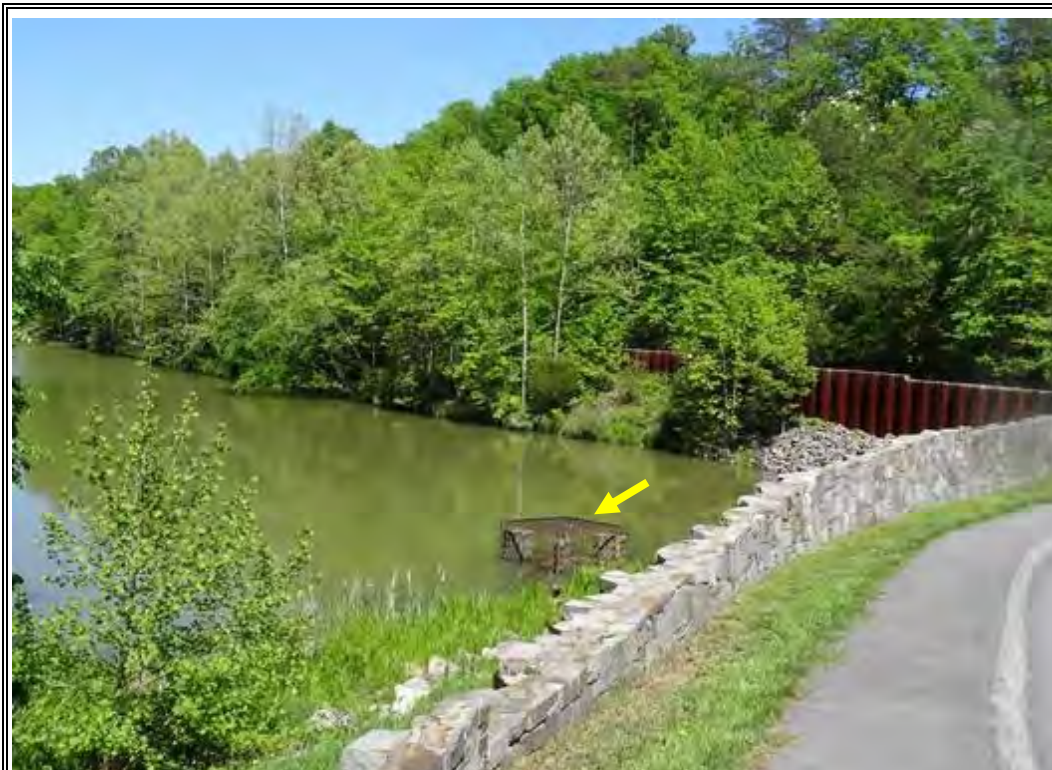
Photo Number

Outlet riser on
west side of Lake
Marion

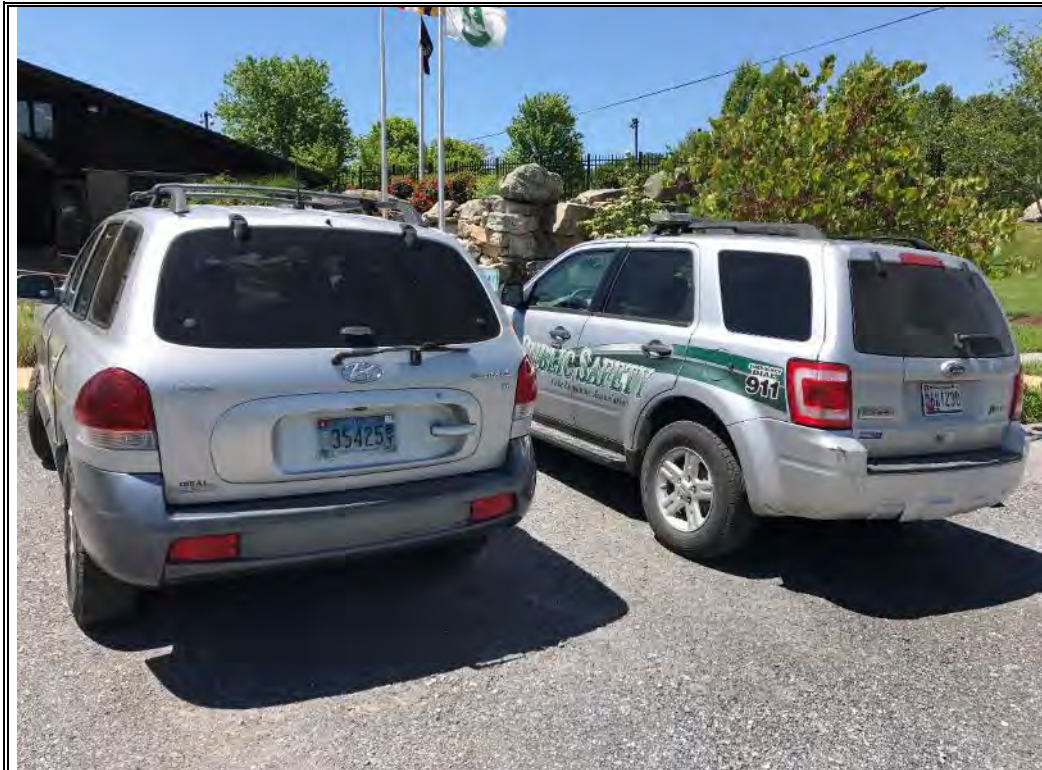
The Association maintains several road vehicles for management personnel

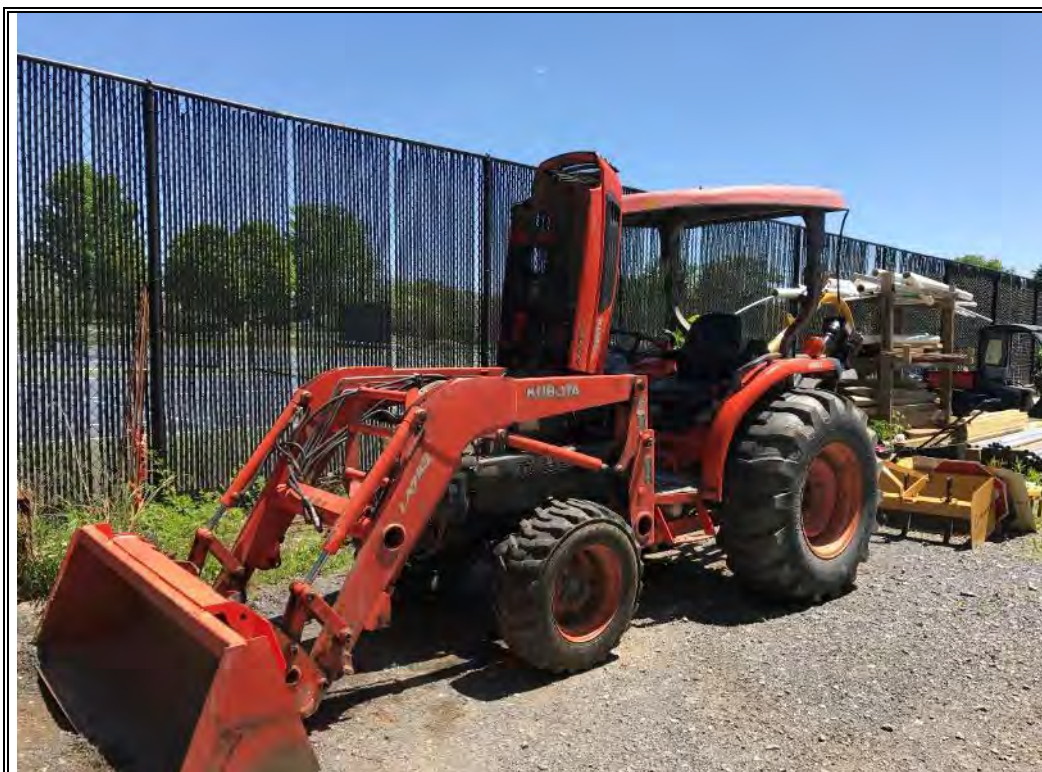
Photo Number

The Association also has a multi-function tractor and other maintenance equipment
